Hybrid 2z102 Traveler

November 9, 1999

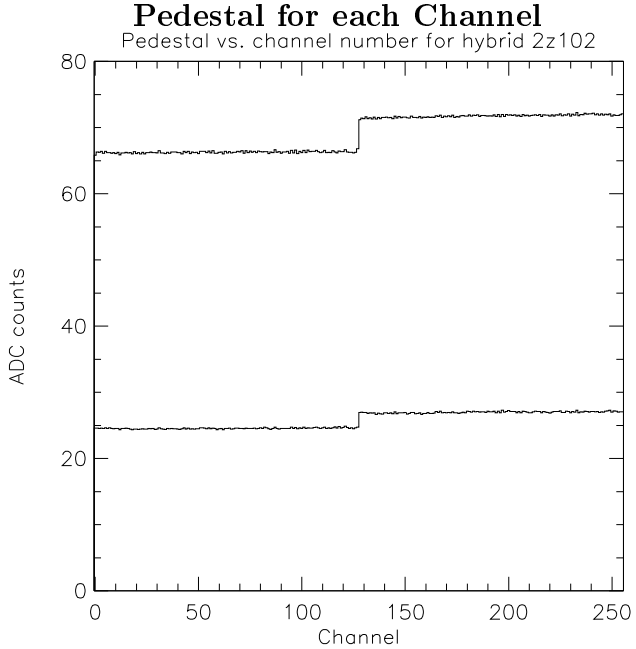
Pedestal for each Channel

The following plot shows the pedestals vs. channel number with and without charge injection:

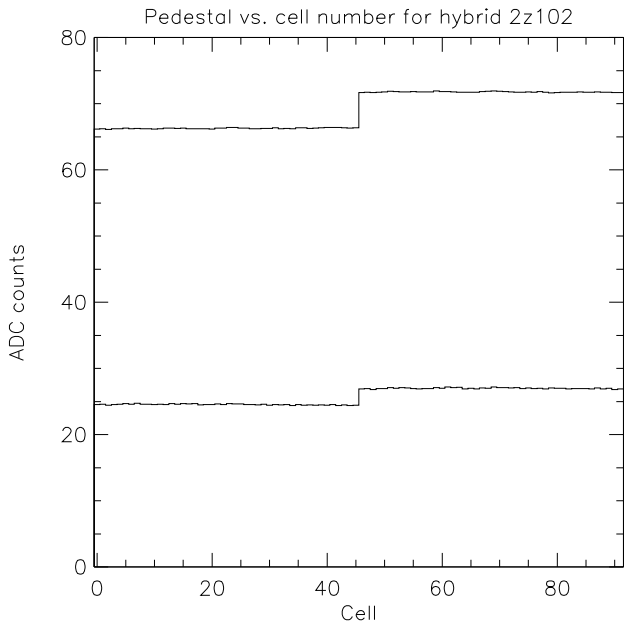
Pedestal vs. Pipeline Cell ID

The following plot shows the average pedestal vs. pipeline cell ID with and without charge injection. The x-axis is cell ID offset by 46 for each chip. Thus cell ID 5 for chip 1 is at x=5, chip 2 at x=51, chip 3 at x=97, etc.

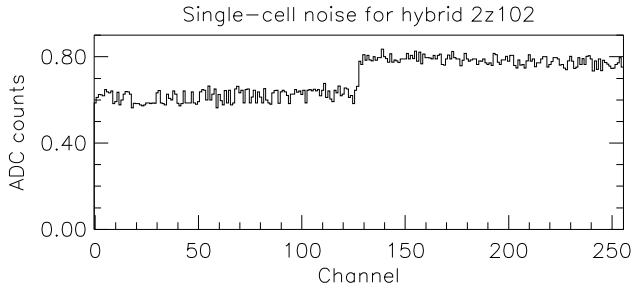
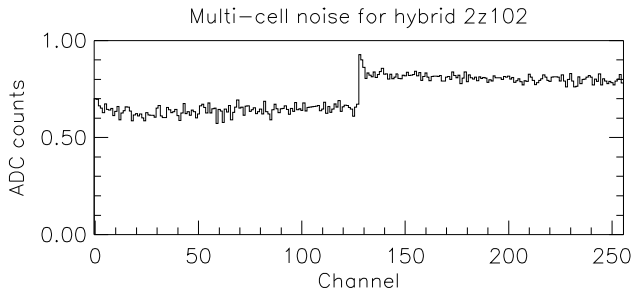
RMS Noise

The following plots show the single-cell and multi-cell RMS noise:

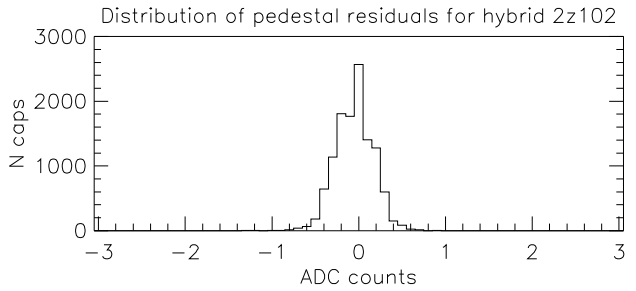
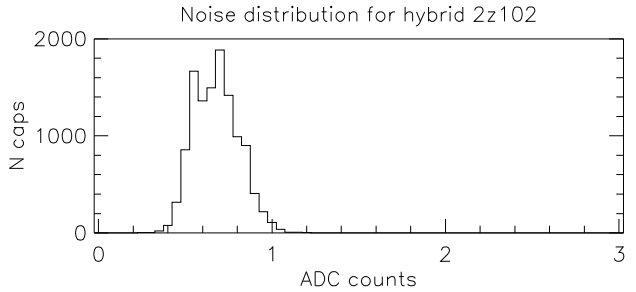
Distribution of Pedestals and Noise

The following are histograms of the pedestal of each pipeline capacitor relative to the chip average (top); and the RMS noise of each capacitor (bottom):

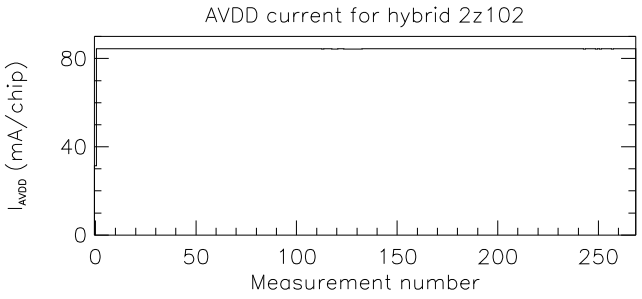
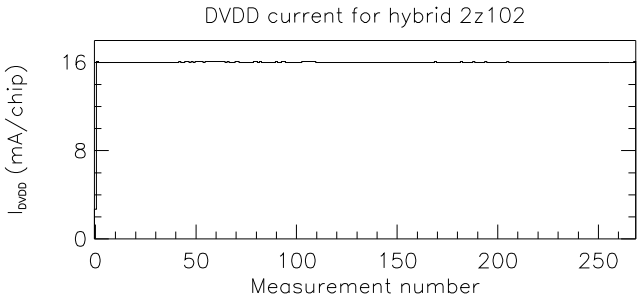
Supply Currents During Burn-in

The following plots show the supply currents per chip as a function of measurment number. Currents are measured approximately every 10 minutes:
