Hybrid 2z124 Traveler

October 11, 1999

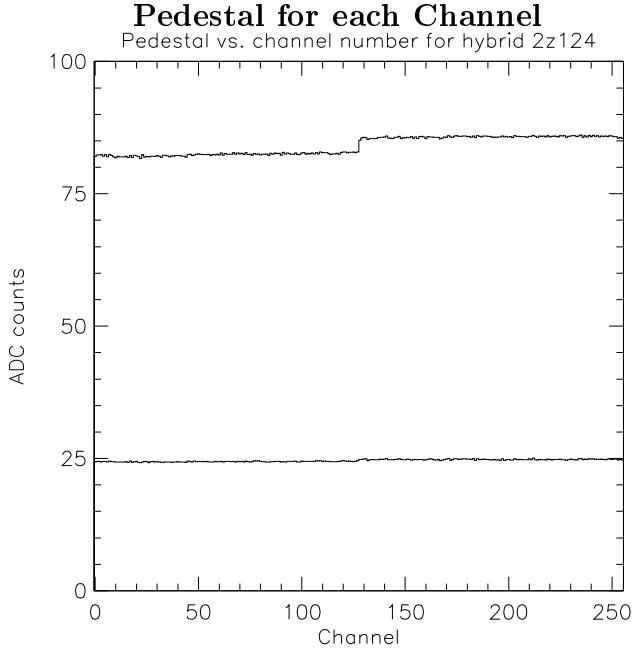
Pedestal for each Channel

The following plot shows the pedestals vs. channel number with and without charge injection:

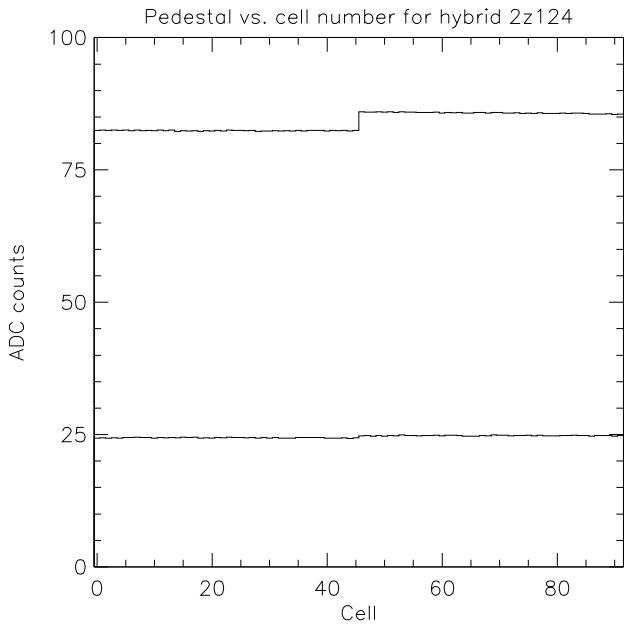
Pedestal vs. Pipeline Cell ID

The following plot shows the average pedestal vs. pipeline cell ID with and without charge injection. The x-axis is cell ID offset by 46 for each chip. Thus cell ID 5 for chip 1 is at x=5, chip 2 at x=51, chip 3 at x=97, etc.

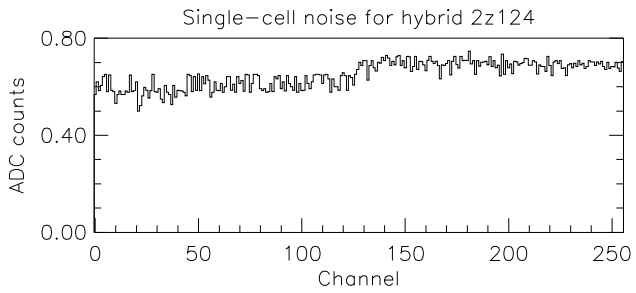
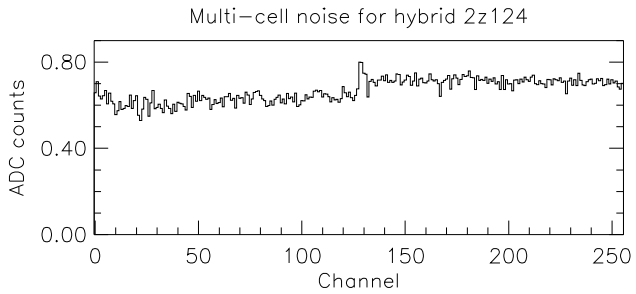
RMS Noise

The following plots show the single-cell and multi-cell RMS noise:

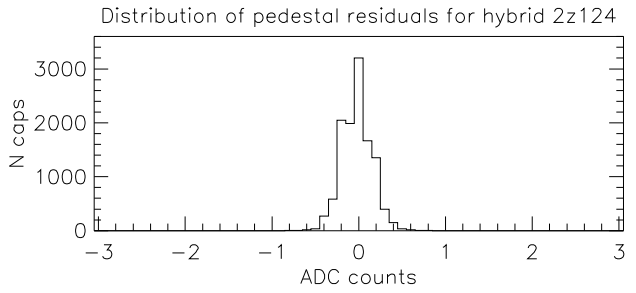
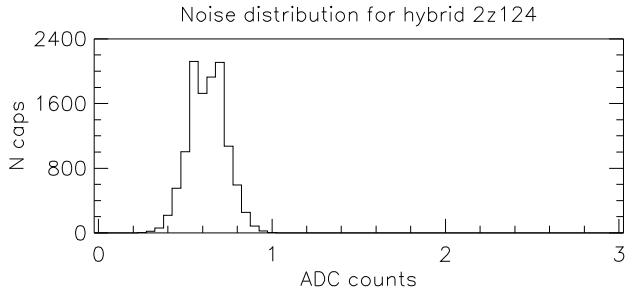
Distribution of Pedestals and Noise

The following are histograms of the pedestal of each pipeline capacitor relative to the chip average (top); and the RMS noise of each capacitor (bottom):

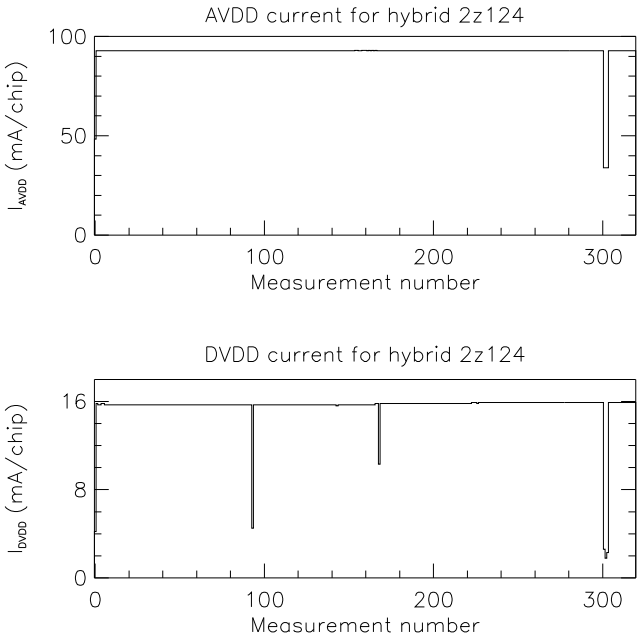
Supply Currents During Burn-in

The following plots show the supply currents per chip as a function of measurment number. Currents are measured approximately every 10 minutes:
