Hybrid 2z130 Traveler

January 13, 2000

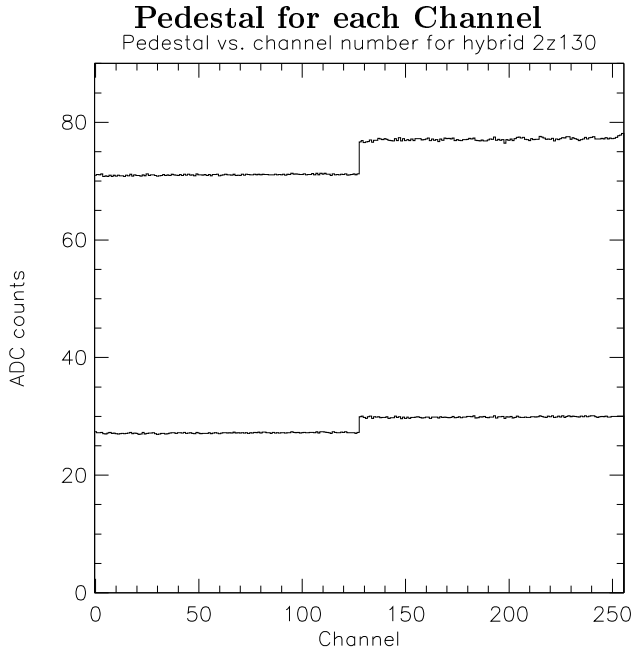
The following plot shows the pedestals vs. channel number with and without charge injection:

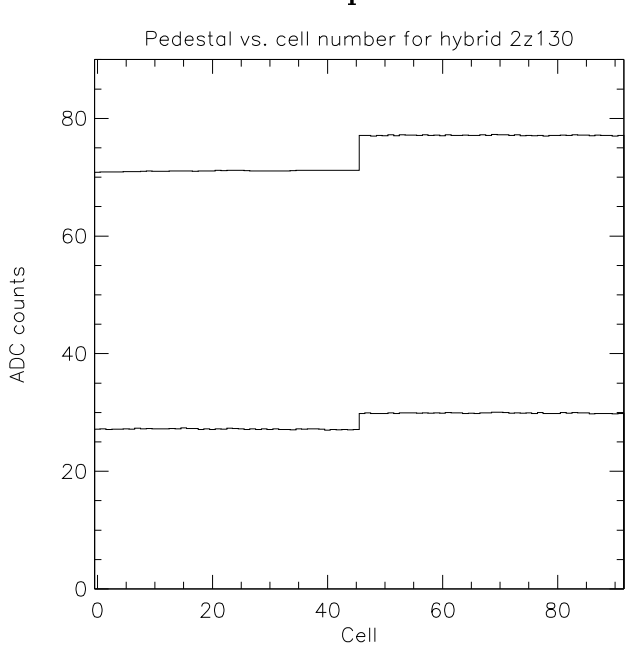
The following plot shows the average pedestal vs. pipeline cell ID with and without charge injection. The x-axis is cell ID offset by 46 for each chip. Thus cell ID 5 for chip 1 is at x=5, chip 2 at x=51, chip 3 at x=97, etc.

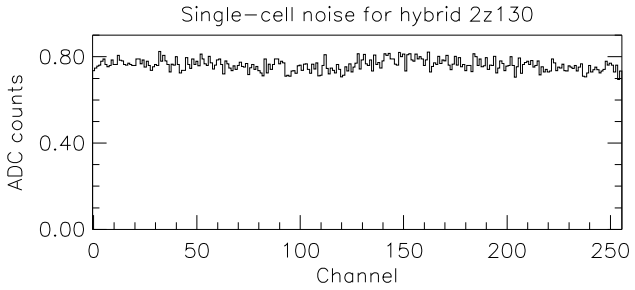
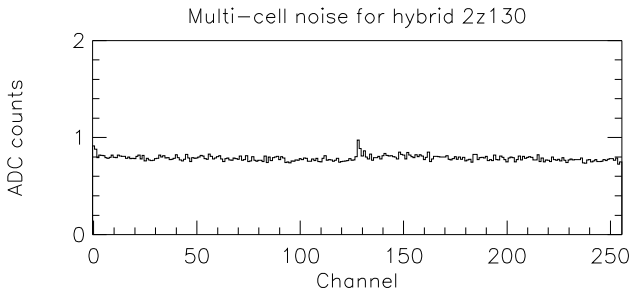
RMS Noise

The following plots show the single-cell and multi-cell RMS noise:

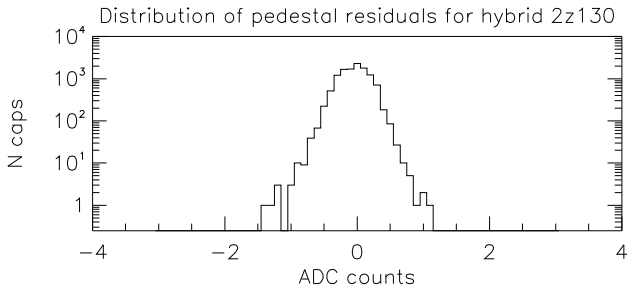
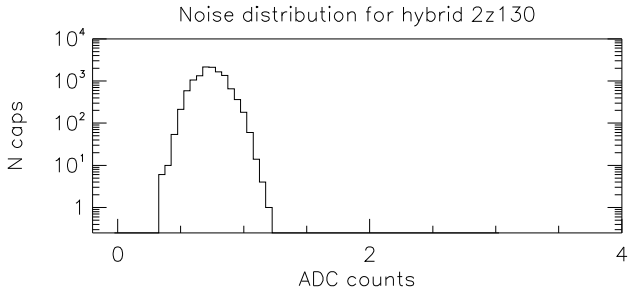
Distribution of Pedestals and Noise

The following are histograms of the pedestal of each pipeline capacitor relative to the chip average (top); and the RMS noise of each capacitor (bottom):

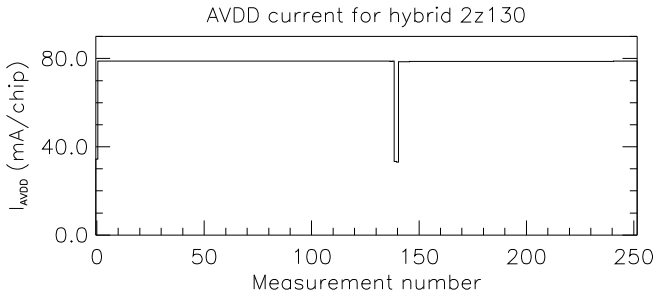
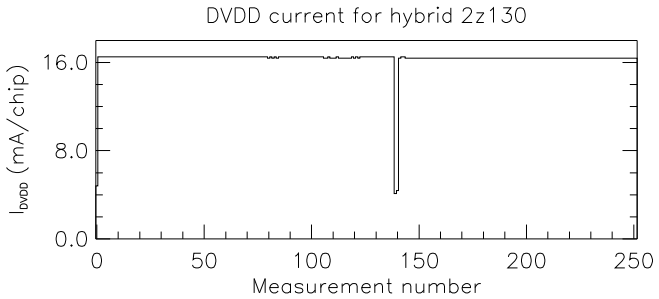
Supply Currents During Burn-in

The following plots show the supply currents per chip as a function of measurment number. Currents are measured approximately every 10 minutes:
