Hybrid 2z224 Traveler

March 14, 2000

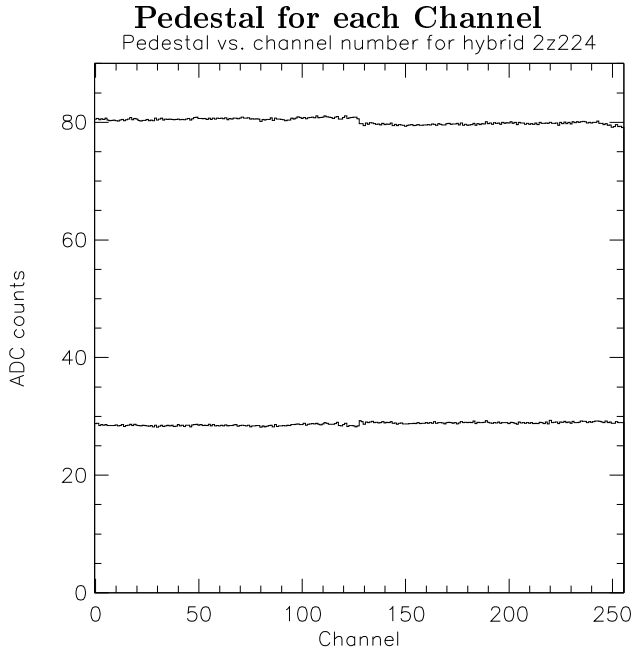
The following plot shows the pedestals vs. channel number with and without charge injection:

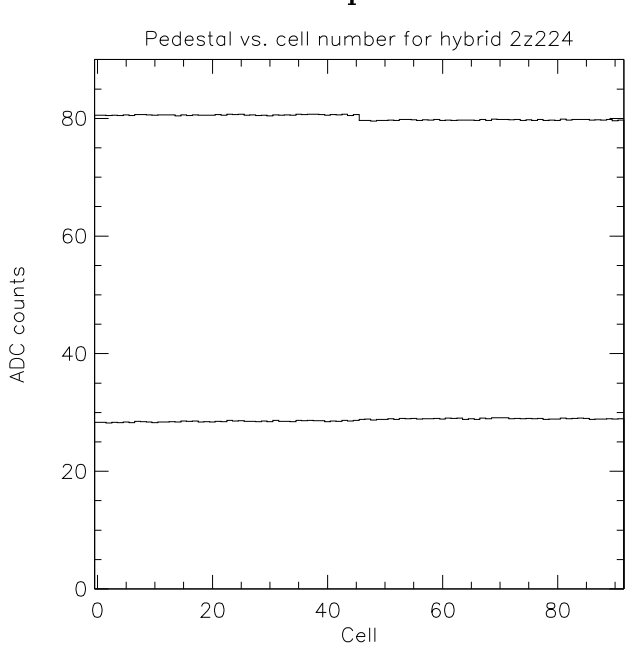
The following plot shows the average pedestal vs. pipeline cell ID with and without charge injection. The x-axis is cell ID offset by 46 for each chip. Thus cell ID 5 for chip 1 is at x=5, chip 2 at x=51, chip 3 at x=97, etc.

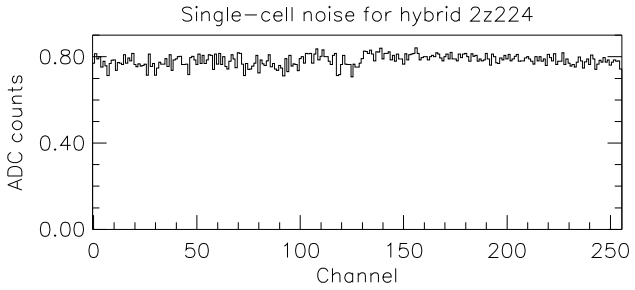
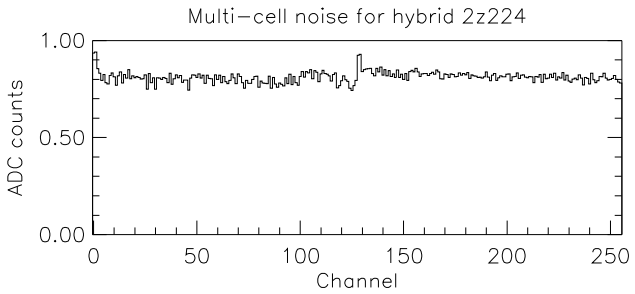
RMS Noise

The following plots show the single-cell and multi-cell RMS noise:

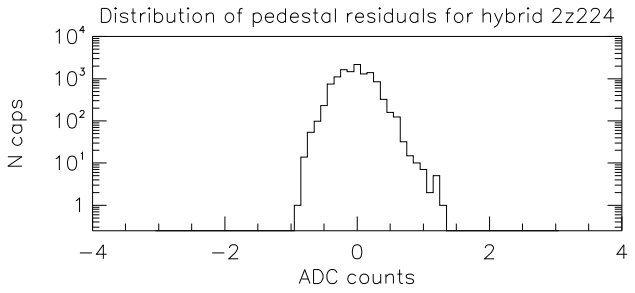
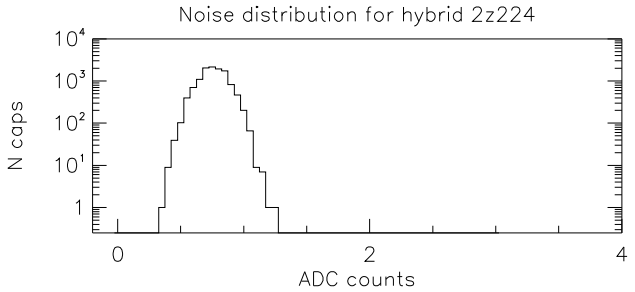
Distribution of Pedestals and Noise

The following are histograms of the pedestal of each pipeline capacitor relative to the chip average (top); and the RMS noise of each capacitor (bottom):

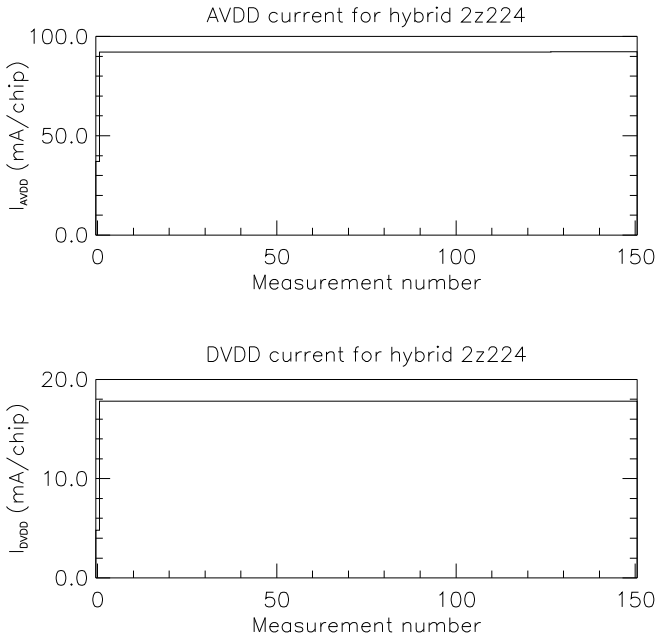
Supply Currents During Burn-in

The following plots show the supply currents per chip as a function of measurment number. Currents are measured approximately every 10 minutes:
