Hybrid 2z24 Traveler

December 13, 1999

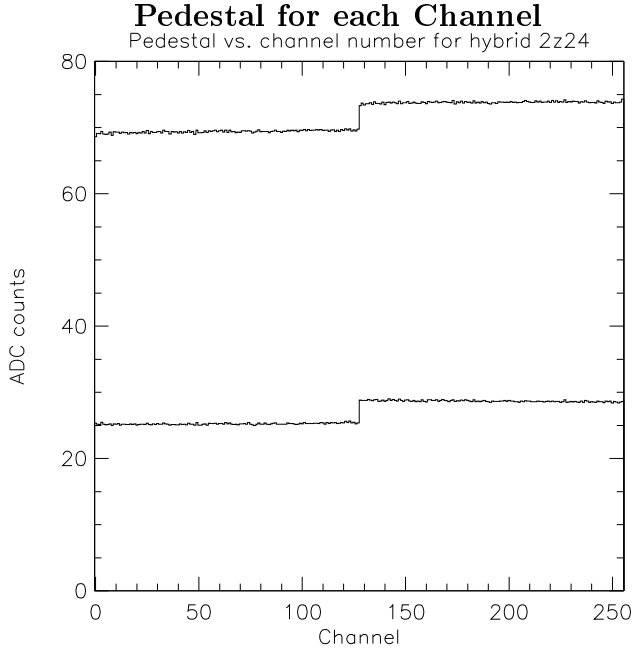
Pedestal for each Channel

The following plot shows the pedestals vs. channel number with and without charge injection:

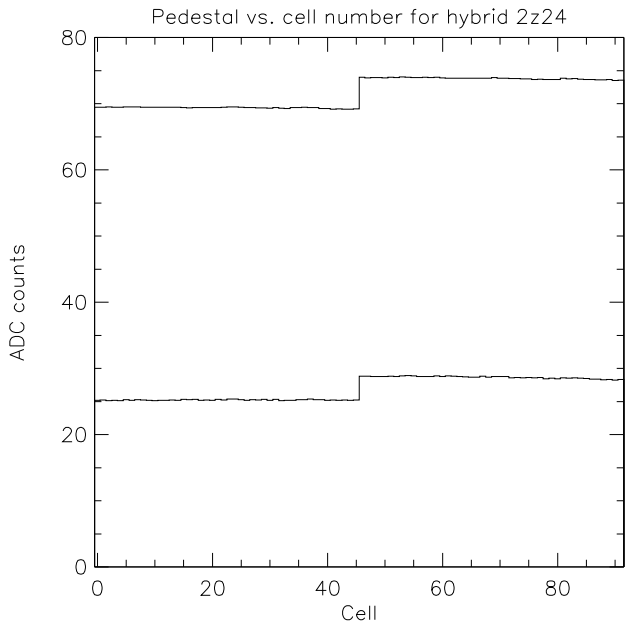
Pedestal vs. Pipeline Cell ID

The following plot shows the average pedestal vs. pipeline cell ID with and without charge injection. The x-axis is cell ID offset by 46 for each chip. Thus cell ID 5 for chip 1 is at x=5, chip 2 at x=51, chip 3 at x=97, etc.

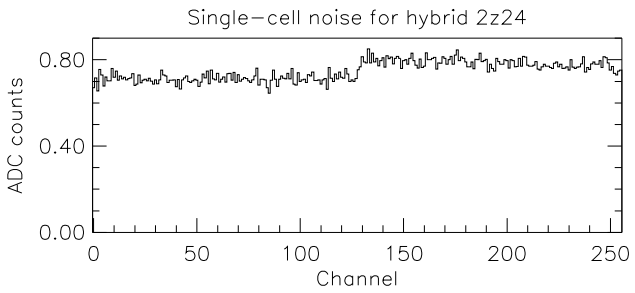
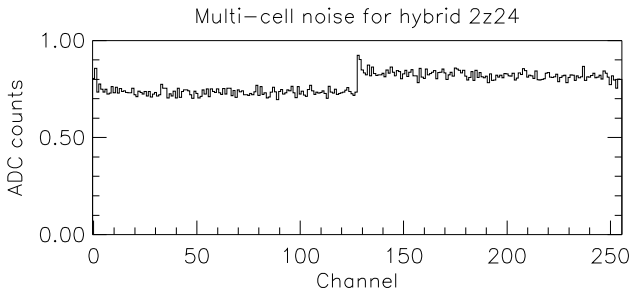
RMS Noise

The following plots show the single-cell and multi-cell RMS noise:

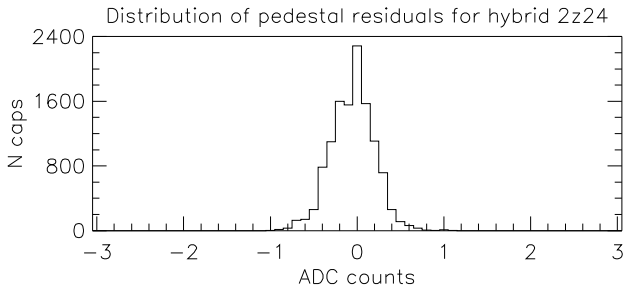
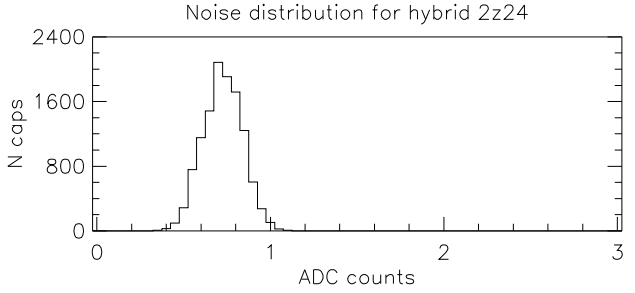
Distribution of Pedestals and Noise

The following are histograms of the pedestal of each pipeline capacitor relative to the chip average (top); and the RMS noise of each capacitor (bottom):

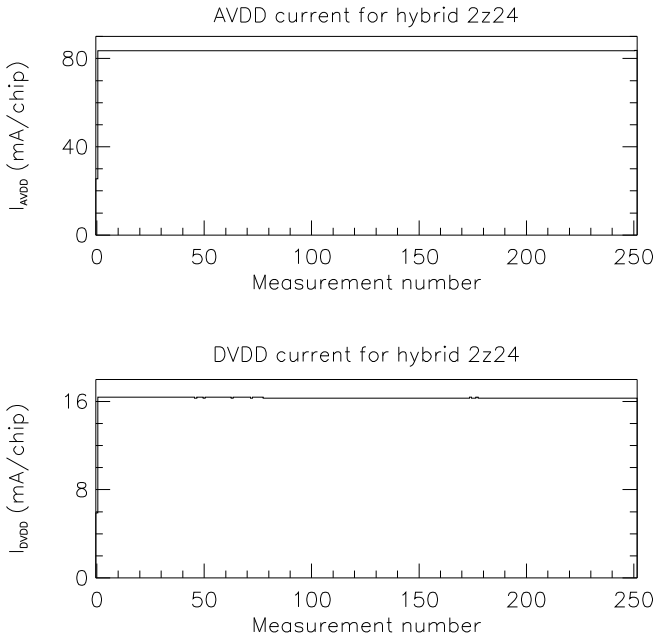
Supply Currents During Burn-in

The following plots show the supply currents per chip as a function of measurment number. Currents are measured approximately every 10 minutes:
