Hybrid 2z31 Traveler

September 27, 1999

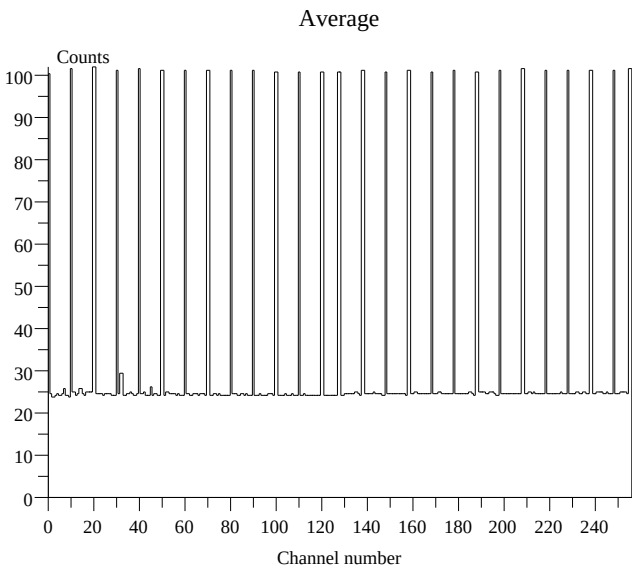
Pedestal

The following plot shows the pedestals vs. channel number

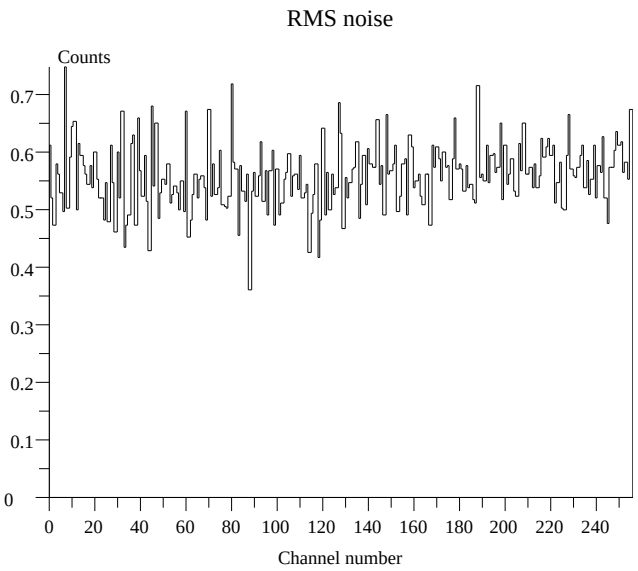
RMS Noise

The following plot shows the single cell RMS noise:

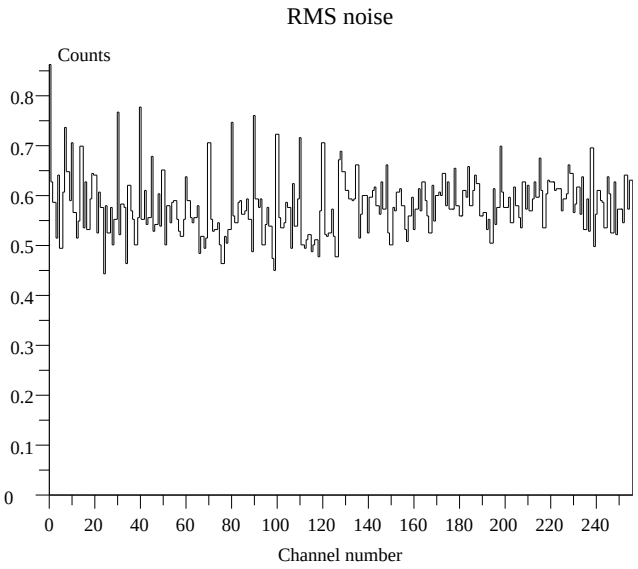
Multi-Cell Noise

The following plot show the multi-cell RMS noise:

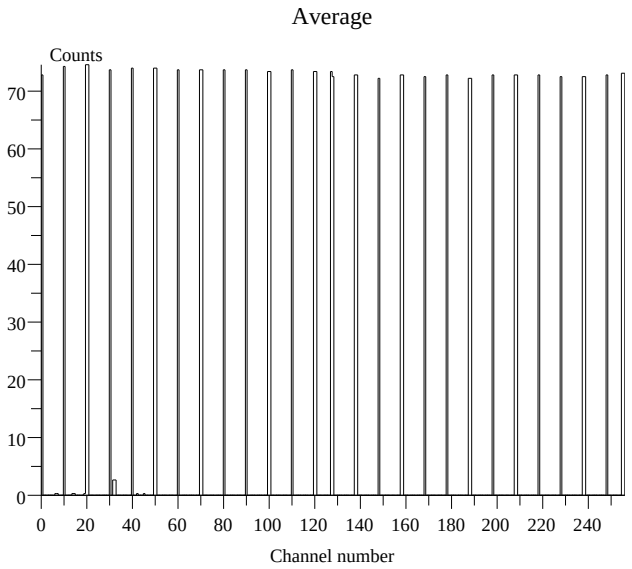
Dynamic Threshold Subtraction

Some noise (about 1.0) in channel 33 in DTS mode

The following plot shows the readout of channels with charge injection with the dynamic threshold subtraction turned on:
