Hybrid 2z79 Traveler

November 17, 1999

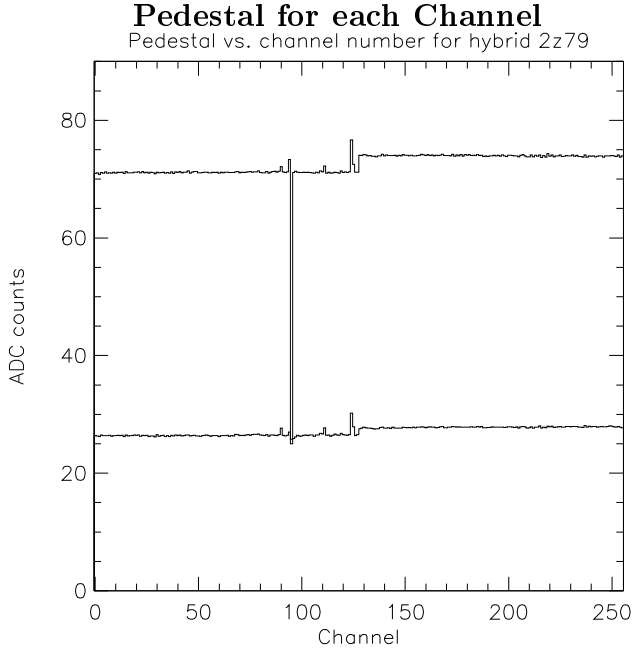
Pedestal for each Channel

The following plot shows the pedestals vs. channel number with and without charge injection:

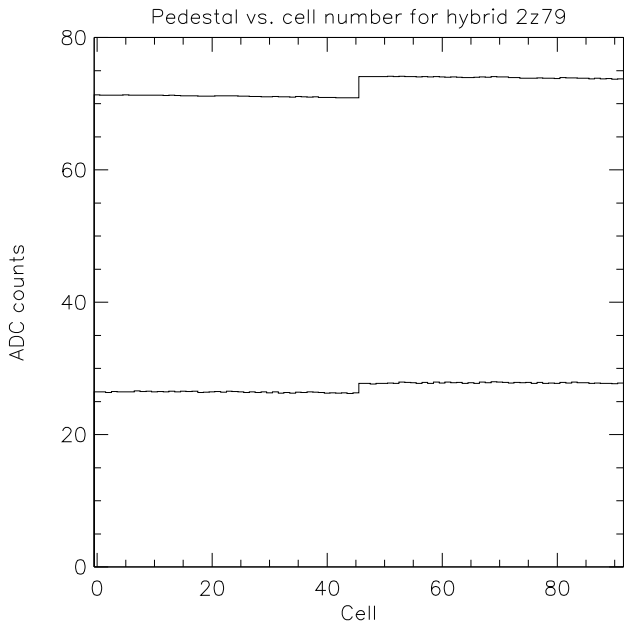
Pedestal vs. Pipeline Cell ID

The following plot shows the average pedestal vs. pipeline cell ID with and without charge injection. The x-axis is cell ID offset by 46 for each chip. Thus cell ID 5 for chip 1 is at x=5, chip 2 at x=51, chip 3 at x=97, etc.

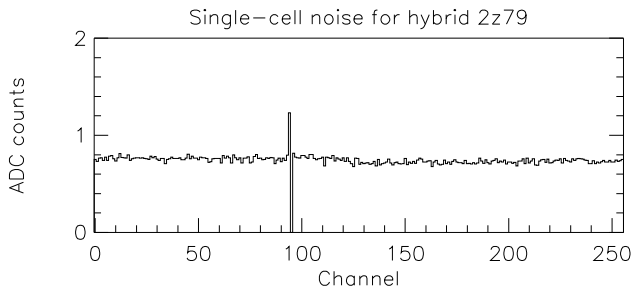
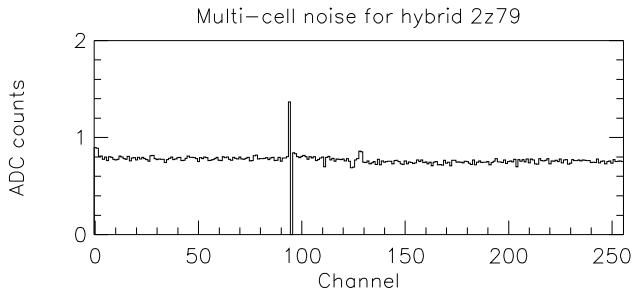
RMS Noise

The following plots show the single-cell and multi-cell RMS noise:

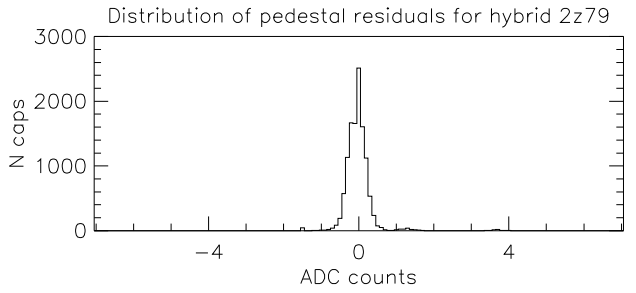
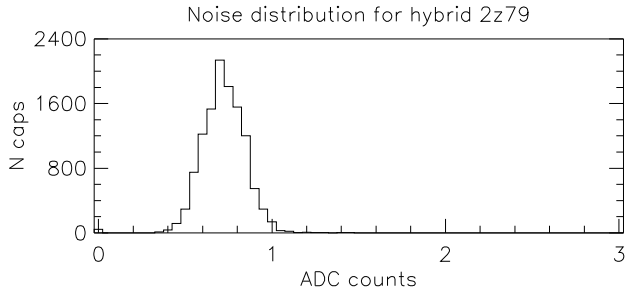
Distribution of Pedestals and Noise

The following are histograms of the pedestal of each pipeline capacitor relative to the chip average (top); and the RMS noise of each capacitor (bottom):

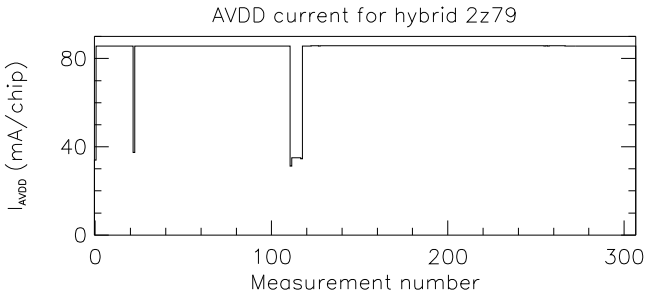
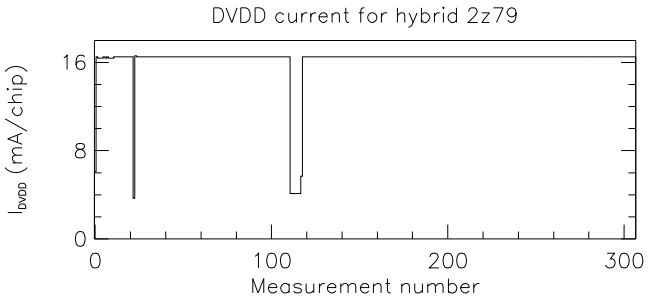
Supply Currents During Burn-in

The following plots show the supply currents per chip as a function of measurment number. Currents are measured approximately every 10 minutes:
