Hybrid 2z96 Traveler

October 27, 1999

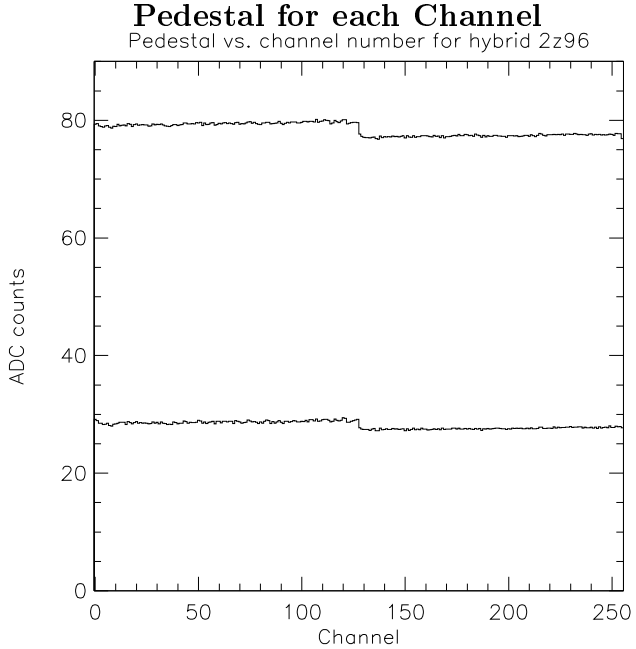
Pedestal for each Channel

The following plot shows the pedestals vs. channel number with and without charge injection:

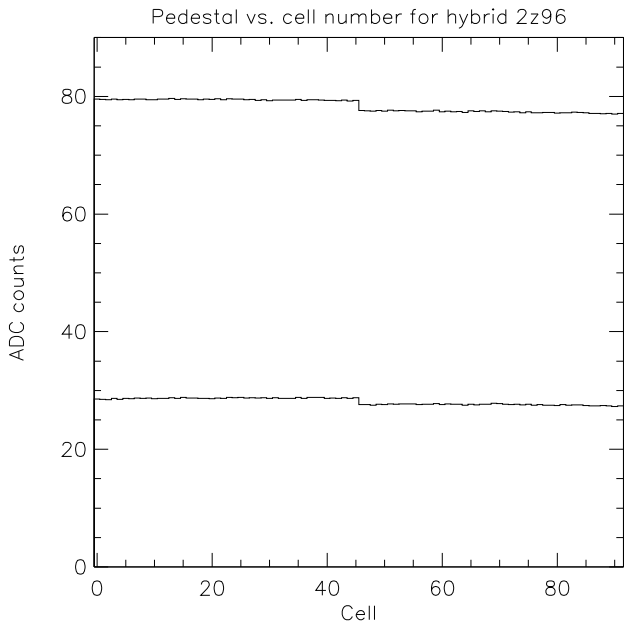
Pedestal vs. Pipeline Cell ID

The following plot shows the average pedestal vs. pipeline cell ID with and without charge injection. The x-axis is cell ID offset by 46 for each chip. Thus cell ID 5 for chip 1 is at x=5, chip 2 at x=51, chip 3 at x=97, etc.

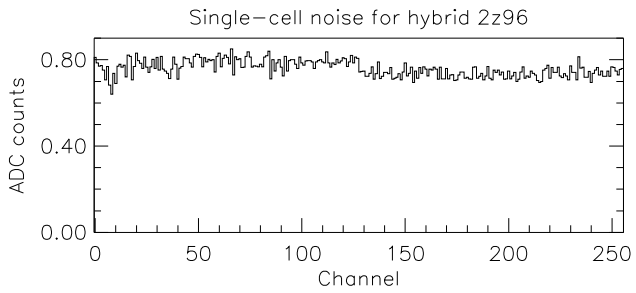
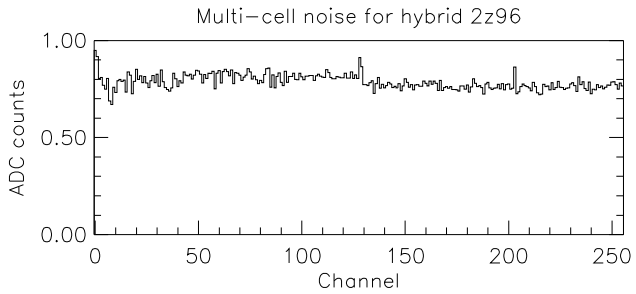
RMS Noise

The following plots show the single-cell and multi-cell RMS noise:

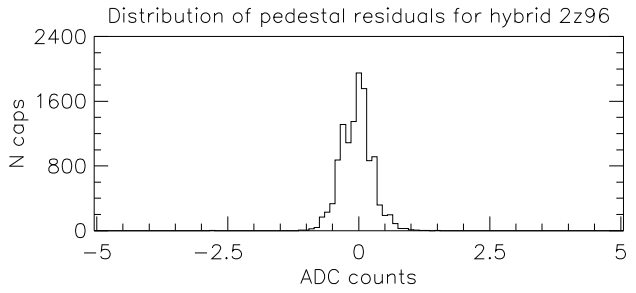
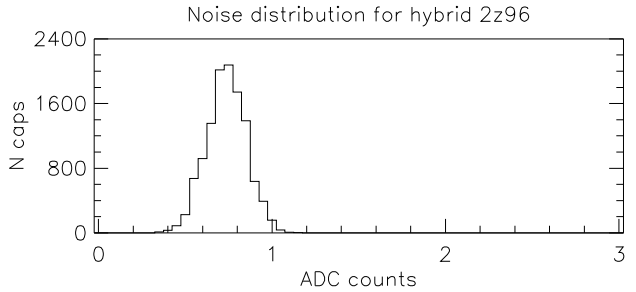
Distribution of Pedestals and Noise

The following are histograms of the pedestal of each pipeline capacitor relative to the chip average (top); and the RMS noise of each capacitor (bottom):

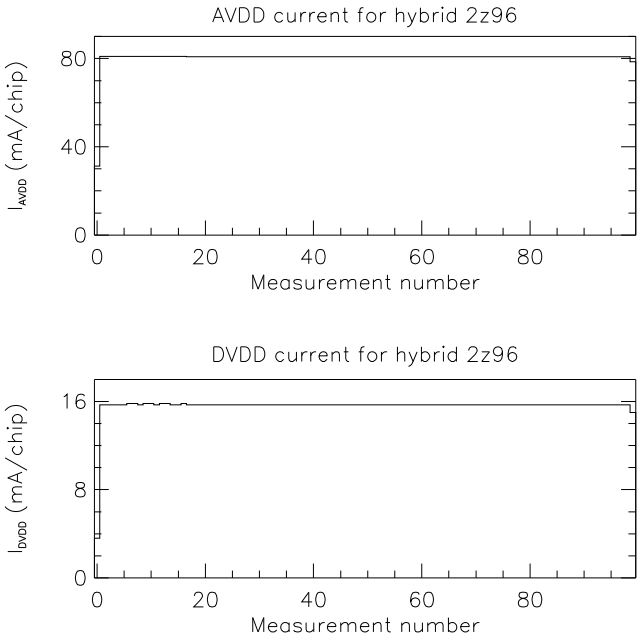
Supply Currents During Burn-in

The following plots show the supply currents per chip as a function of measurment number. Currents are measured approximately every 10 minutes:
