Hybrid 3l5 Traveler

May 11, 2000

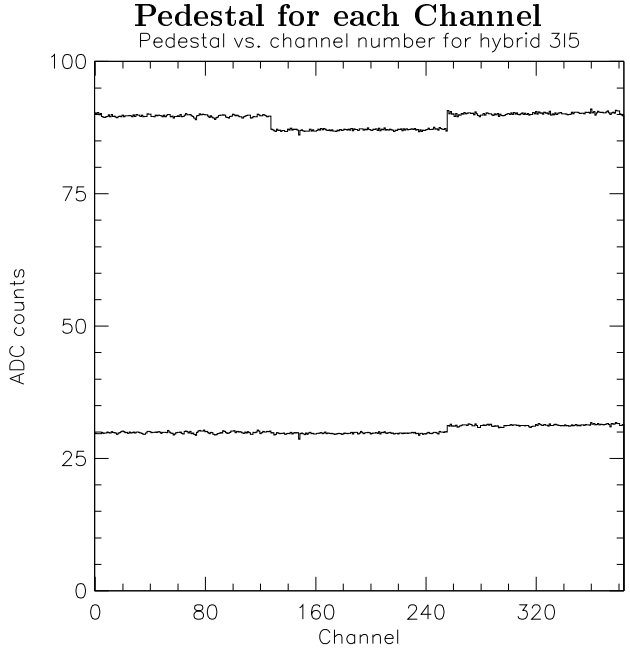
Pedestal for each Channel

The following plot shows the pedestals vs. channel number with and without charge injection:

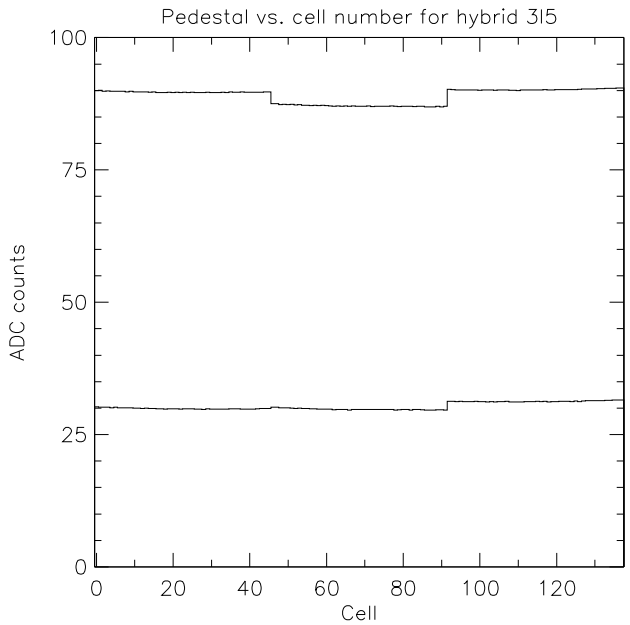
Pedestal vs. Pipeline Cell ID

The following plot shows the average pedestal vs. pipeline cell ID with and without charge injection. The x-axis is cell ID offset by 46 for each chip. Thus cell ID 5 for chip 1 is at x=5, chip 2 at x=51, chip 3 at x=97, etc.

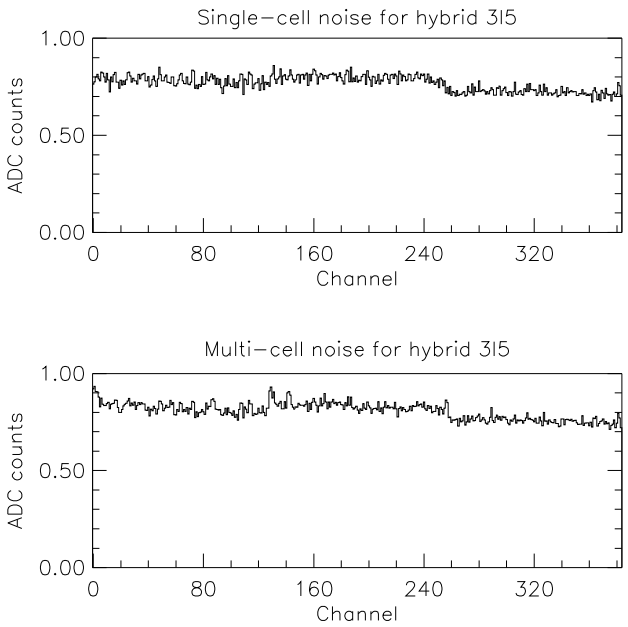
RMS Noise

The following plots show the single-cell and multi-cell RMS noise:

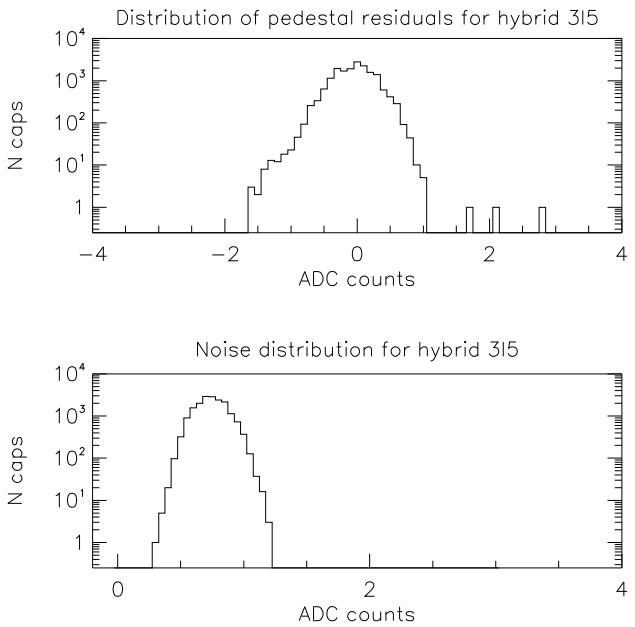
Distribution of Pedestals and Noise

The following are histograms of the pedestal of each pipeline capacitor relative to the chip average (top); and the RMS noise of each capacitor (bottom):

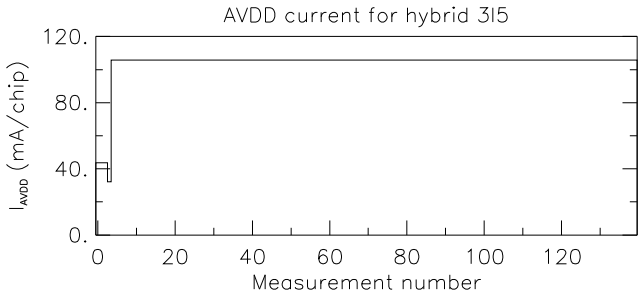
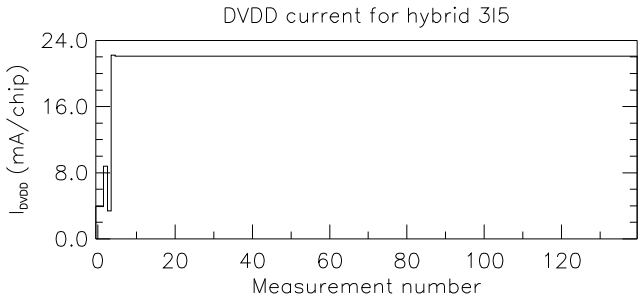
Supply Currents During Burn-in

The following plots show the supply currents per chip as a function of measurment number. Currents are measured approximately every 10 minutes:
