Hybrid 3p103 Traveler

December 2, 1999

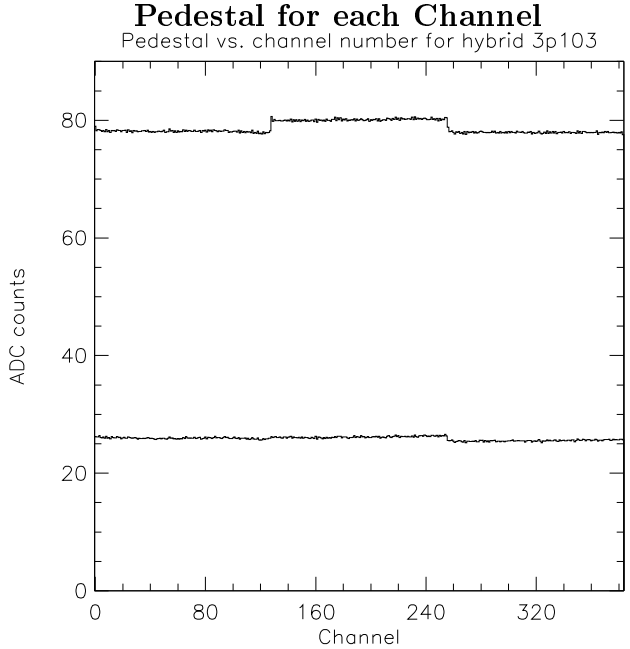
Pedestal for each Channel

The following plot shows the pedestals vs. channel number with and without charge injection:

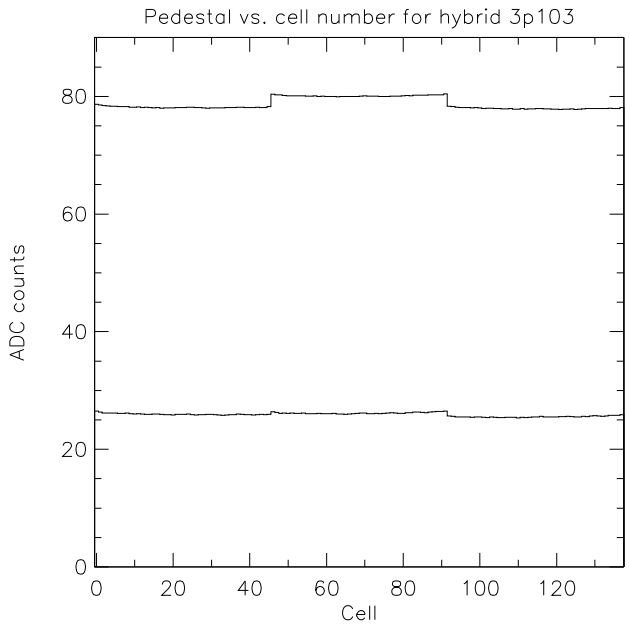
Pedestal vs. Pipeline Cell ID

The following plot shows the average pedestal vs. pipeline cell ID with and without charge injection. The x-axis is cell ID offset by 46 for each chip. Thus cell ID 5 for chip 1 is at x=5, chip 2 at x=51, chip 3 at x=97, etc.

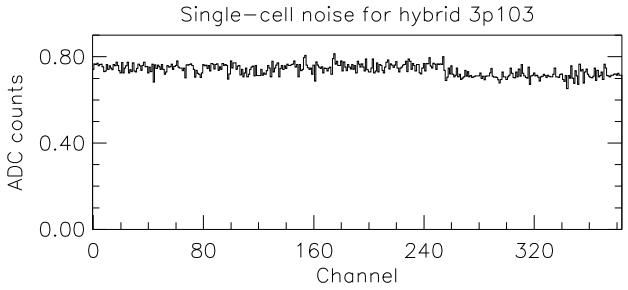
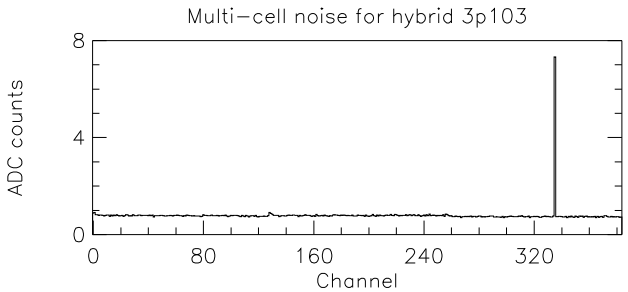
RMS Noise

The following plots show the single-cell and multi-cell RMS noise:

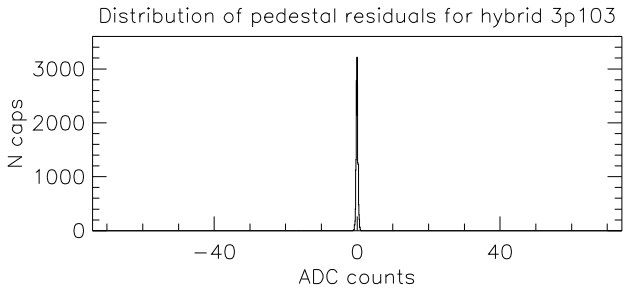
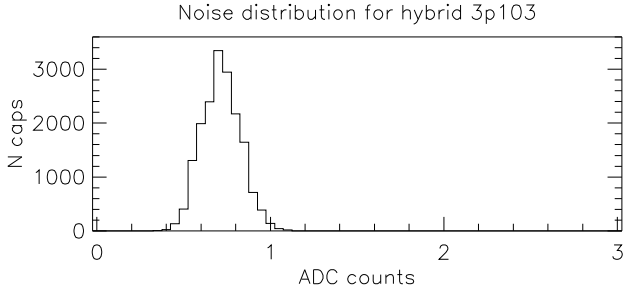
Distribution of Pedestals and Noise

The following are histograms of the pedestal of each pipeline capacitor relative to the chip average (top); and the RMS noise of each capacitor (bottom):

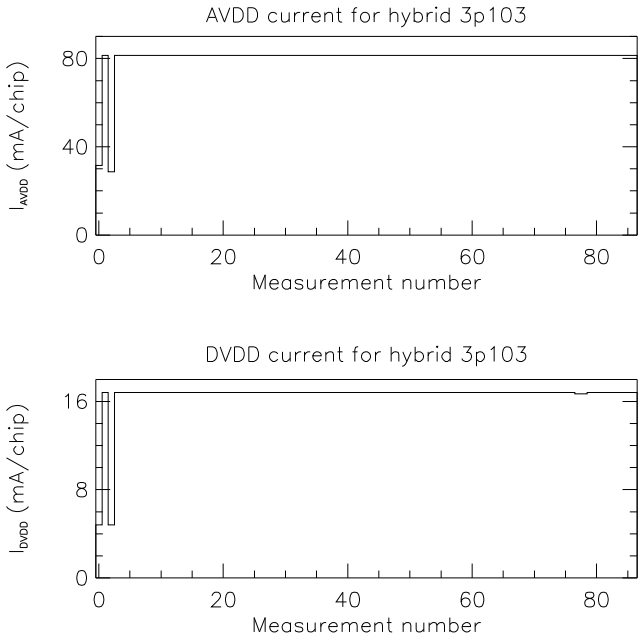
Supply Currents During Burn-in

The following plots show the supply currents per chip as a function of measurment number. Currents are measured approximately every 10 minutes:
