Hybrid 3p105 Traveler

January 4, 2000

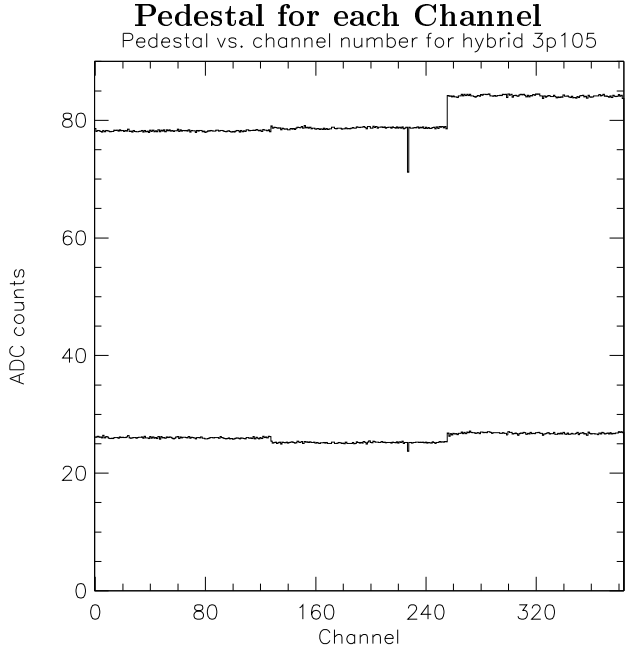
Pedestal for each Channel

The following plot shows the pedestals vs. channel number with and without charge injection:

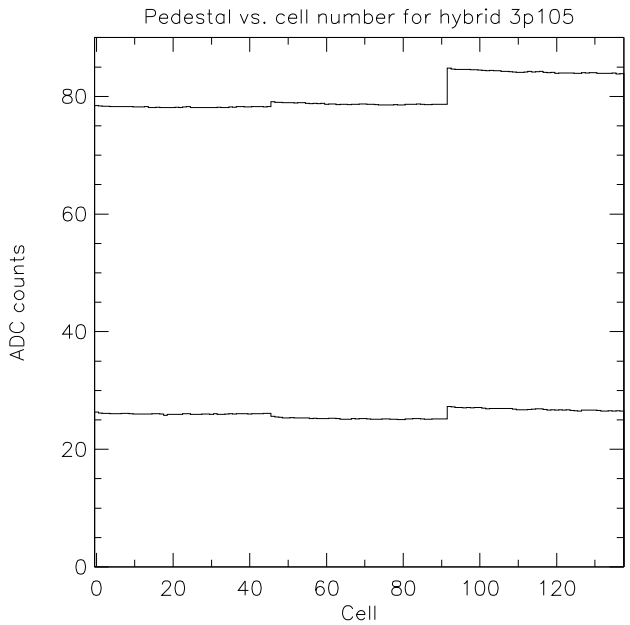
Pedestal vs. Pipeline Cell ID

The following plot shows the average pedestal vs. pipeline cell ID with and without charge injection. The x-axis is cell ID offset by 46 for each chip. Thus cell ID 5 for chip 1 is at x=5, chip 2 at x=51, chip 3 at x=97, etc.

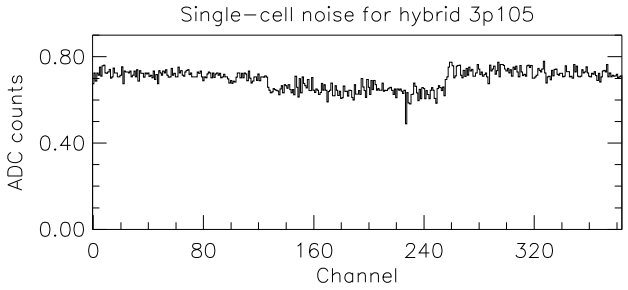
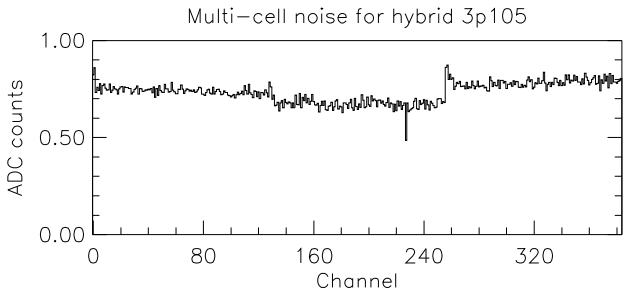
RMS Noise

The following plots show the single-cell and multi-cell RMS noise:

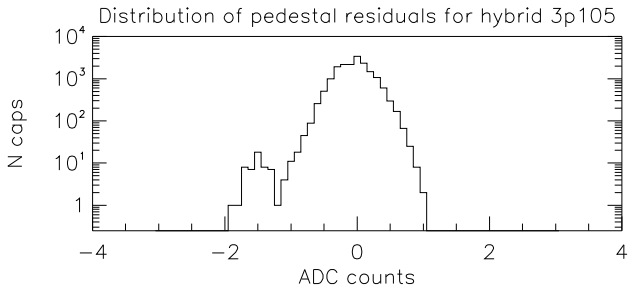
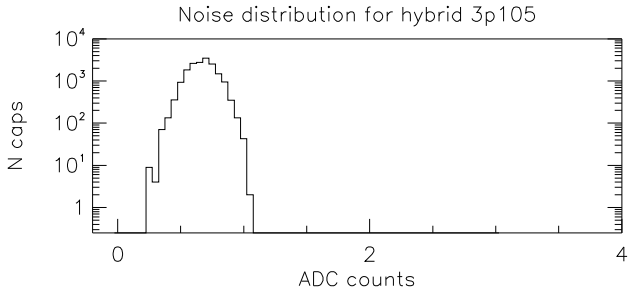
Distribution of Pedestals and Noise

The following are histograms of the pedestal of each pipeline capacitor relative to the chip average (top); and the RMS noise of each capacitor (bottom):

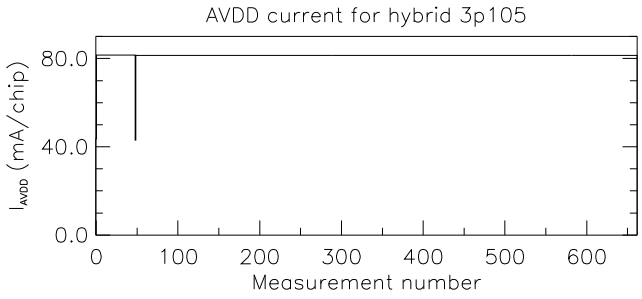
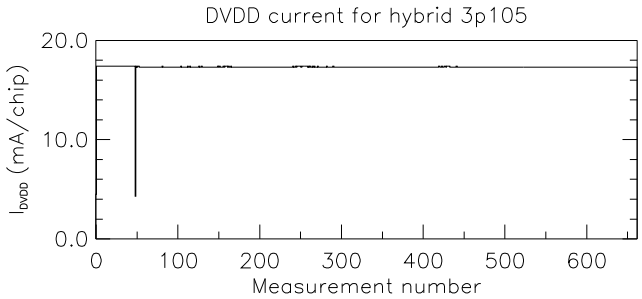
Supply Currents During Burn-in

The following plots show the supply currents per chip as a function of measurment number. Currents are measured approximately every 10 minutes:
