Hybrid 3p133 Traveler

December 9, 1999

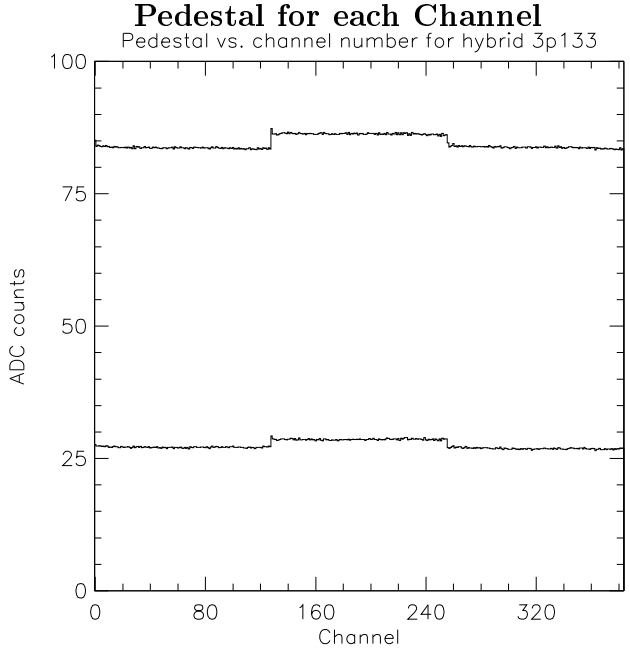
Pedestal for each Channel

The following plot shows the pedestals vs. channel number with and without charge injection:

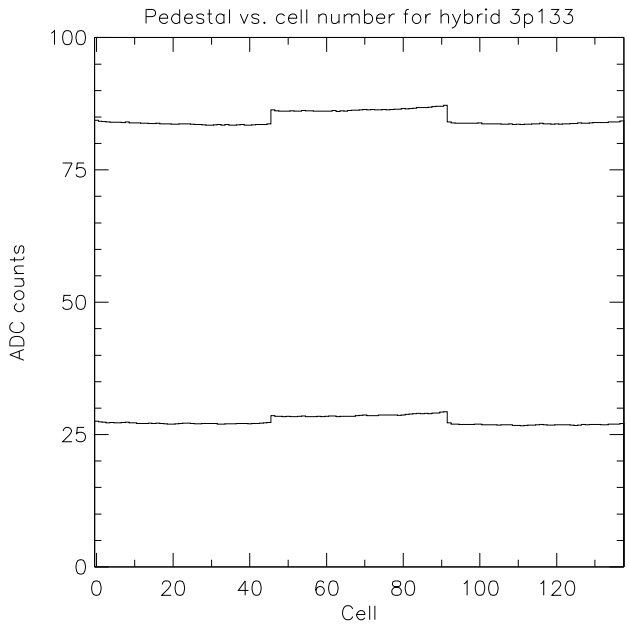
Pedestal vs. Pipeline Cell ID

The following plot shows the average pedestal vs. pipeline cell ID with and without charge injection. The x-axis is cell ID offset by 46 for each chip. Thus cell ID 5 for chip 1 is at x=5, chip 2 at x=51, chip 3 at x=97, etc.

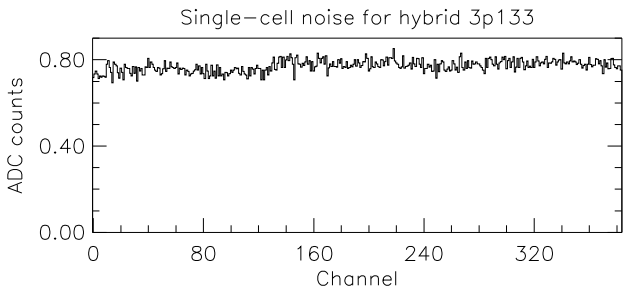
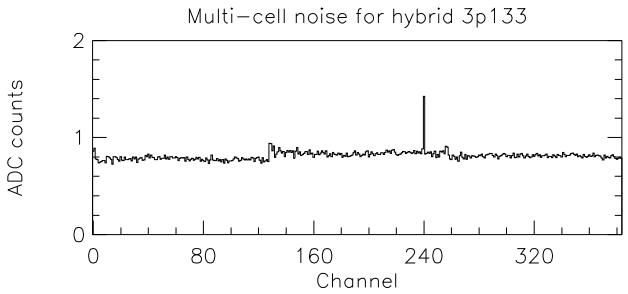
RMS Noise

The following plots show the single-cell and multi-cell RMS noise:

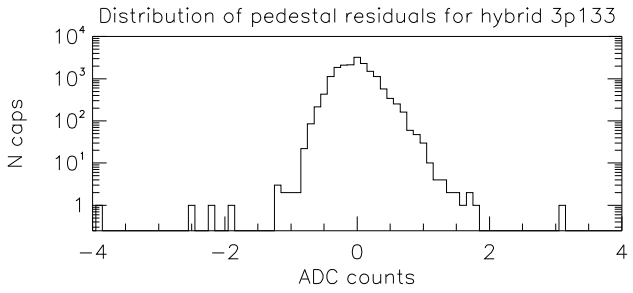
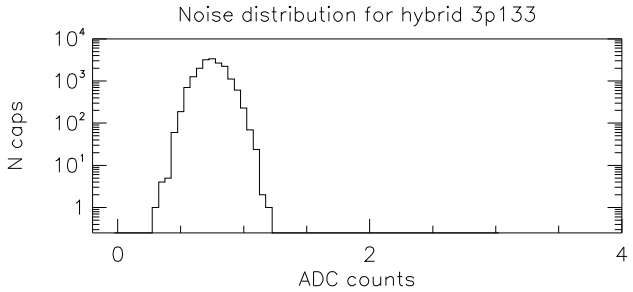
Distribution of Pedestals and Noise

The following are histograms of the pedestal of each pipeline capacitor relative to the chip average (top); and the RMS noise of each capacitor (bottom):

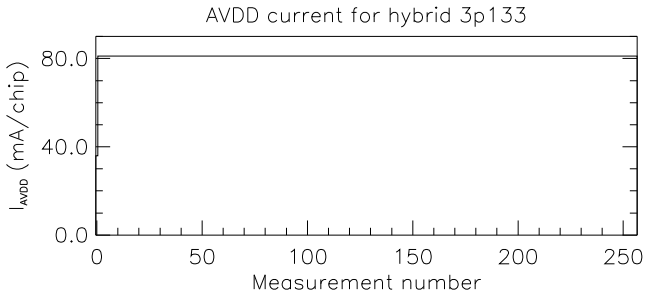
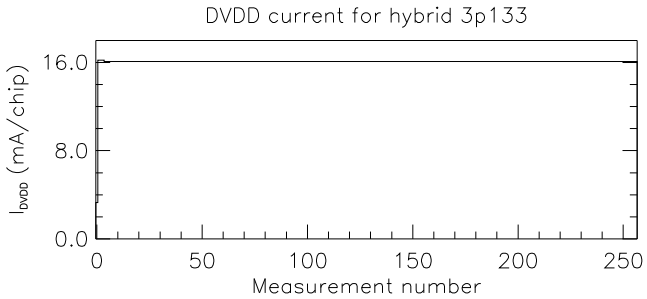
Supply Currents During Burn-in

The following plots show the supply currents per chip as a function of measurment number. Currents are measured approximately every 10 minutes:
