Hybrid 3p135 Traveler

January 4, 2000

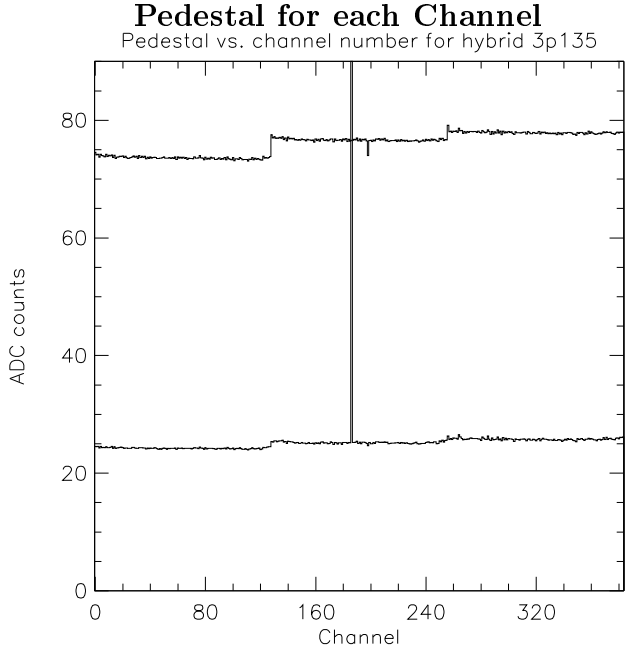
Pedestal for each Channel

Hybrid 3p135 quality: fair
Chip classification: good fair good
Bad channels (chip-channel): 1-58
Bad cells: none
Random bad capacitors: none
Channels at pedestal needed for DCMS: 34.6 29.7 33.7
```
