Hybrid 3p149 Traveler

December 21, 1999

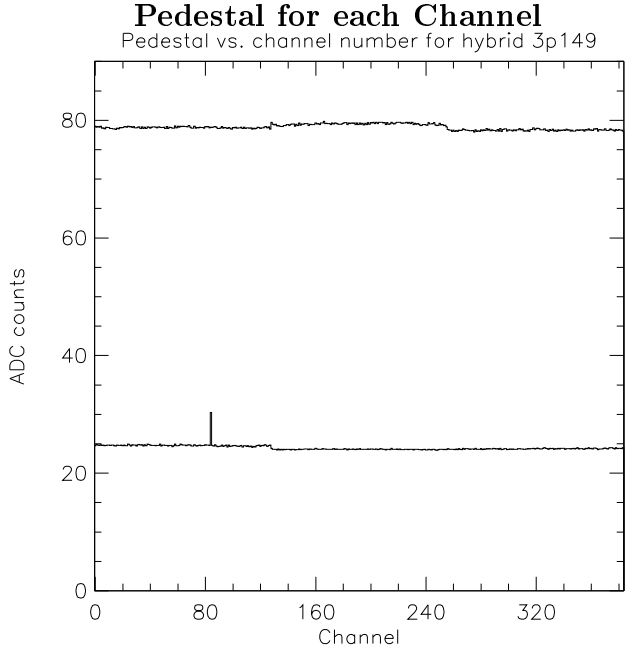
Pedestal for each Channel

Hybrid 3p149 quality: fair
Chip classification: fair good good
Bad channels (chip-channel): 0-84
Bad cells: none
Random bad capacitors: none
Channels at pedestal needed for DCMS: 31.6 33.7 31.7
```

The following plot shows the pedestals vs. channel number with and without charge injection:

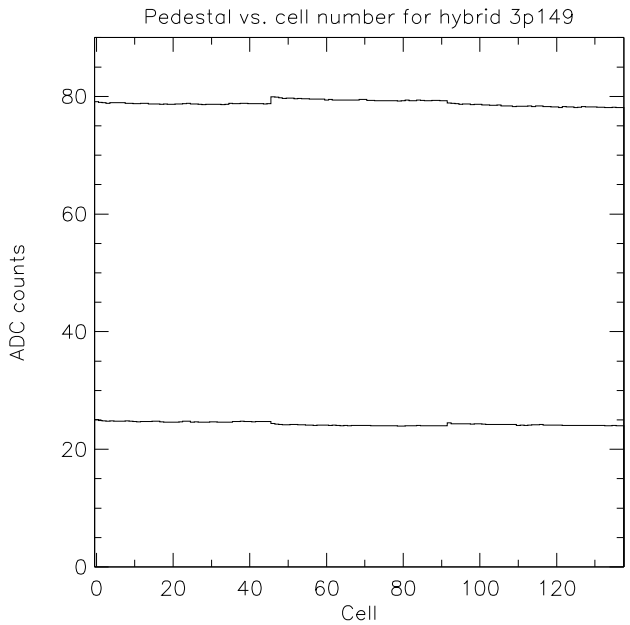
Pedestal vs. Pipeline Cell ID

The following plot shows the average pedestal vs. pipeline cell ID with and without charge injection. The x-axis is cell ID offset by 46 for each chip. Thus cell ID 5 for chip 1 is at x=5, chip 2 at x=51, chip 3 at x=97, etc.

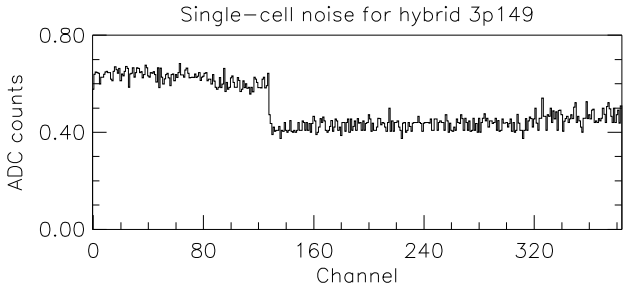
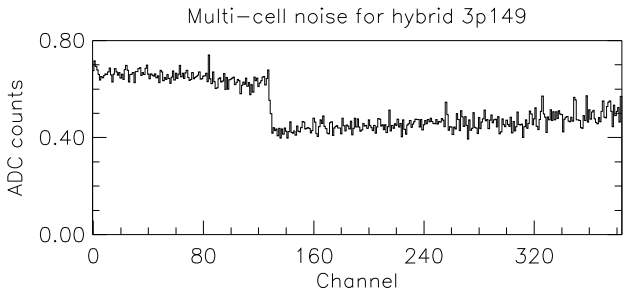
RMS Noise

The following plots show the single-cell and multi-cell RMS noise:

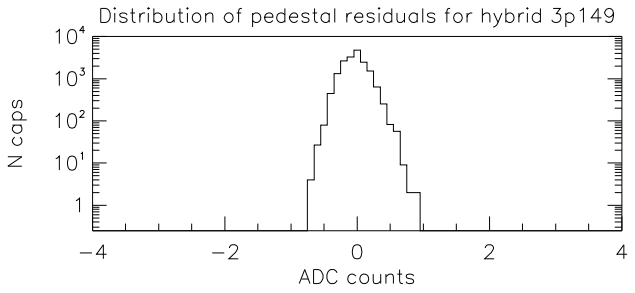
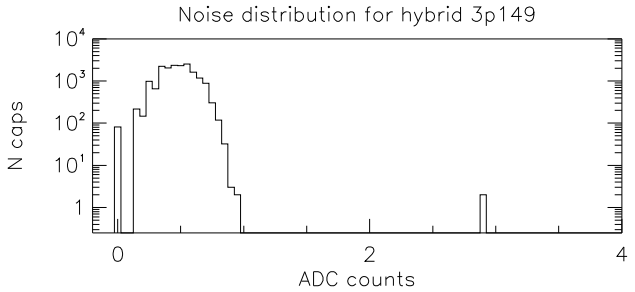
Distribution of Pedestals and Noise

The following are histograms of the pedestal of each pipeline capacitor relative to the chip average (top); and the RMS noise of each capacitor (bottom):

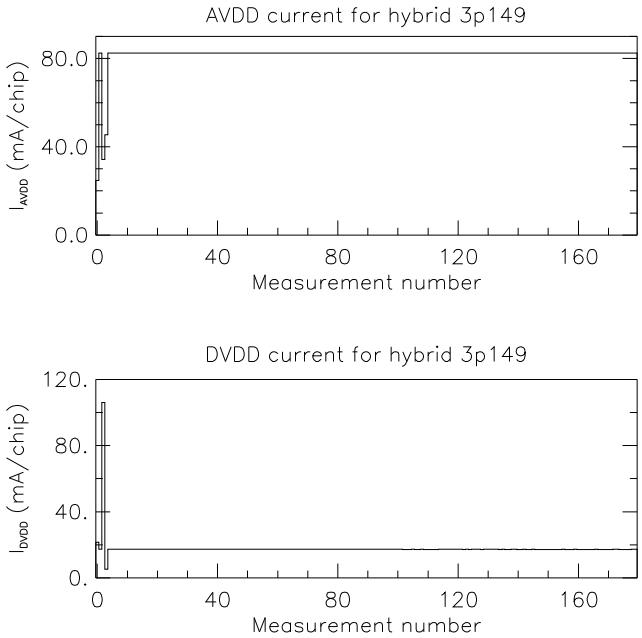
Supply Currents During Burn-in

The following plots show the supply currents per chip as a function of measurment number. Currents are measured approximately every 10 minutes:
