Hybrid 3p34 Traveler

October 11, 1999

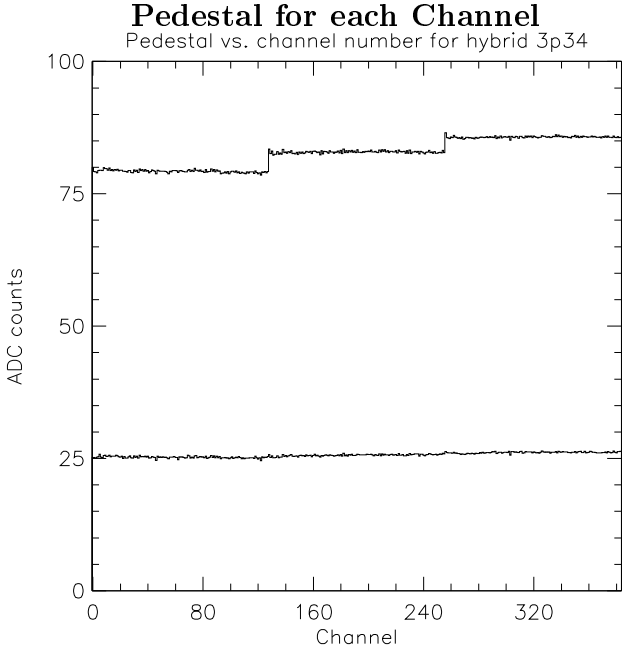
Pedestal for each Channel

The following plot shows the pedestals vs. channel number with and without charge injection:

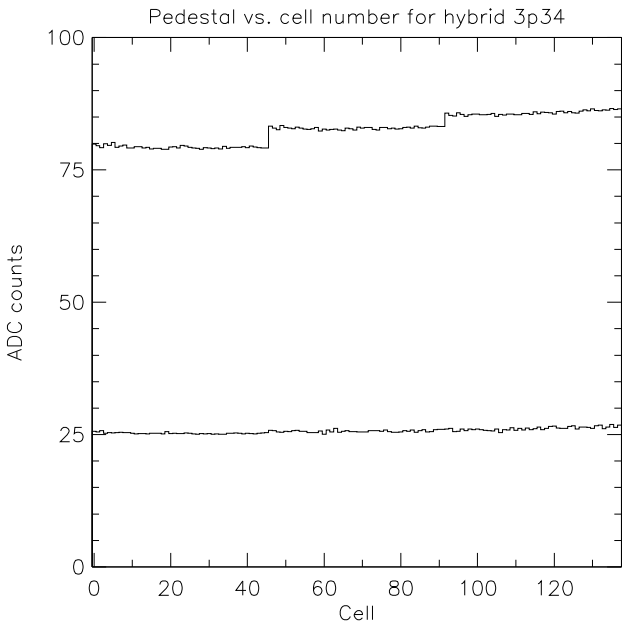
Pedestal vs. Pipeline Cell ID

The following plot shows the average pedestal vs. pipeline cell ID with and without charge injection. The x-axis is cell ID offset by 46 for each chip. Thus cell ID 5 for chip 1 is at x=5, chip 2 at x=51, chip 3 at x=97, etc.

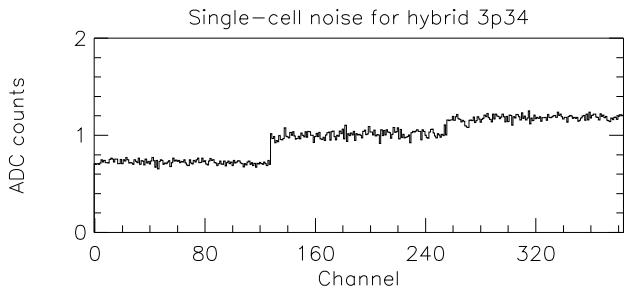
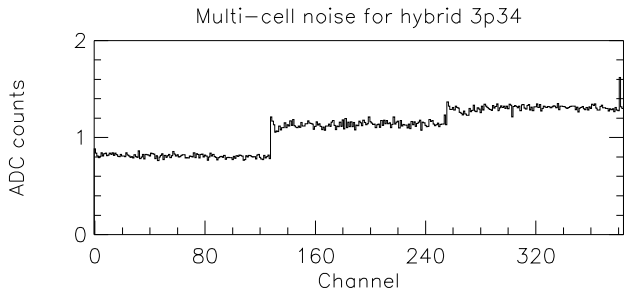
RMS Noise

The following plots show the single-cell and multi-cell RMS noise:

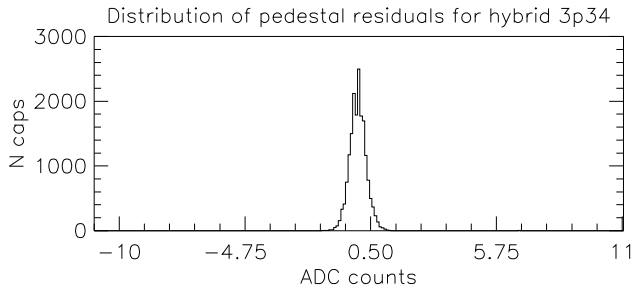
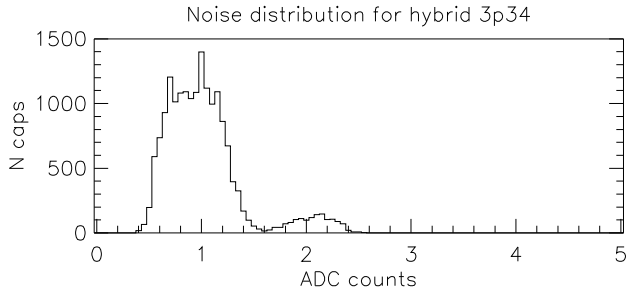
Distribution of Pedestals and Noise

The following are histograms of the pedestal of each pipeline capacitor relative to the chip average (top); and the RMS noise of each capacitor (bottom):

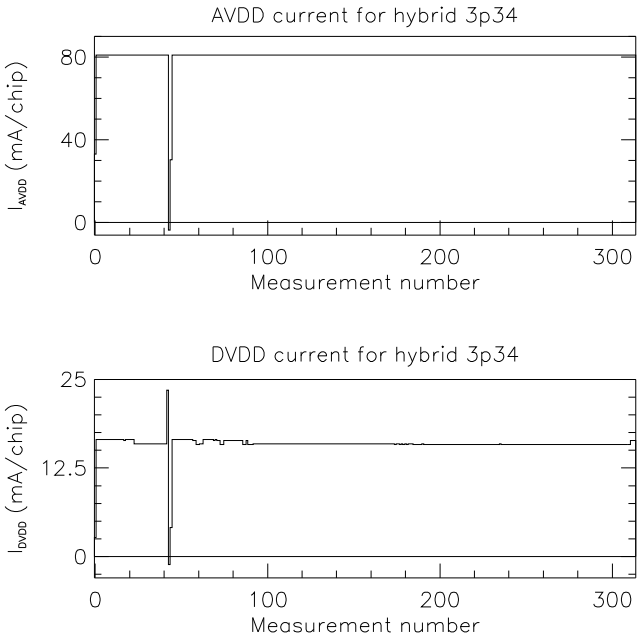
Supply Currents During Burn-in

The following plots show the supply currents per chip as a function of measurment number. Currents are measured approximately every 10 minutes:
