# Hybrid 3p39 Traveler

December 9, 1999

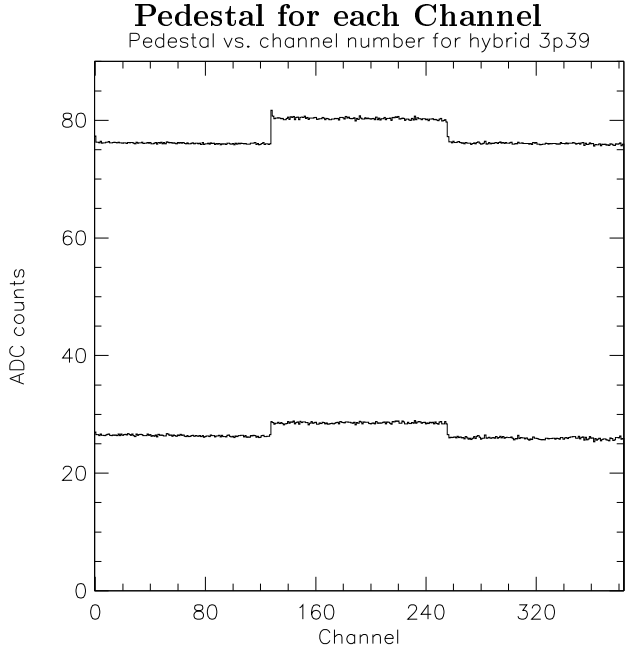
**Pedestal for each Channel**

The following plot shows the pedestals vs. channel number with and without charge injection:

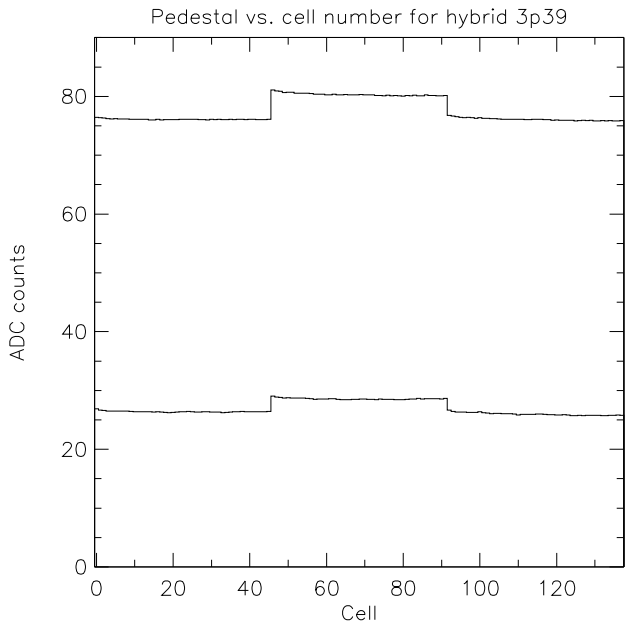
**Pedestal vs. Pipeline Cell ID**

The following plot shows the average pedestal vs. pipeline cell ID with and without charge injection. The x-axis is cell ID offset by 46 for each chip. Thus cell ID 5 for chip 1 is at x=5, chip 2 at x=51, chip 3 at x=97, etc.

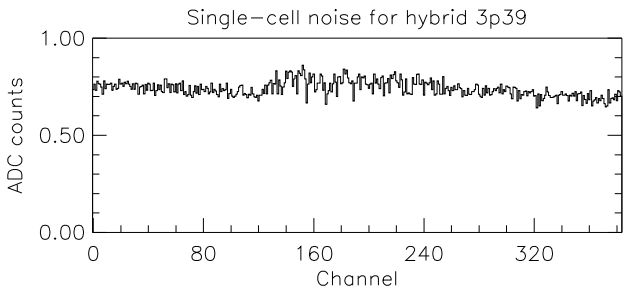
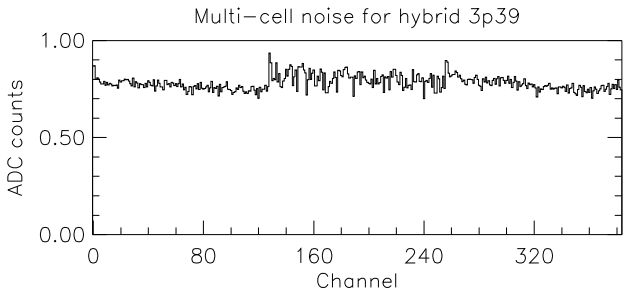
**RMS Noise**

The following plots show the single-cell and multi-cell RMS noise:

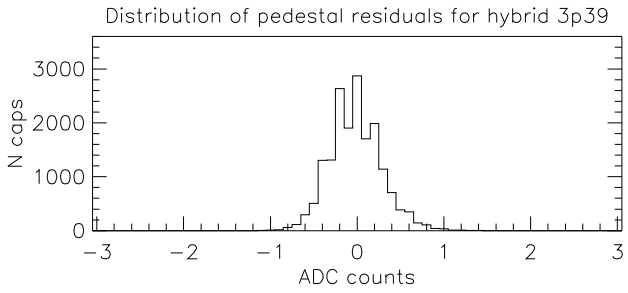
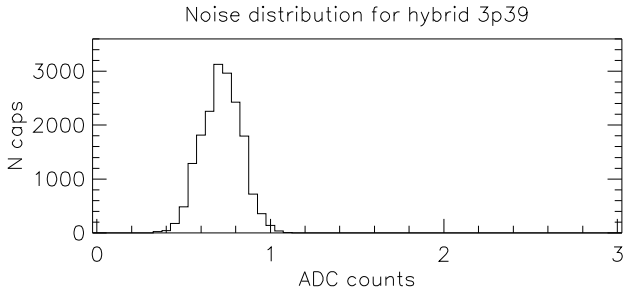
**Distribution of Pedestals and Noise**

The following are histograms of the pedestal of each pipeline capacitor relative to the chip average (top); and the RMS noise of each capacitor (bottom):

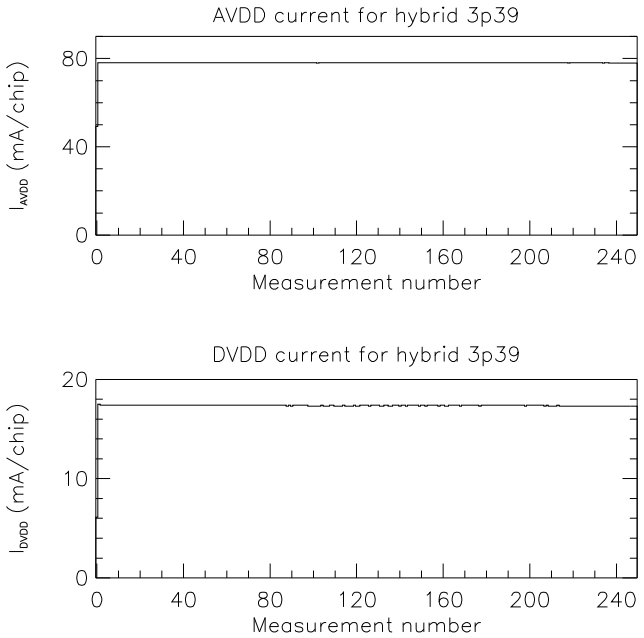
**Supply Currents During Burn-in**

The following plots show the supply currents per chip as a function of measurment number. Currents are measured approximately every 10 minutes:
