Hybrid 3p65 Traveler

December 14, 1999

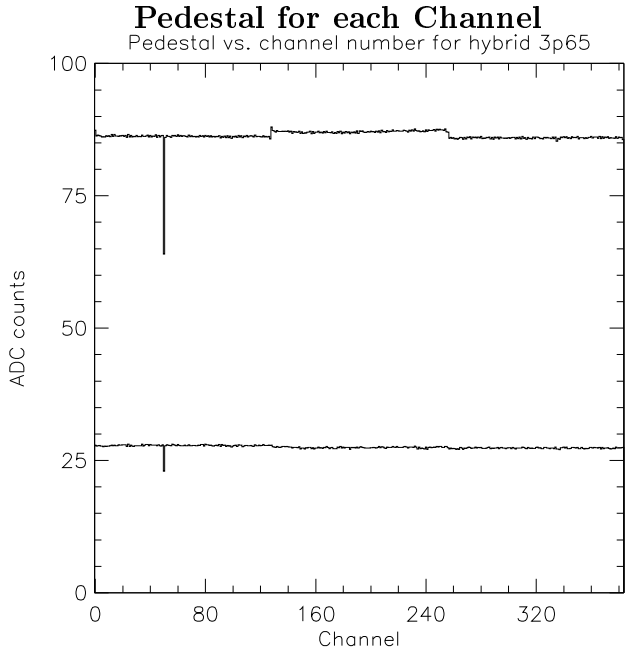
The following plot shows the pedestals vs. channel number with and without charge injection:

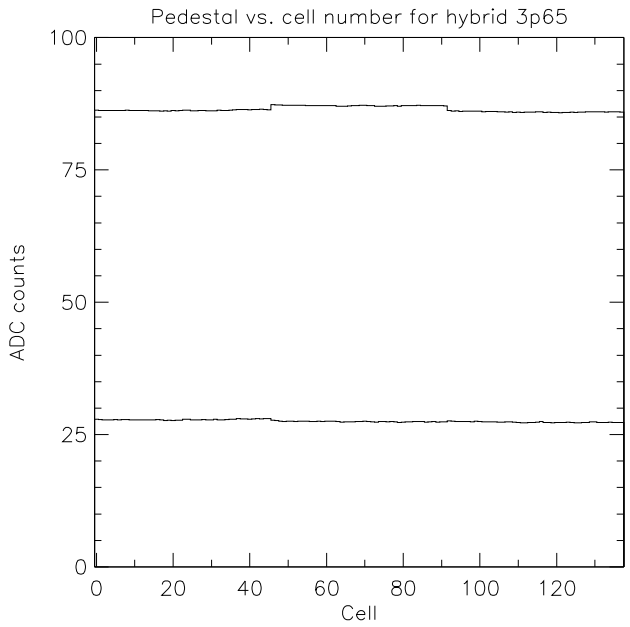
The following plot shows the average pedestal vs. pipeline cell ID with and without charge injection. The x-axis is cell ID offset by 46 for each chip. Thus cell ID 5 for chip 1 is at x=5, chip 2 at x=51, chip 3 at x=97, etc.

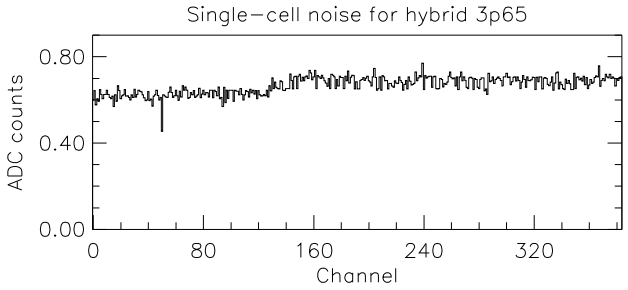
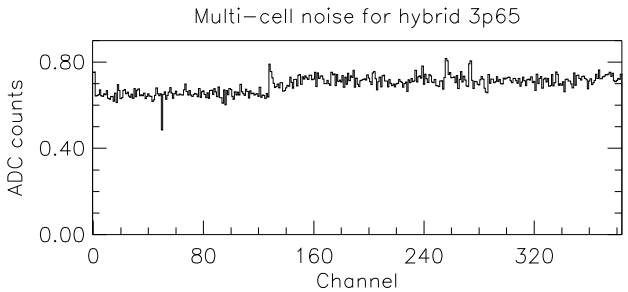
RMS Noise

The following plots show the single-cell and multi-cell RMS noise:

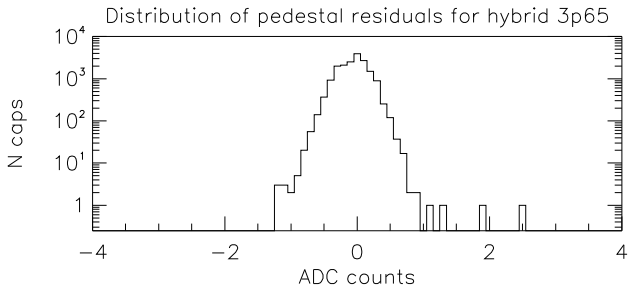
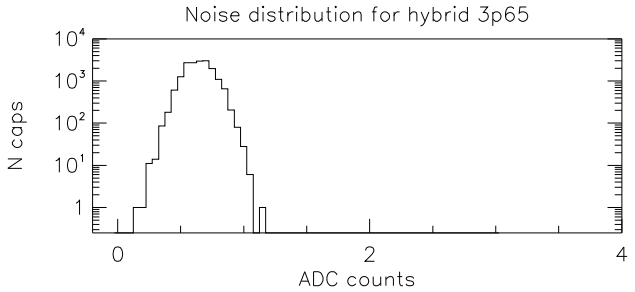
Distribution of Pedestals and Noise

The following are histograms of the pedestal of each pipeline capacitor relative to the chip average (top); and the RMS noise of each capacitor (bottom):

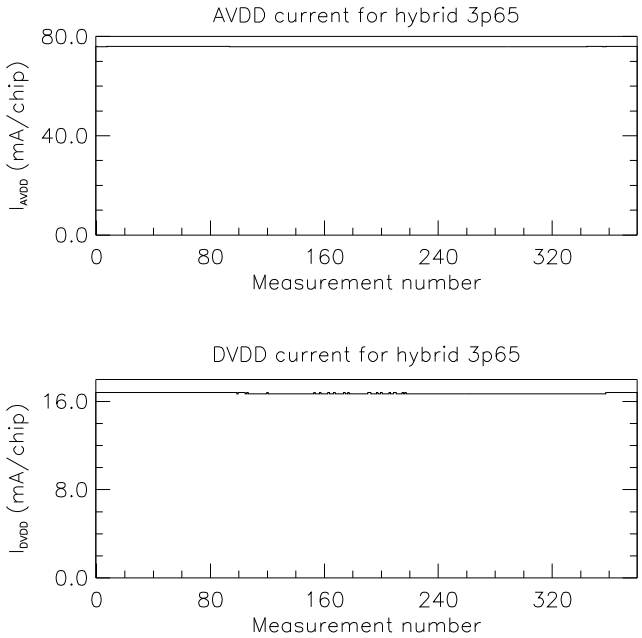
Supply Currents During Burn-in

The following plots show the supply currents per chip as a function of measurment number. Currents are measured approximately every 10 minutes:
