Hybrid 3p70 Traveler

January 7, 2000

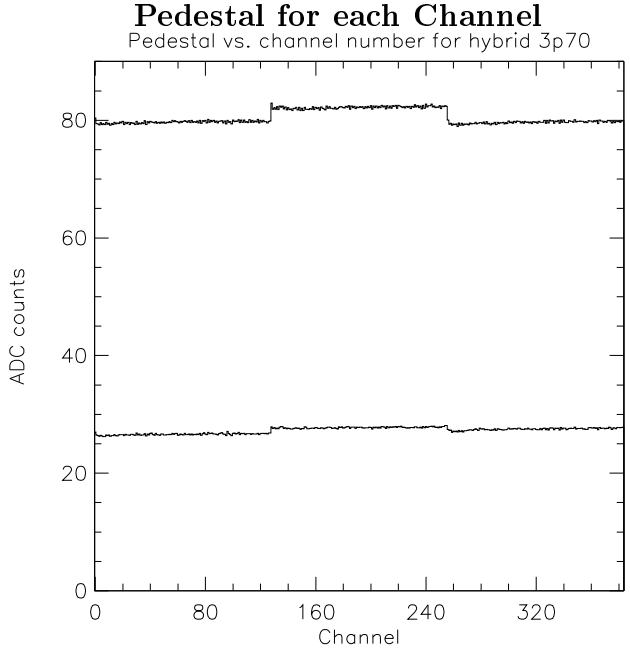
Pedestal for each Channel

The following plot shows the pedestals vs. channel number with and without charge injection:

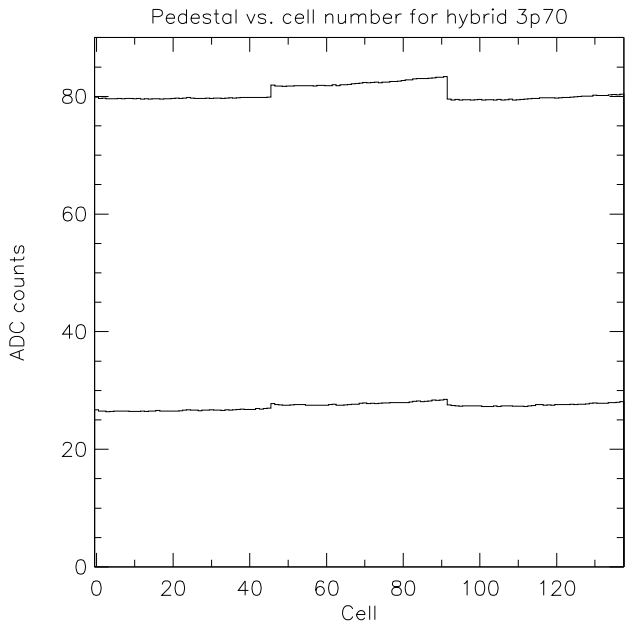
Pedestal vs. Pipeline Cell ID

The following plot shows the average pedestal vs. pipeline cell ID with and without charge injection. The x-axis is cell ID offset by 46 for each chip. Thus cell ID 5 for chip 1 is at x=5, chip 2 at x=51, chip 3 at x=97, etc.

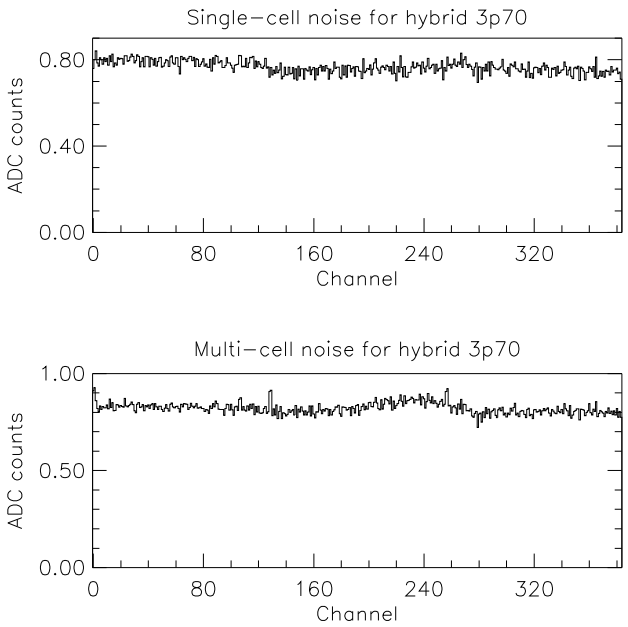
RMS Noise

The following plots show the single-cell and multi-cell RMS noise:

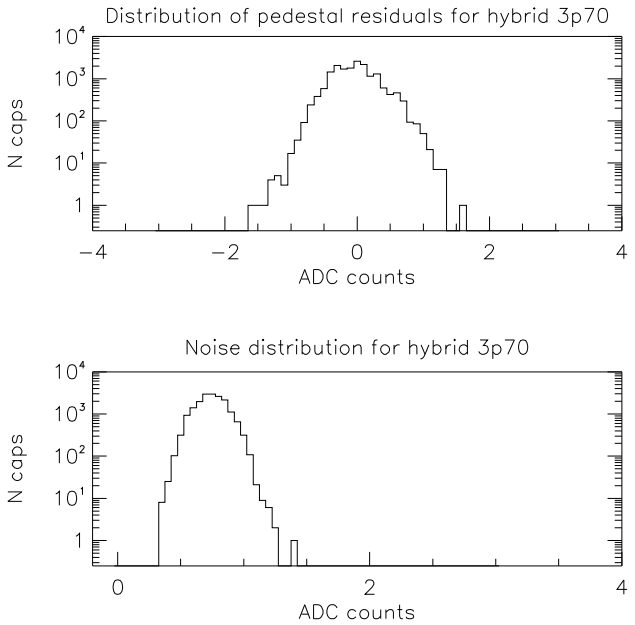
Distribution of Pedestals and Noise

The following are histograms of the pedestal of each pipeline capacitor relative to the chip average (top); and the RMS noise of each capacitor (bottom):

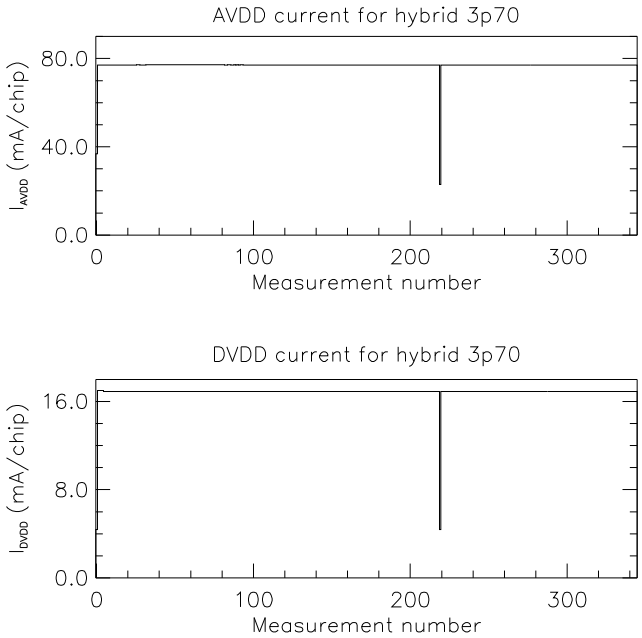
Supply Currents During Burn-in

The following plots show the supply currents per chip as a function of measurment number. Currents are measured approximately every 10 minutes:
