Hybrid 3p74 Traveler

December 14, 1999

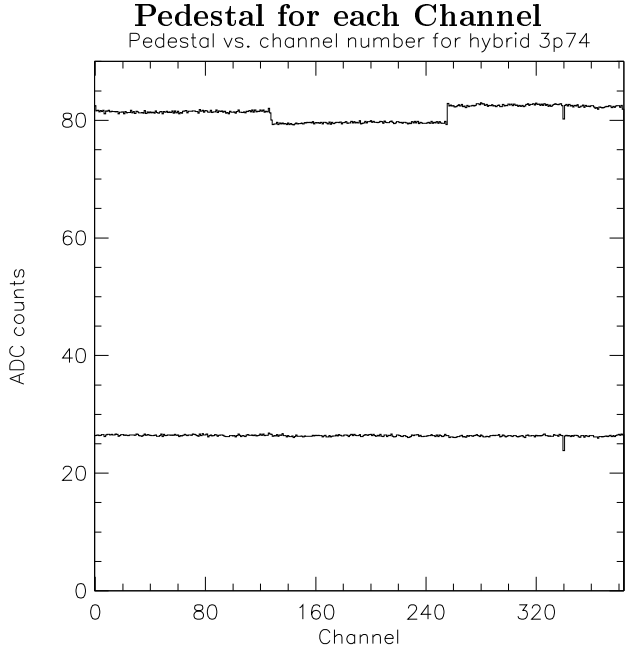
Pedestal for each Channel

The following plot shows the pedestals vs. channel number with and without charge injection:

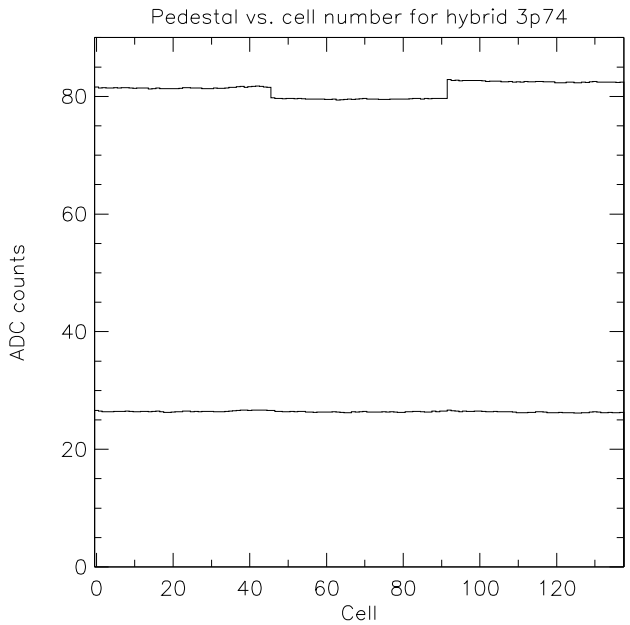
Pedestal vs. Pipeline Cell ID

The following plot shows the average pedestal vs. pipeline cell ID with and without charge injection. The x-axis is cell ID offset by 46 for each chip. Thus cell ID 5 for chip 1 is at x=5, chip 2 at x=51, chip 3 at x=97, etc.

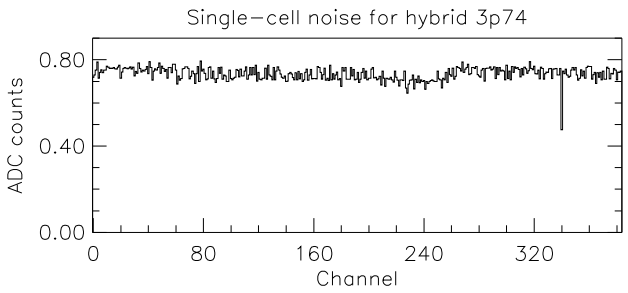
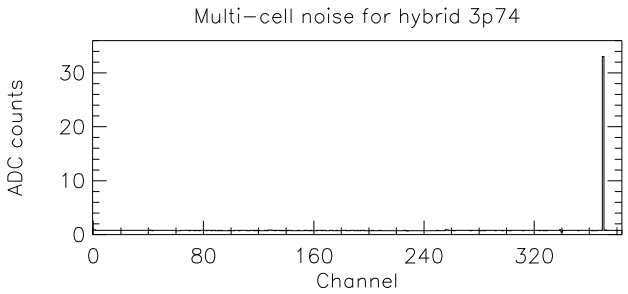
RMS Noise

The following plots show the single-cell and multi-cell RMS noise:

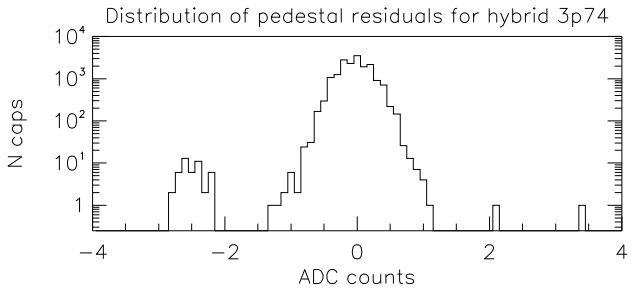
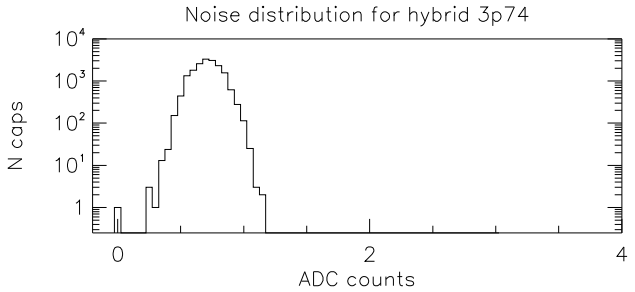
Distribution of Pedestals and Noise

The following are histograms of the pedestal of each pipeline capacitor relative to the chip average (top); and the RMS noise of each capacitor (bottom):

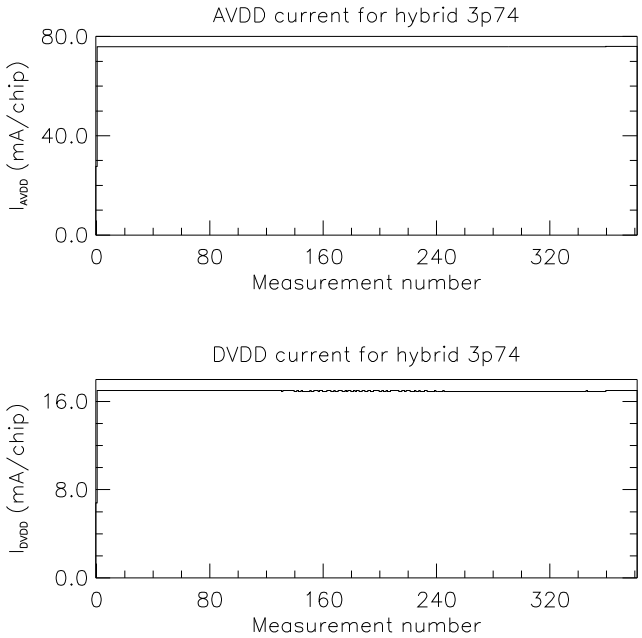
Supply Currents During Burn-in

The following plots show the supply currents per chip as a function of measurment number. Currents are measured approximately every 10 minutes:
