Hybrid 3p75 Traveler

January 7, 2000

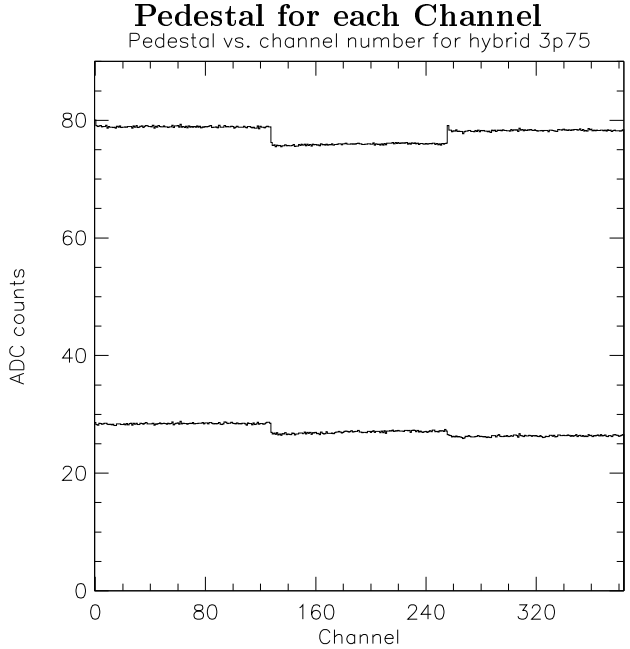
Pedestal for each Channel

The following plot shows the pedestals vs. channel number with and without charge injection:

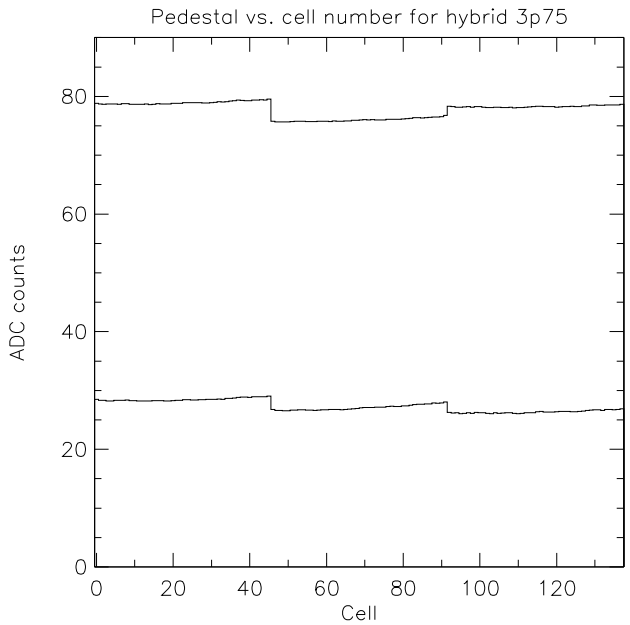
Pedestal vs. Pipeline Cell ID

The following plot shows the average pedestal vs. pipeline cell ID with and without charge injection. The x-axis is cell ID offset by 46 for each chip. Thus cell ID 5 for chip 1 is at x=5, chip 2 at x=51, chip 3 at x=97, etc.

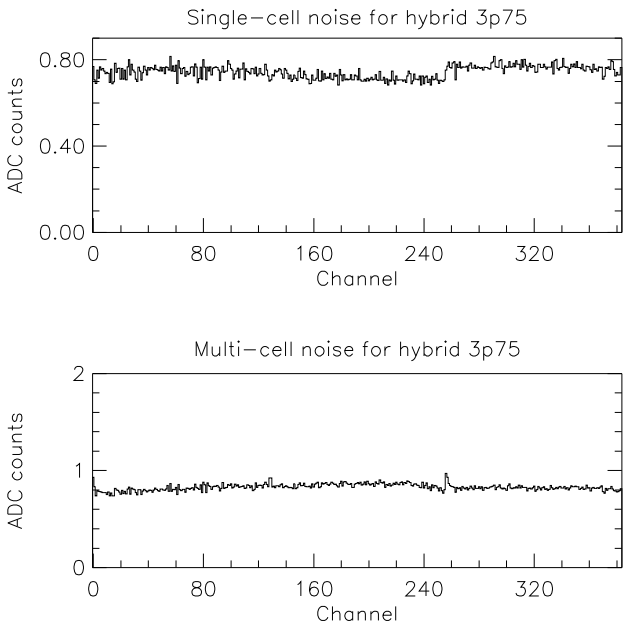
RMS Noise

The following plots show the single-cell and multi-cell RMS noise:

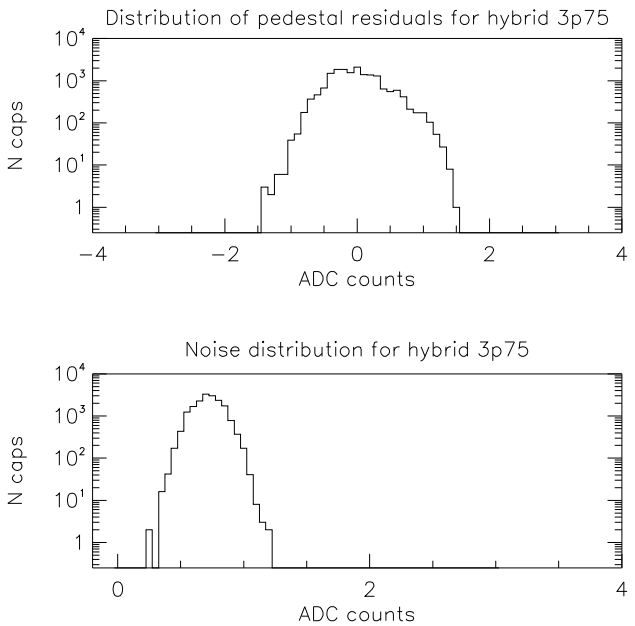
Distribution of Pedestals and Noise

The following are histograms of the pedestal of each pipeline capacitor relative to the chip average (top); and the RMS noise of each capacitor (bottom):

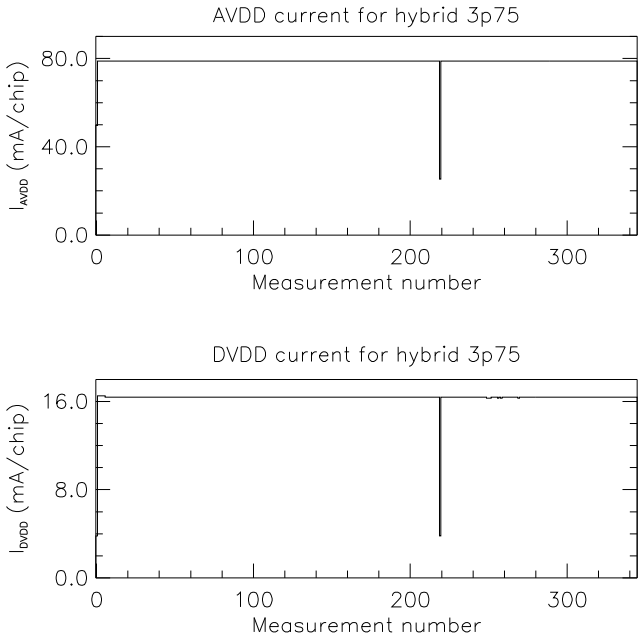
Supply Currents During Burn-in

The following plots show the supply currents per chip as a function of measurment number. Currents are measured approximately every 10 minutes:
