Hybrid 3p95 Traveler

June 5, 2000

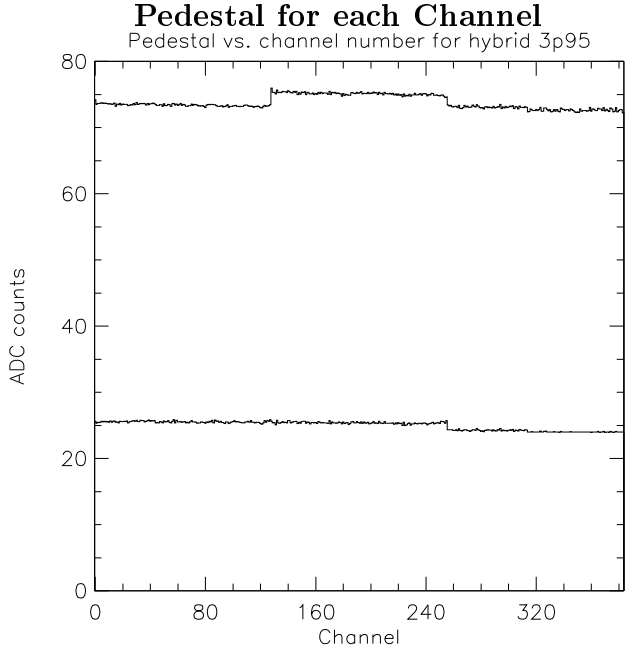
Pedestal for each Channel

The following plot shows the pedestals vs. channel number with and without charge injection:

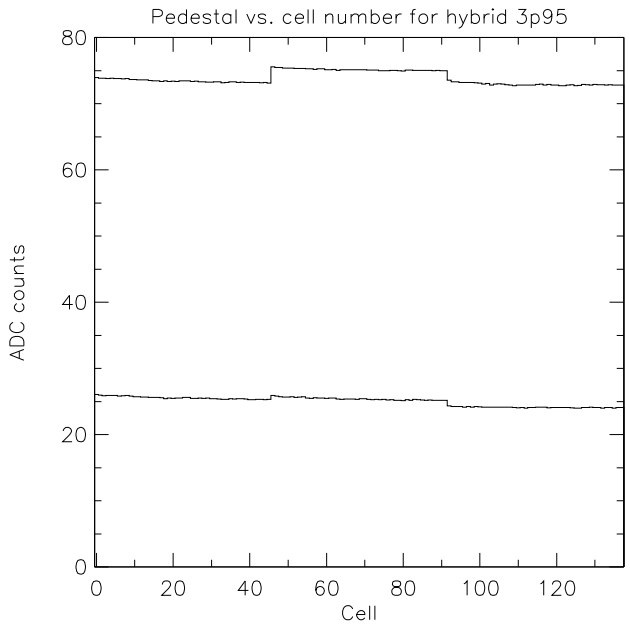
Pedestal vs. Pipeline Cell ID

The following plot shows the average pedestal vs. pipeline cell ID with and without charge injection. The x-axis is cell ID offset by 46 for each chip. Thus cell ID 5 for chip 1 is at x=5, chip 2 at x=51, chip 3 at x=97, etc.

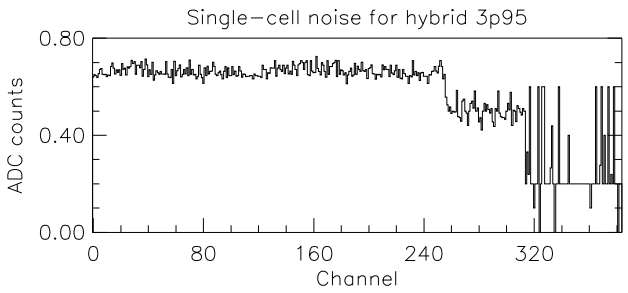
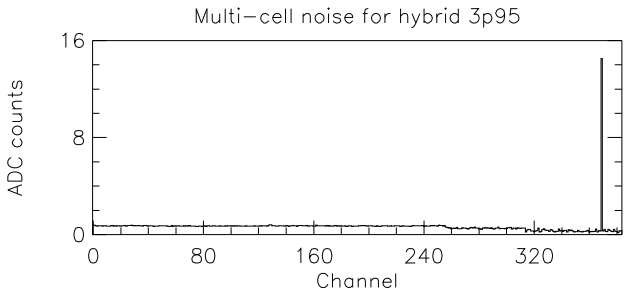
RMS Noise

The following plots show the single-cell and multi-cell RMS noise:

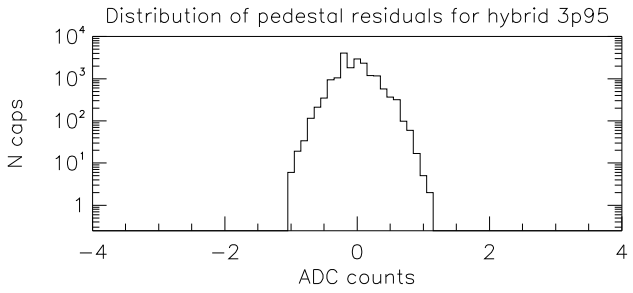
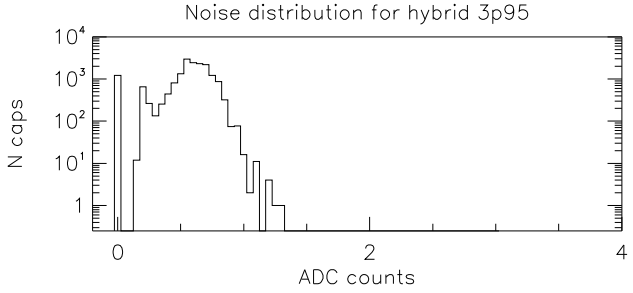
Distribution of Pedestals and Noise

The following are histograms of the pedestal of each pipeline capacitor relative to the chip average (top); and the RMS noise of each capacitor (bottom):

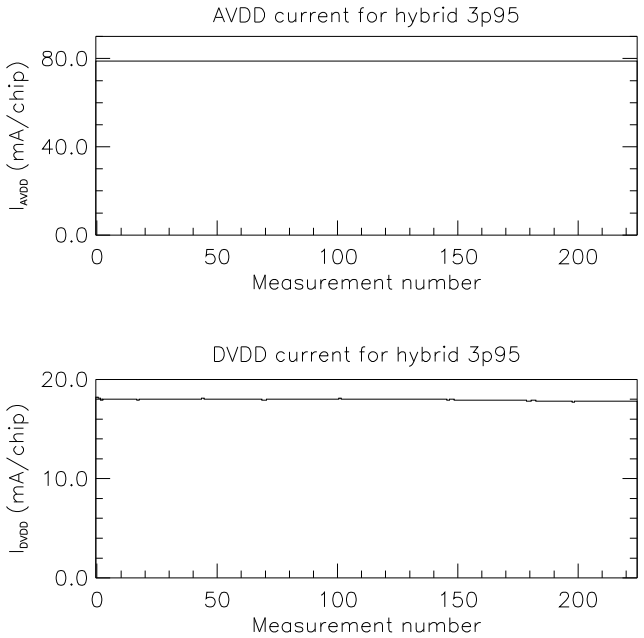
Supply Currents During Burn-in

The following plots show the supply currents per chip as a function of measurment number. Currents are measured approximately every 10 minutes:
