Hybrid 3z159 Traveler

October 27, 1999

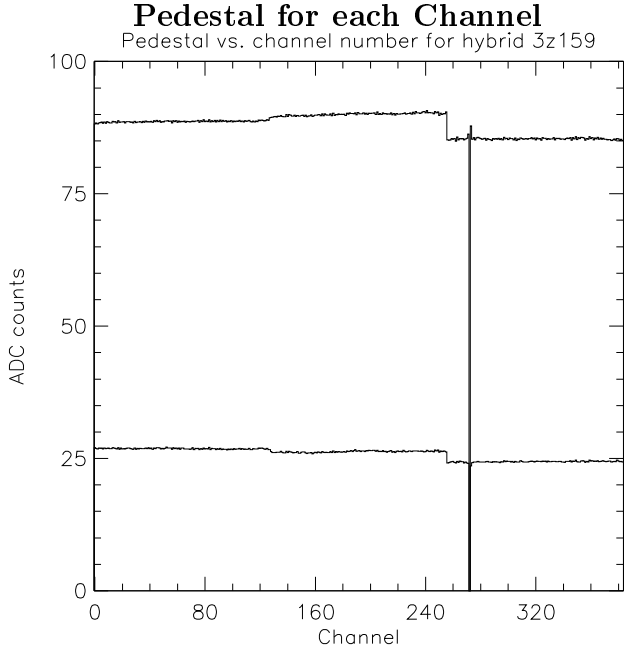
Pedestal for each Channel

The following plot shows the pedestals vs. channel number with and without charge injection:

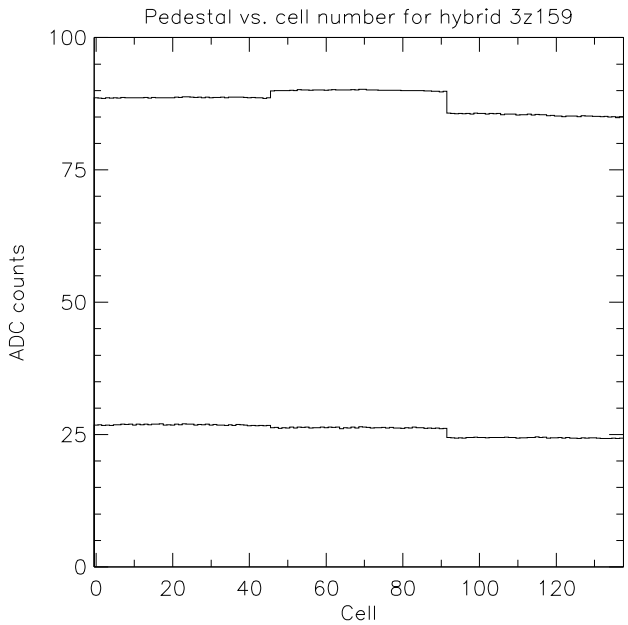
Pedestal vs. Pipeline Cell ID

The following plot shows the average pedestal vs. pipeline cell ID with and without charge injection. The x-axis is cell ID offset by 46 for each chip. Thus cell ID 5 for chip 1 is at x=5, chip 2 at x=51, chip 3 at x=97, etc.

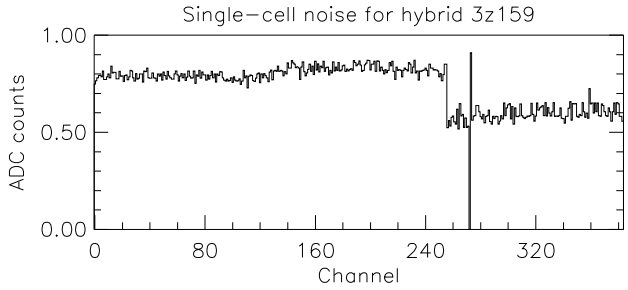
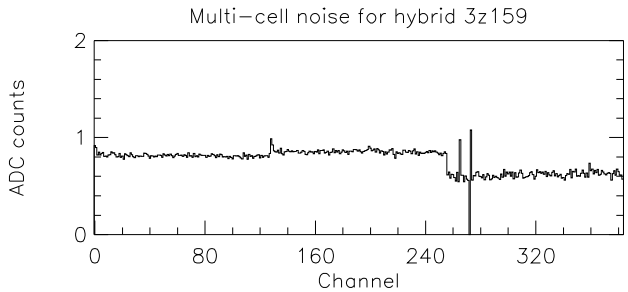
RMS Noise

The following plots show the single-cell and multi-cell RMS noise:

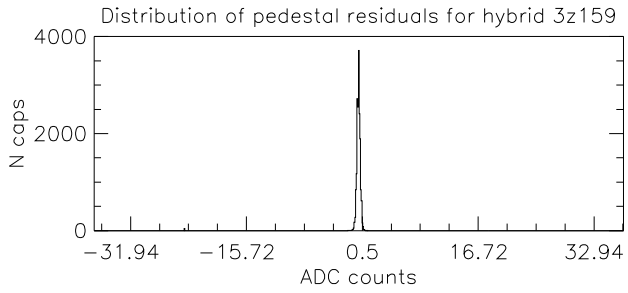
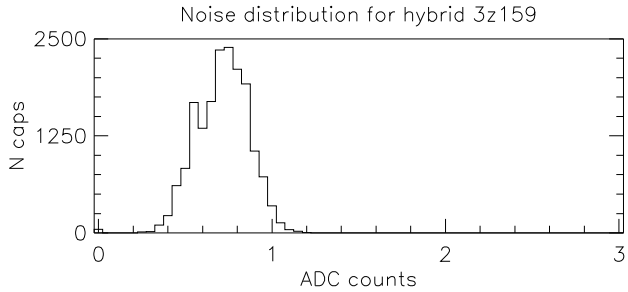
Distribution of Pedestals and Noise

The following are histograms of the pedestal of each pipeline capacitor relative to the chip average (top); and the RMS noise of each capacitor (bottom):

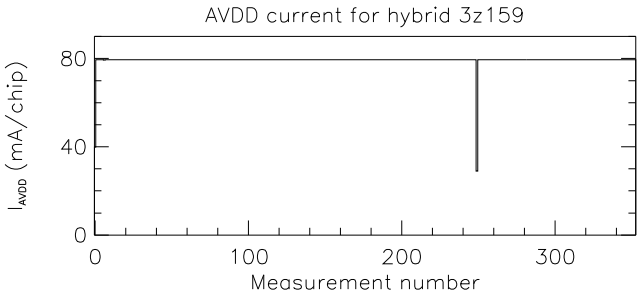
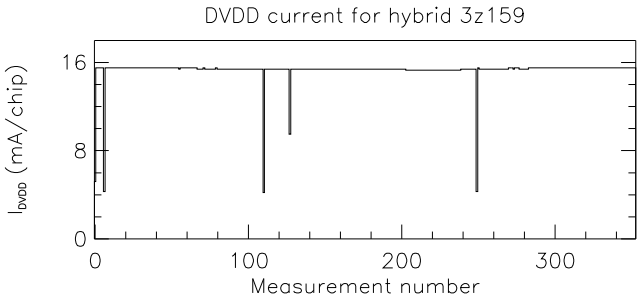
Supply Currents During Burn-in

The following plots show the supply currents per chip as a function of measurment number. Currents are measured approximately every 10 minutes:
