Hybrid 3z17 Traveler

October 12, 1999

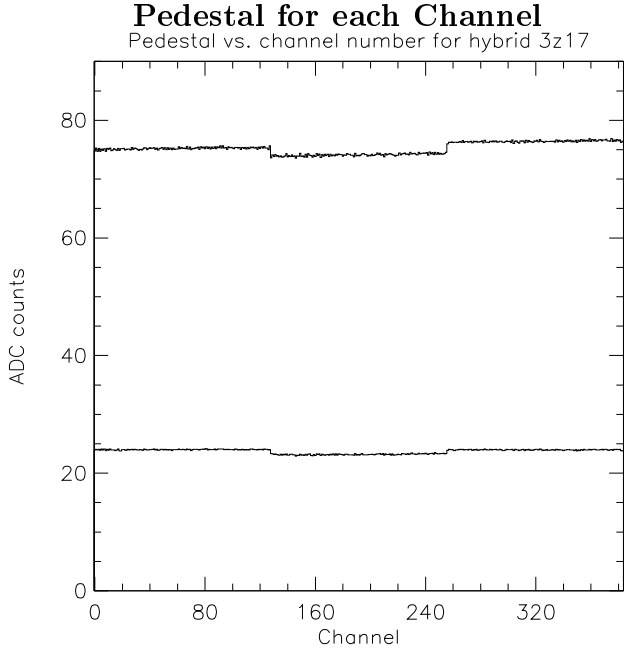
Pedestal for each Channel

The following plot shows the pedestals vs. channel number with and without charge injection:

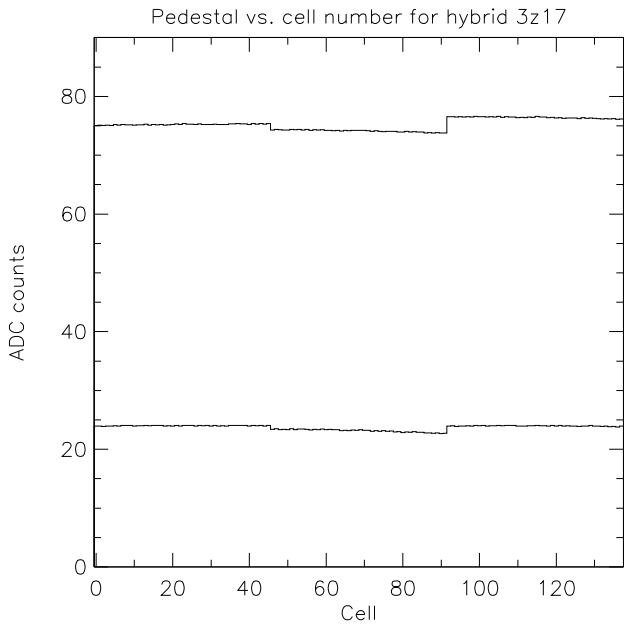
Pedestal vs. Pipeline Cell ID

The following plot shows the average pedestal vs. pipeline cell ID with and without charge injection. The x-axis is cell ID offset by 46 for each chip. Thus cell ID 5 for chip 1 is at x=5, chip 2 at x=51, chip 3 at x=97, etc.

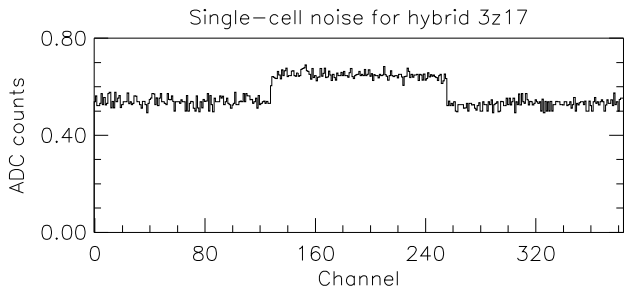
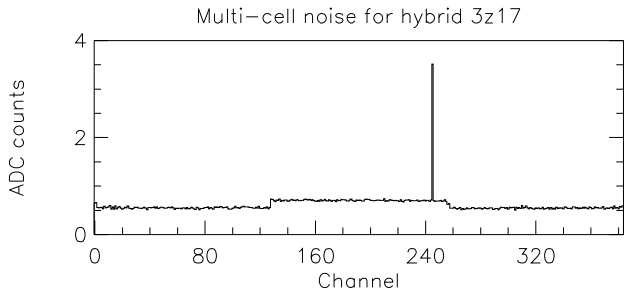
RMS Noise

The following plots show the single-cell and multi-cell RMS noise:

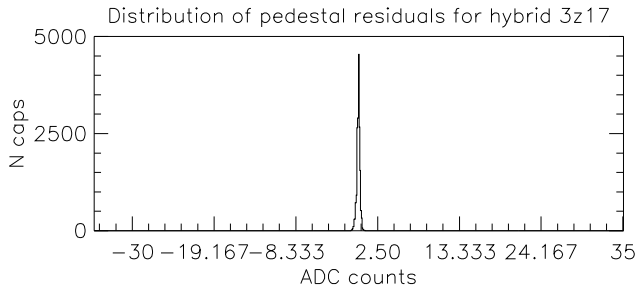
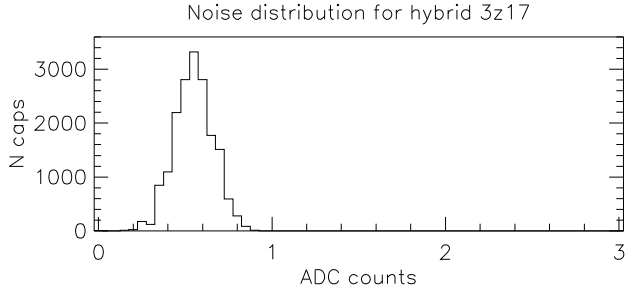
Distribution of Pedestals and Noise

The following are histograms of the pedestal of each pipeline capacitor relative to the chip average (top); and the RMS noise of each capacitor (bottom):

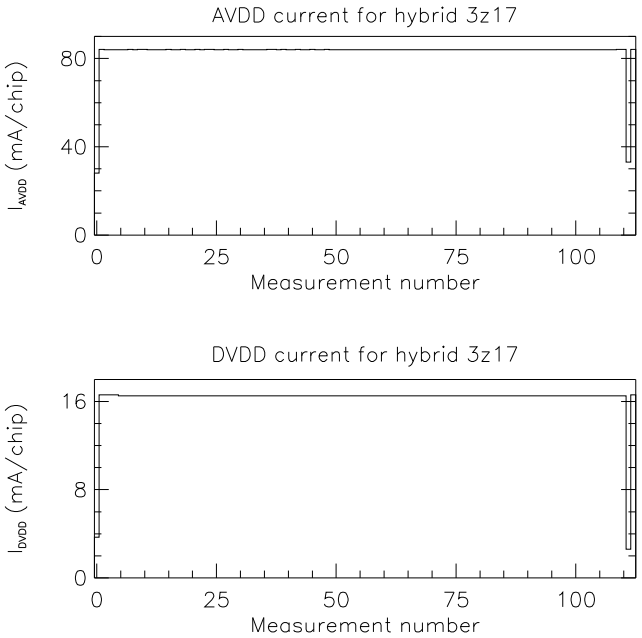
Supply Currents During Burn-in

The following plots show the supply currents per chip as a function of measurment number. Currents are measured approximately every 10 minutes:
