Hybrid 3z24 Traveler

October 13, 1999

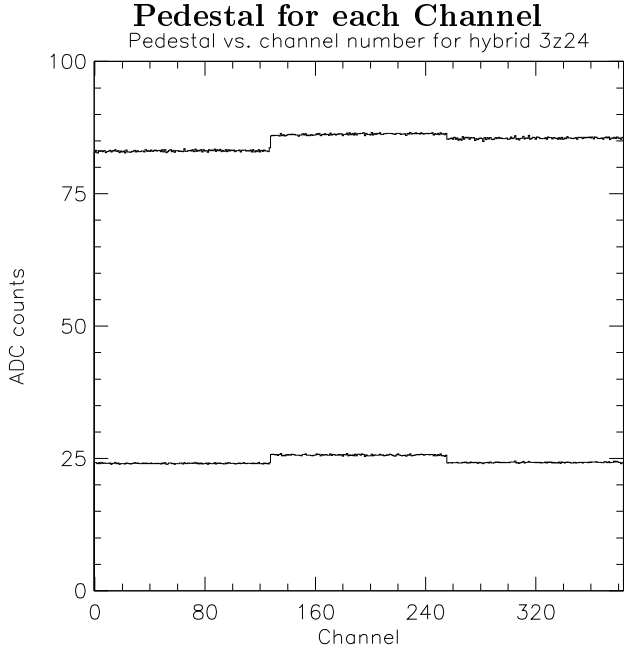
Pedestal for each Channel

Hybrid 3z24 quality: good
Chip classification: good good good
Bad channels: none
Bad cells: none
Random bad capacitors: none
Channels at pedestal needed for DCMS: 37.8 39.6 33.7
```
