Hybrid 3z40 Traveler

October 13, 1999

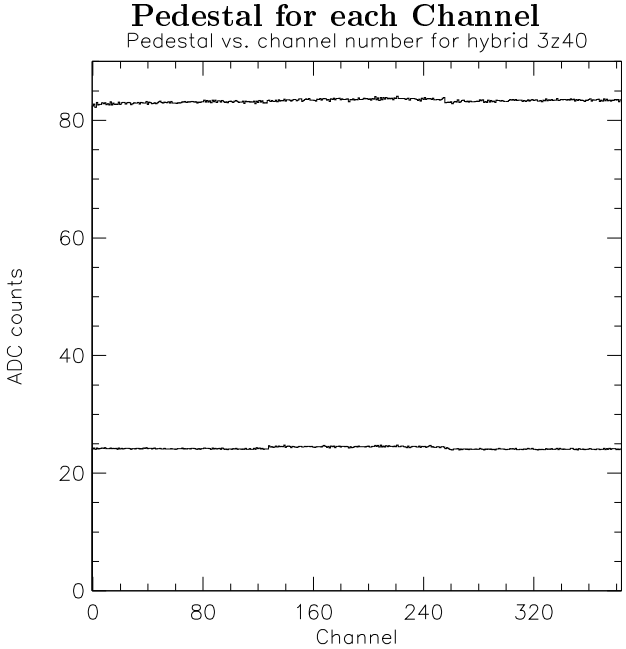
Pedestal for each Channel

The following plot shows the pedestals vs. channel number with and without charge injection:

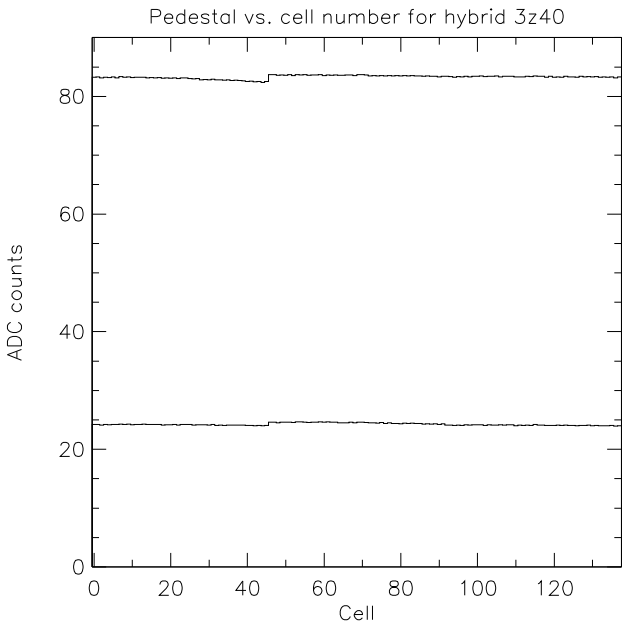
Pedestal vs. Pipeline Cell ID

The following plot shows the average pedestal vs. pipeline cell ID with and without charge injection. The x-axis is cell ID offset by 46 for each chip. Thus cell ID 5 for chip 1 is at x=5, chip 2 at x=51, chip 3 at x=97, etc.

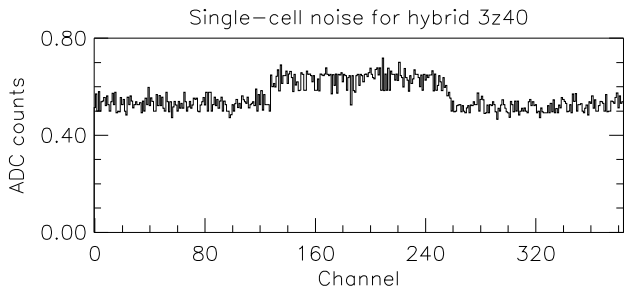
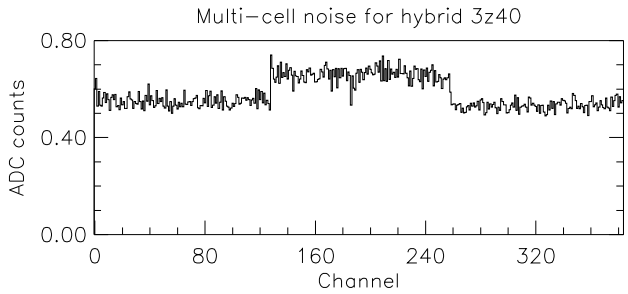
RMS Noise

The following plots show the single-cell and multi-cell RMS noise:

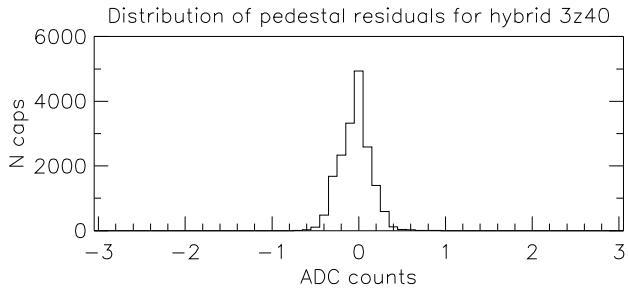
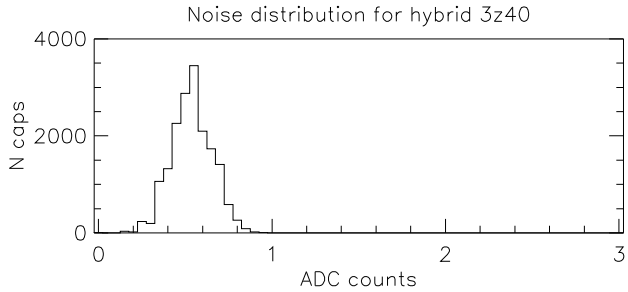
Distribution of Pedestals and Noise

The following are histograms of the pedestal of each pipeline capacitor relative to the chip average (top); and the RMS noise of each capacitor (bottom):

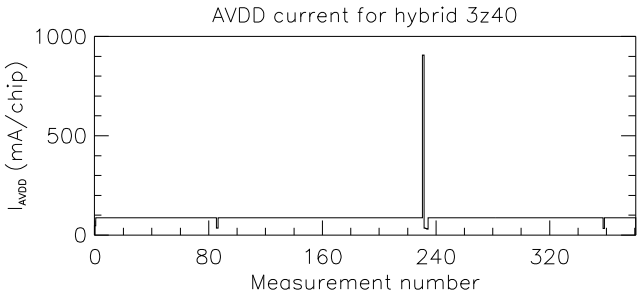
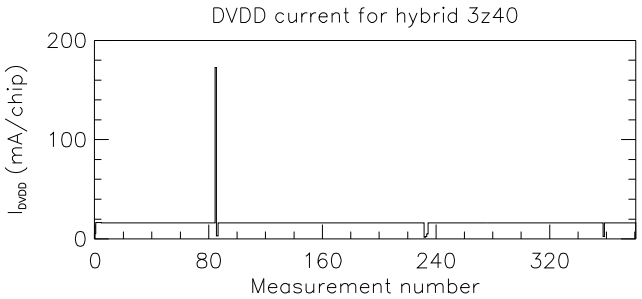
Supply Currents During Burn-in

The following plots show the supply currents per chip as a function of measurment number. Currents are measured approximately every 10 minutes:
