Hybrid 3z78 Traveler

November 9, 1999

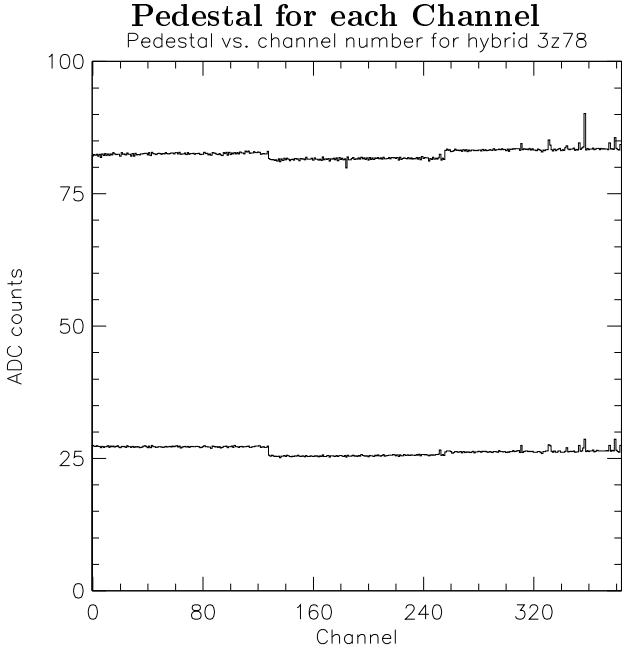
Pedestal for each Channel

Hybrid 3z78 quality: fair
Chip classification: good good fair
Bad channels (chip-channel): 2-101 2-127
Bad cells: none
Random bad capacitors (chip-cell-channel): 2-13-101 2-18-101 2-4-101
   2-44-101
Channels at pedestal needed for DCMS: 31.7 33.3 32.1
```

The following plot shows the pedestals vs. channel number with and without charge injection:

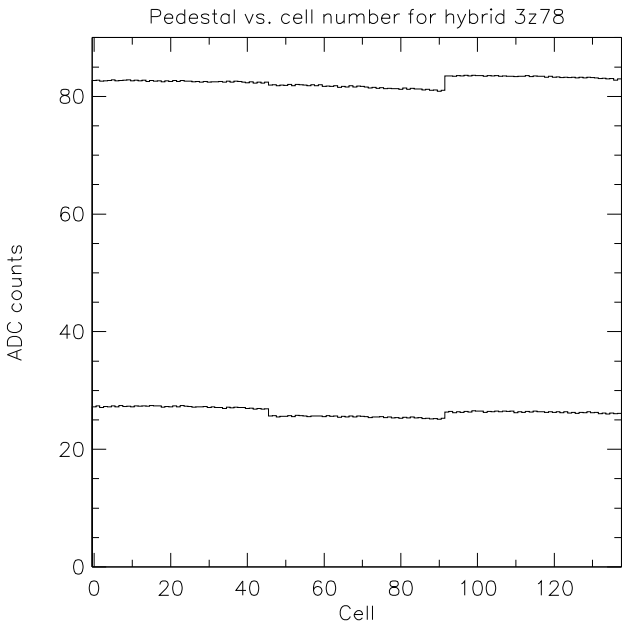
Pedestal vs. Pipeline Cell ID

The following plot shows the average pedestal vs. pipeline cell ID with and without charge injection. The x-axis is cell ID offset by 46 for each chip. Thus cell ID 5 for chip 1 is at x=5, chip 2 at x=51, chip 3 at x=97, etc.

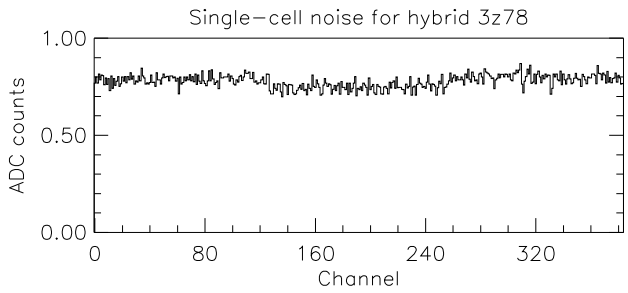
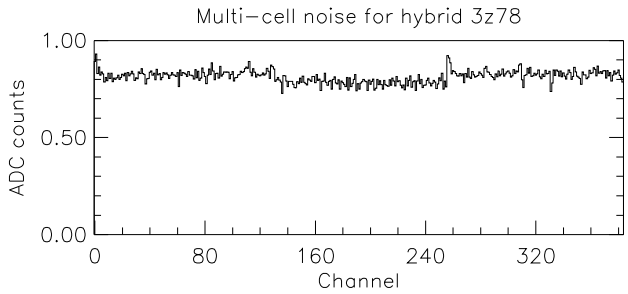
RMS Noise

The following plots show the single-cell and multi-cell RMS noise:

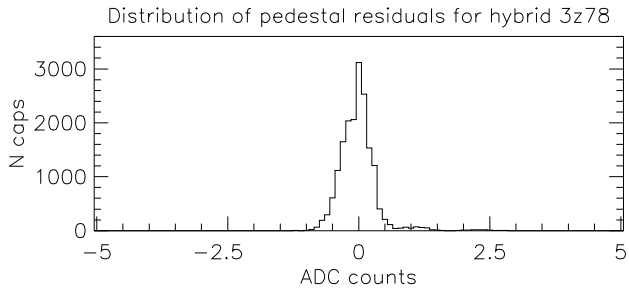
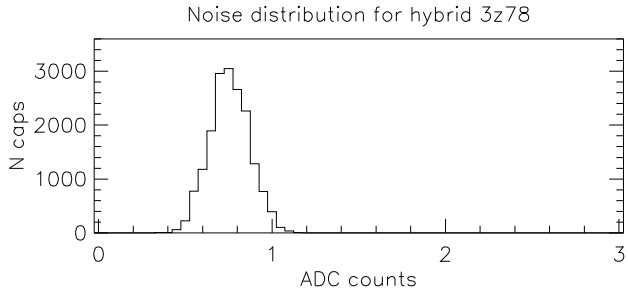
Distribution of Pedestals and Noise

The following are histograms of the pedestal of each pipeline capacitor relative to the chip average (top); and the RMS noise of each capacitor (bottom):

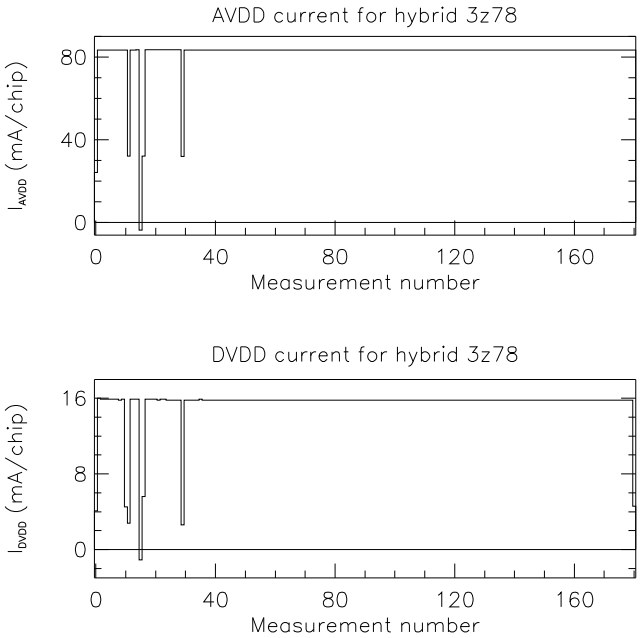
Supply Currents During Burn-in

The following plots show the supply currents per chip as a function of measurment number. Currents are measured approximately every 10 minutes:
