Hybrid 3z8 Traveler

October 12, 1999

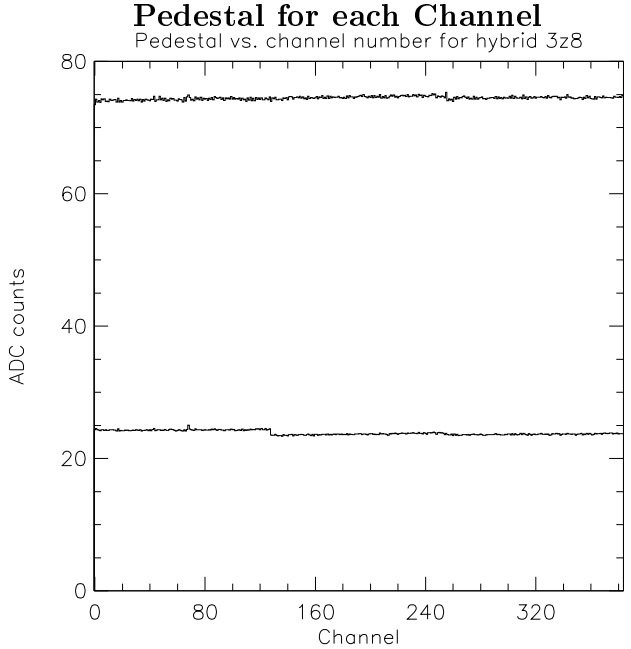
Pedestal for each Channel

The following plot shows the pedestals vs. channel number with and without charge injection:

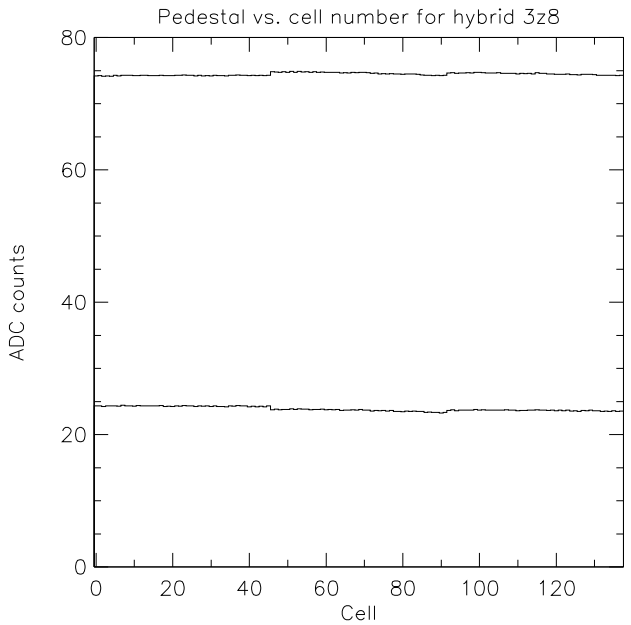
Pedestal vs. Pipeline Cell ID

The following plot shows the average pedestal vs. pipeline cell ID with and without charge injection. The x-axis is cell ID offset by 46 for each chip. Thus cell ID 5 for chip 1 is at x=5, chip 2 at x=51, chip 3 at x=97, etc.

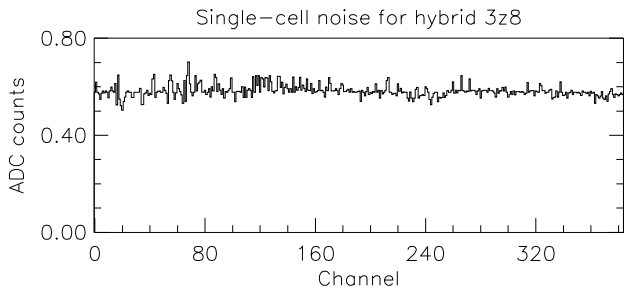
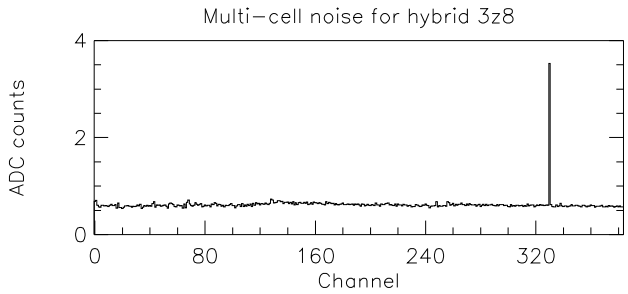
RMS Noise

The following plots show the single-cell and multi-cell RMS noise:

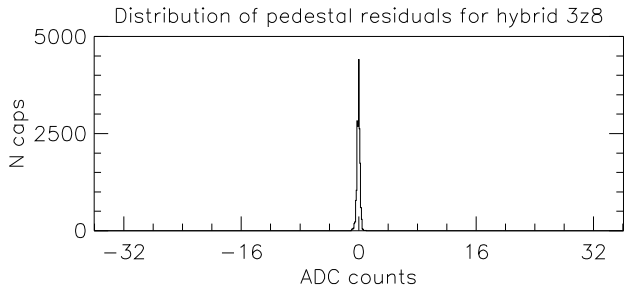
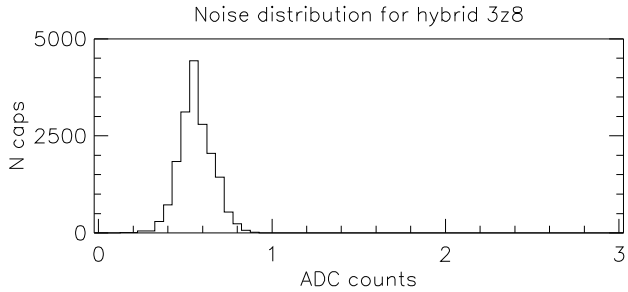
Distribution of Pedestals and Noise

The following are histograms of the pedestal of each pipeline capacitor relative to the chip average (top); and the RMS noise of each capacitor (bottom):

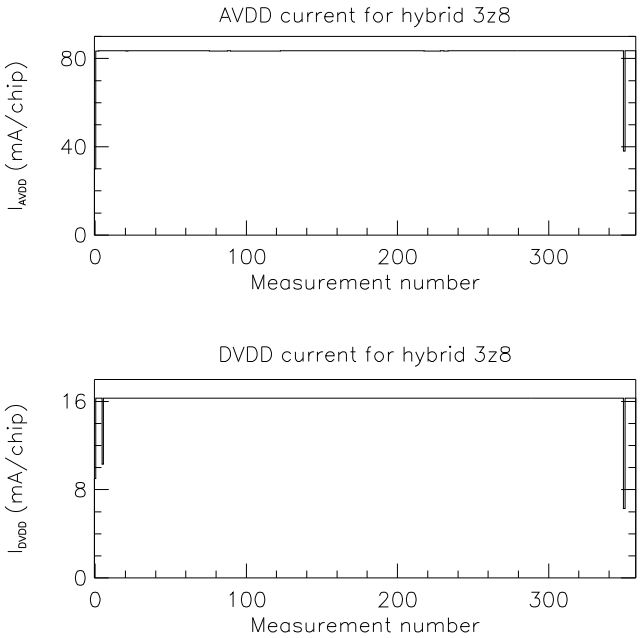
Supply Currents During Burn-in

The following plots show the supply currents per chip as a function of measurment number. Currents are measured approximately every 10 minutes:
