Hybrid 4z128 Traveler

April 7, 2000

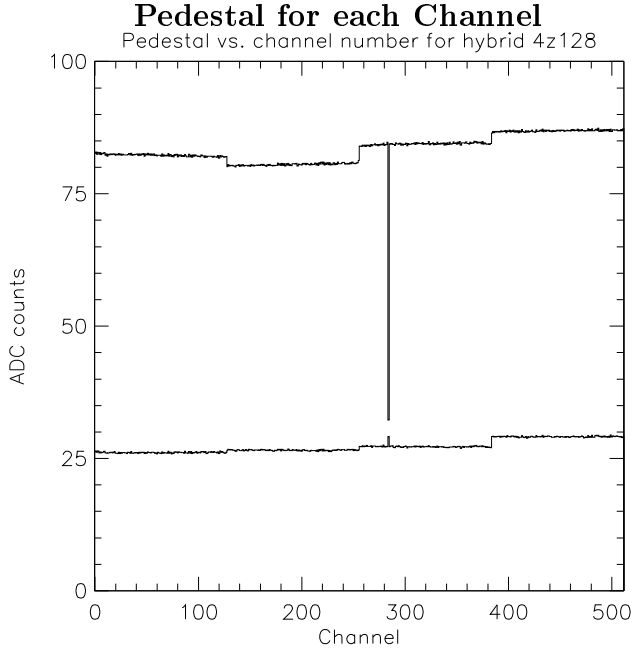
Pedestal for each Channel

The following plot shows the pedestals vs. channel number with and without charge injection:

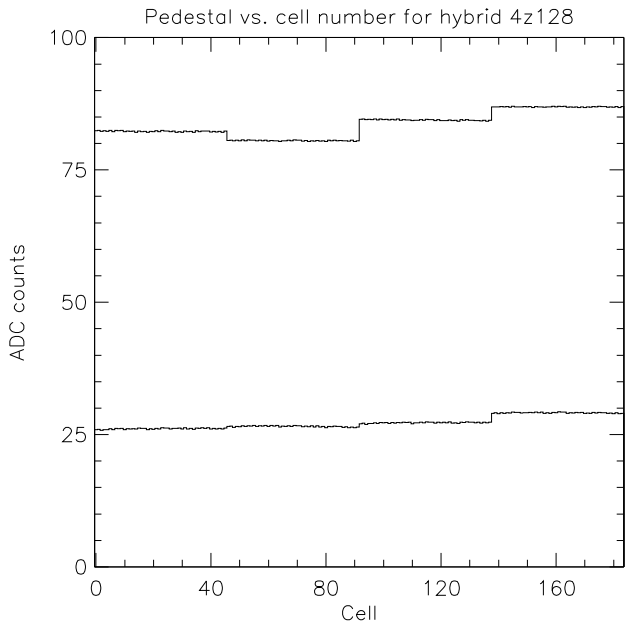
Pedestal vs. Pipeline Cell ID

The following plot shows the average pedestal vs. pipeline cell ID with and without charge injection. The x-axis is cell ID offset by 46 for each chip. Thus cell ID 5 for chip 1 is at x=5, chip 2 at x=51, chip 3 at x=97, etc.

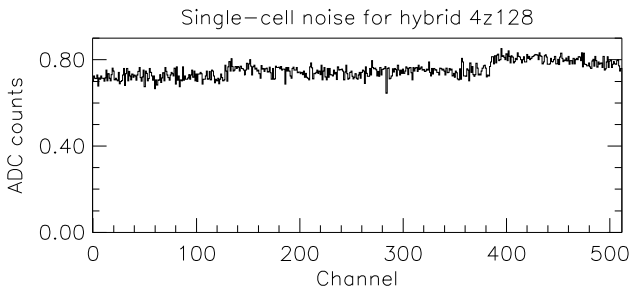
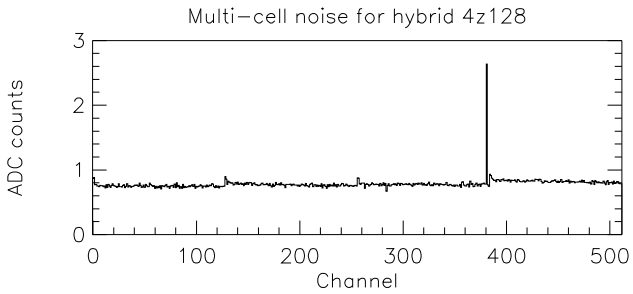
RMS Noise

The following plots show the single-cell and multi-cell RMS noise:

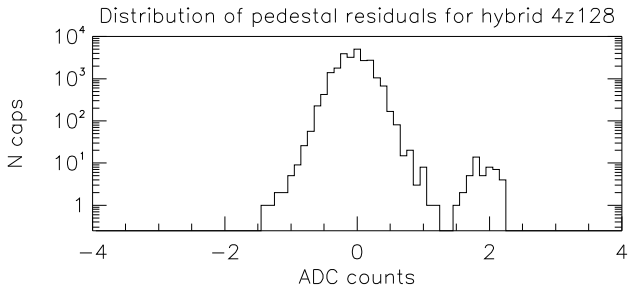
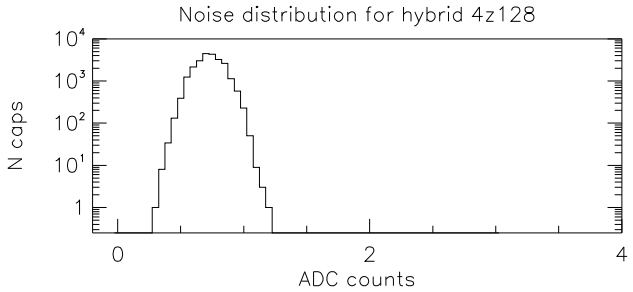
Distribution of Pedestals and Noise

The following are histograms of the pedestal of each pipeline capacitor relative to the chip average (top); and the RMS noise of each capacitor (bottom):

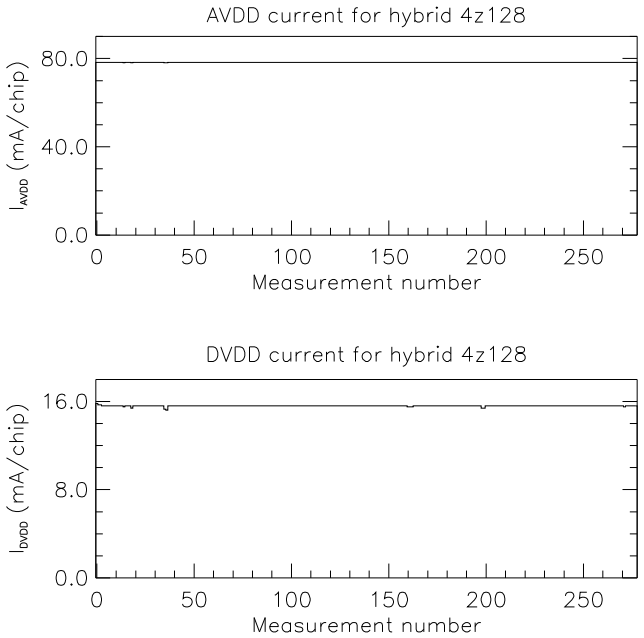
Supply Currents During Burn-in

The following plots show the supply currents per chip as a function of measurment number. Currents are measured approximately every 10 minutes:
