Hybrid 4z138 Traveler

June 5, 2000

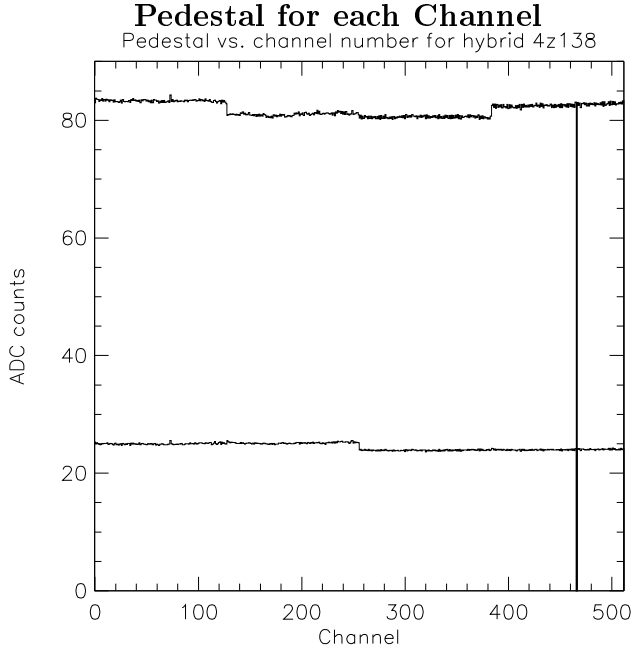
Pedestal for each Channel

The following plot shows the pedestals vs. channel number with and without charge injection:

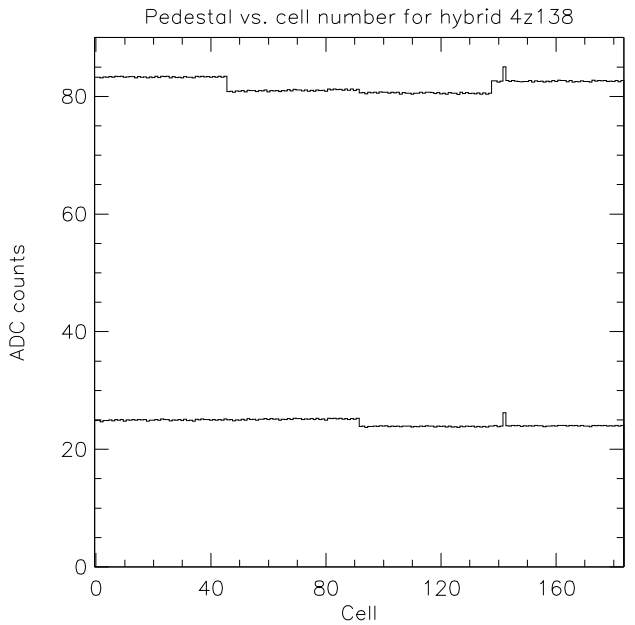
Pedestal vs. Pipeline Cell ID

The following plot shows the average pedestal vs. pipeline cell ID with and without charge injection. The x-axis is cell ID offset by 46 for each chip. Thus cell ID 5 for chip 1 is at x=5, chip 2 at x=51, chip 3 at x=97, etc.

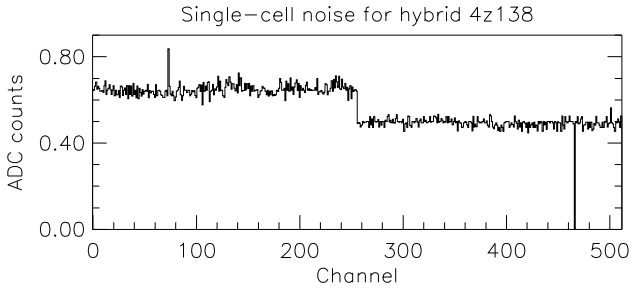
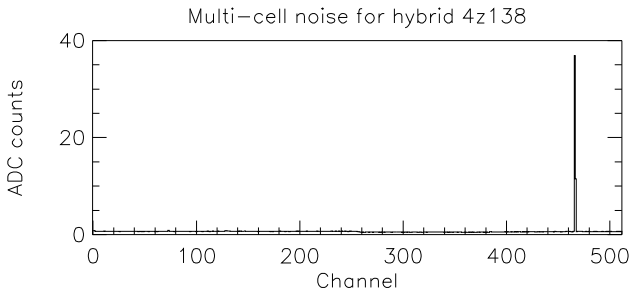
RMS Noise

The following plots show the single-cell and multi-cell RMS noise:

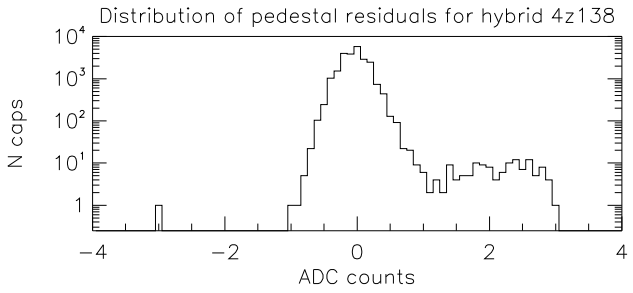
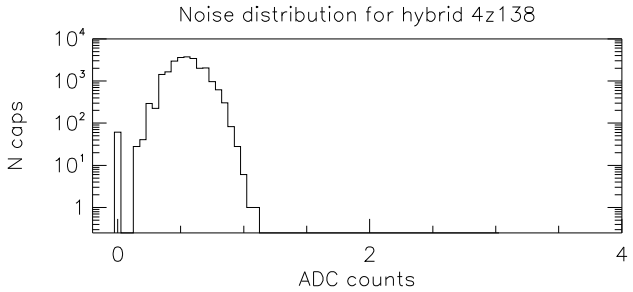
Distribution of Pedestals and Noise

The following are histograms of the pedestal of each pipeline capacitor relative to the chip average (top); and the RMS noise of each capacitor (bottom):

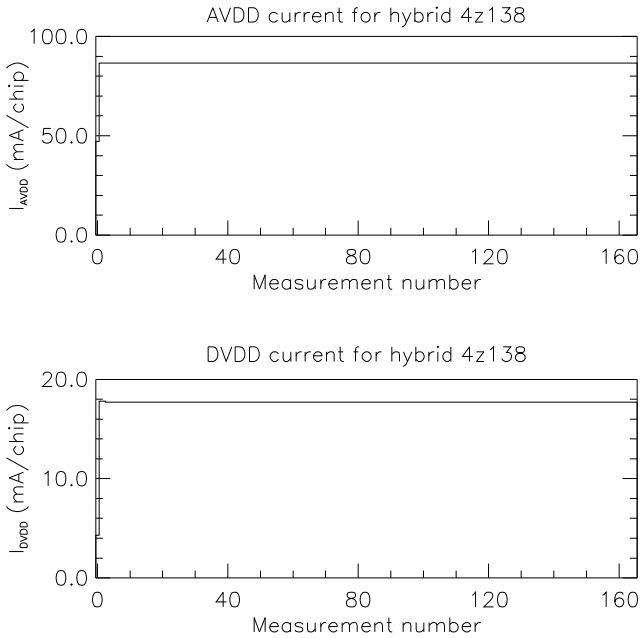
Supply Currents During Burn-in

The following plots show the supply currents per chip as a function of measurment number. Currents are measured approximately every 10 minutes:
