Hybrid 4z201 Traveler

February 28, 2000

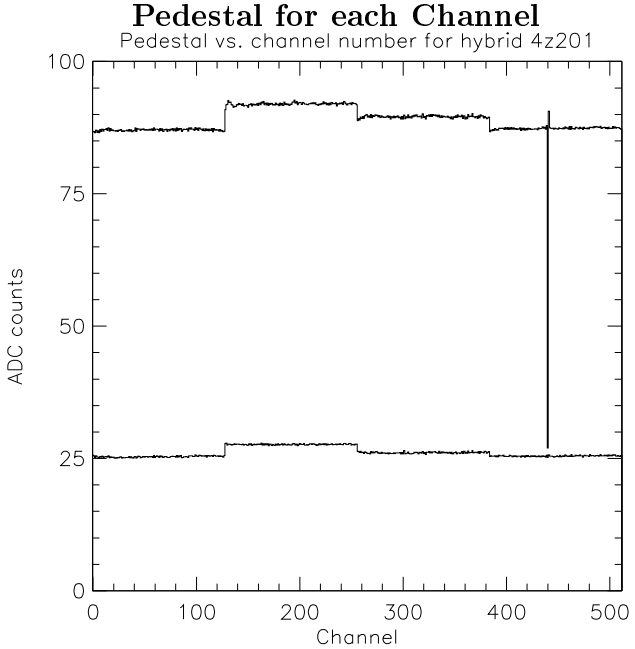
Pedestal for each Channel

The following plot shows the pedestals vs. channel number with and without charge injection:

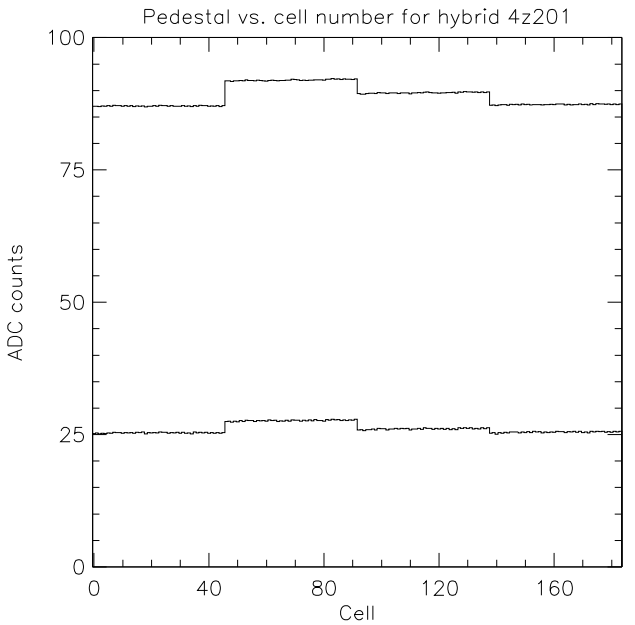
Pedestal vs. Pipeline Cell ID

The following plot shows the average pedestal vs. pipeline cell ID with and without charge injection. The x-axis is cell ID offset by 46 for each chip. Thus cell ID 5 for chip 1 is at x=5, chip 2 at x=51, chip 3 at x=97, etc.

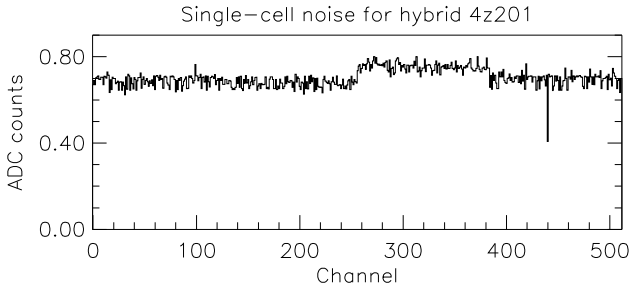
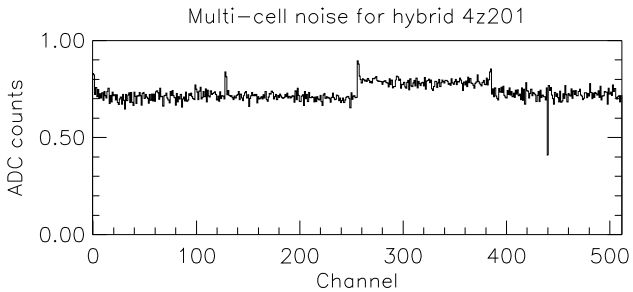
RMS Noise

The following plots show the single-cell and multi-cell RMS noise:

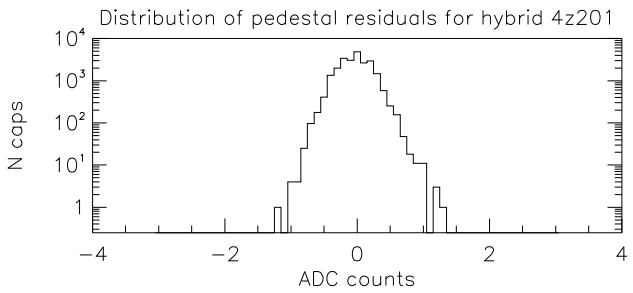
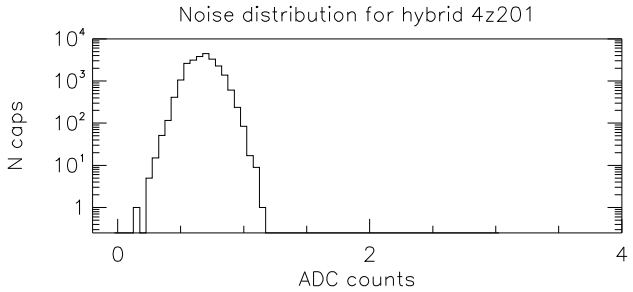
Distribution of Pedestals and Noise

The following are histograms of the pedestal of each pipeline capacitor relative to the chip average (top); and the RMS noise of each capacitor (bottom):

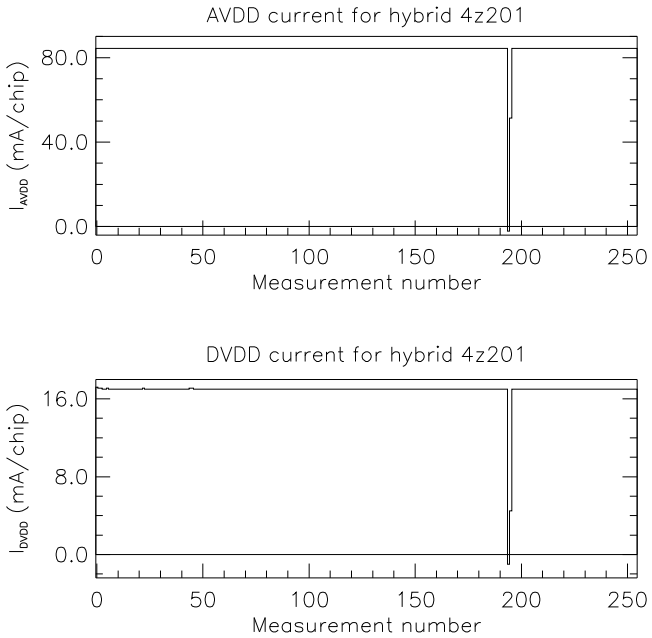
Supply Currents During Burn-in

The following plots show the supply currents per chip as a function of measurment number. Currents are measured approximately every 10 minutes:
