Hybrid 4z55 Traveler

February 24, 2000

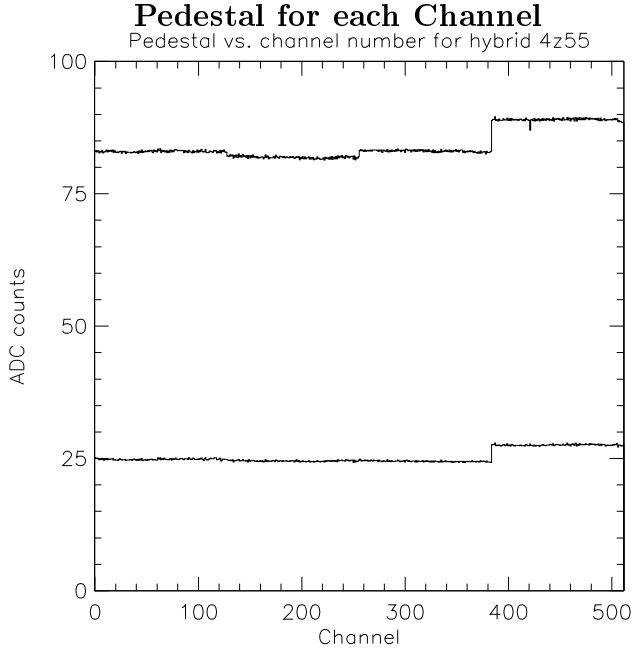
Pedestal for each Channel

The following plot shows the pedestals vs. channel number with and without charge injection:

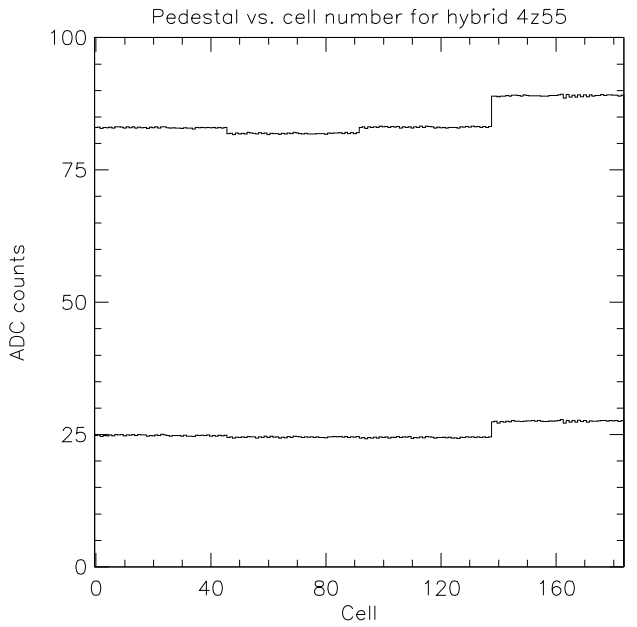
Pedestal vs. Pipeline Cell ID

The following plot shows the average pedestal vs. pipeline cell ID with and without charge injection. The x-axis is cell ID offset by 46 for each chip. Thus cell ID 5 for chip 1 is at x=5, chip 2 at x=51, chip 3 at x=97, etc.

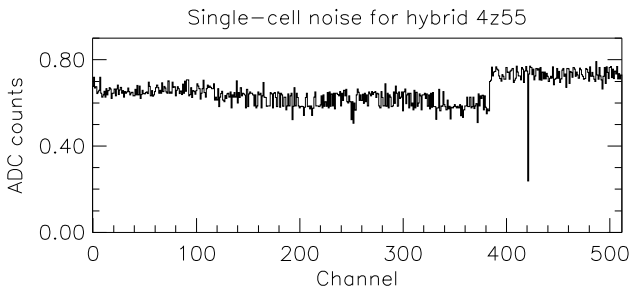
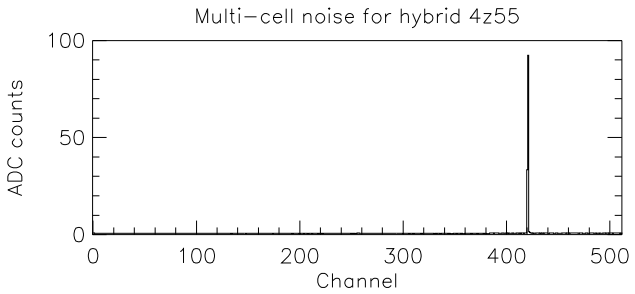
RMS Noise

The following plots show the single-cell and multi-cell RMS noise:

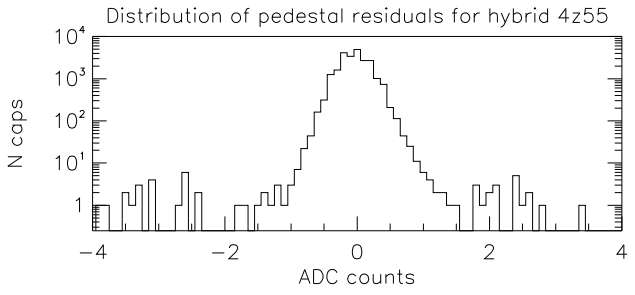
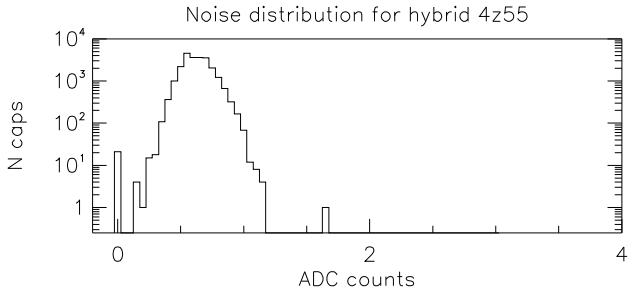
Distribution of Pedestals and Noise

The following are histograms of the pedestal of each pipeline capacitor relative to the chip average (top); and the RMS noise of each capacitor (bottom):

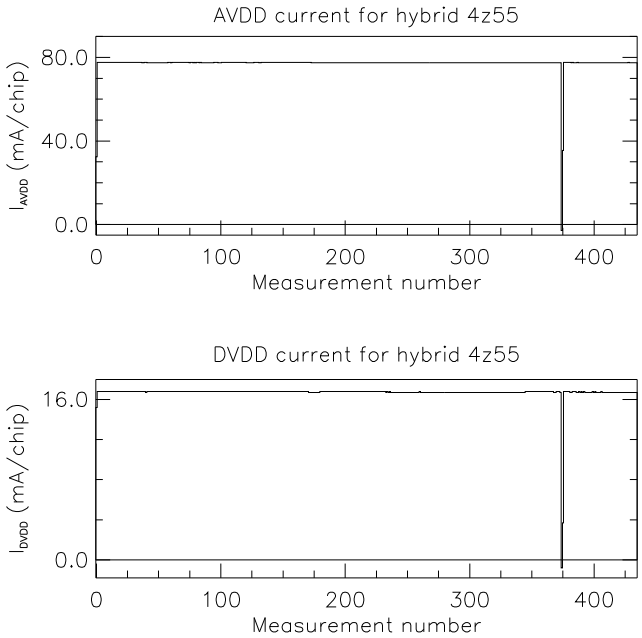
Supply Currents During Burn-in

The following plots show the supply currents per chip as a function of measurment number. Currents are measured approximately every 10 minutes:
