Hybrid 4z64 Traveler

January 21, 2000

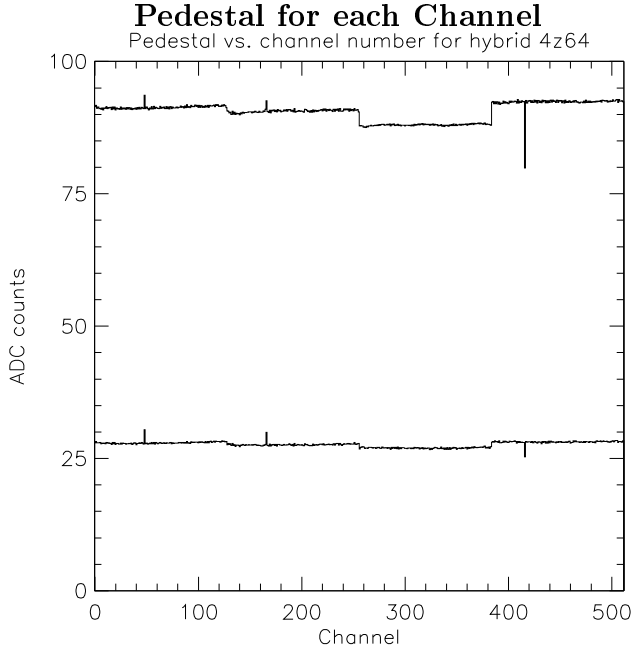
Pedestal for each Channel

The following plot shows the pedestals vs. channel number with and without charge injection:

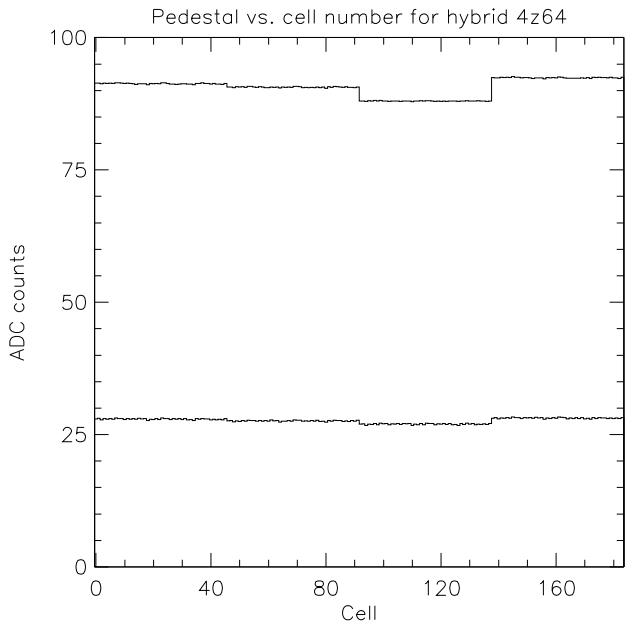
Pedestal vs. Pipeline Cell ID

The following plot shows the average pedestal vs. pipeline cell ID with and without charge injection. The x-axis is cell ID offset by 46 for each chip. Thus cell ID 5 for chip 1 is at x=5, chip 2 at x=51, chip 3 at x=97, etc.

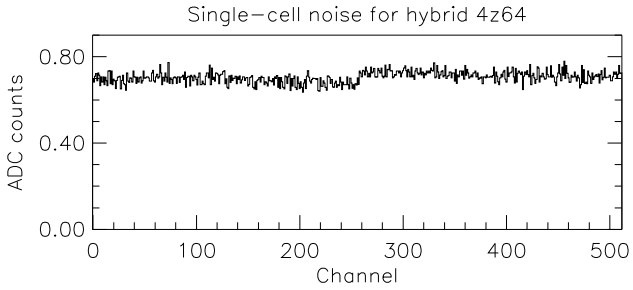
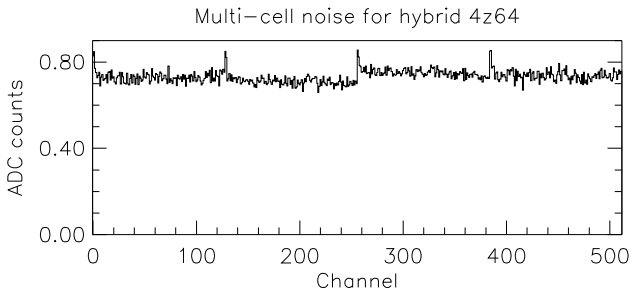
RMS Noise

The following plots show the single-cell and multi-cell RMS noise:

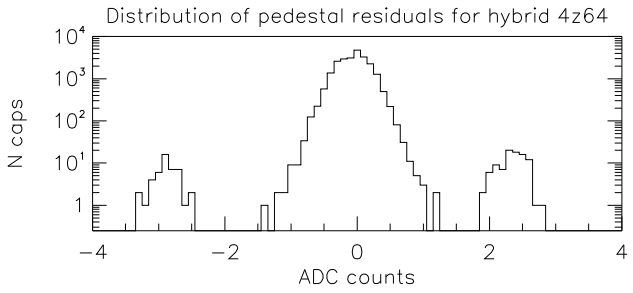
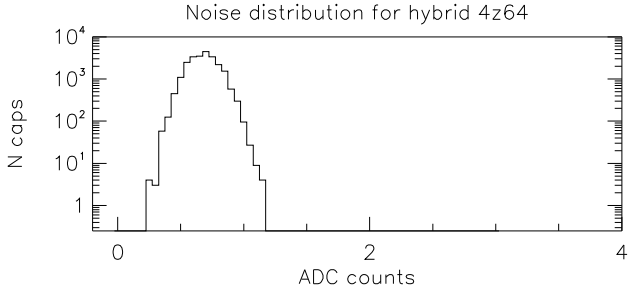
Distribution of Pedestals and Noise

The following are histograms of the pedestal of each pipeline capacitor relative to the chip average (top); and the RMS noise of each capacitor (bottom):

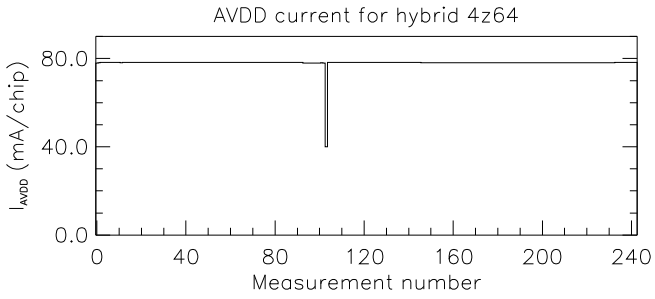
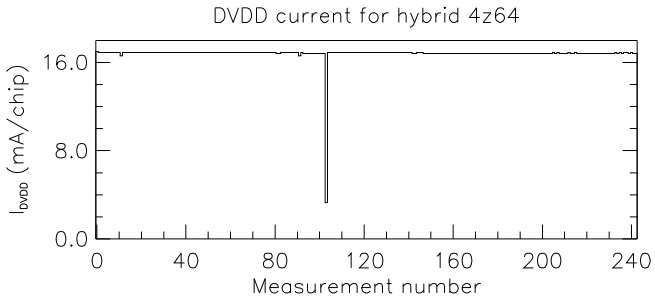
Supply Currents During Burn-in

The following plots show the supply currents per chip as a function of measurment number. Currents are measured approximately every 10 minutes:
