Hybrid 4z80 Traveler

January 12, 2000

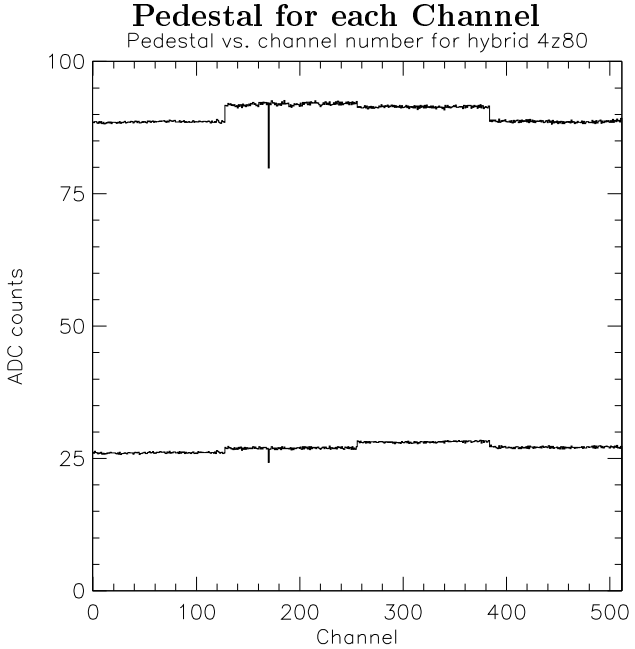
Pedestal for each Channel

Hybrid 4z80 quality: fair
Chip classification: good fair good good
Bad channels (chip-channel): 1-42
Bad cells: none
Random bad capacitors (chip-cell-channel): 1-42-34
Channels at pedestal needed for DCMS: 35.6 37.3 35.7 36.7
```

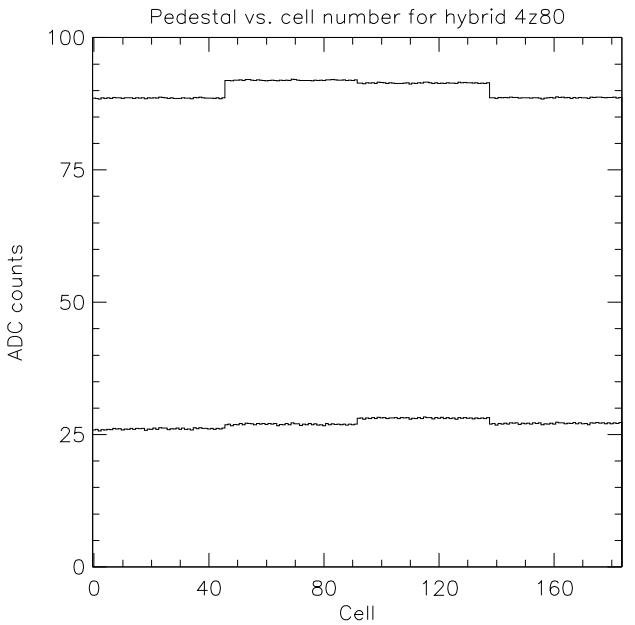
Pedestal vs. Pipeline Cell ID

The following plot shows the average pedestal vs. pipeline cell ID with and without charge injection. The x-axis is cell ID offset by 46 for each chip. Thus cell ID 5 for chip 1 is at x=5, chip 2 at x=51, chip 3 at x=97, etc.

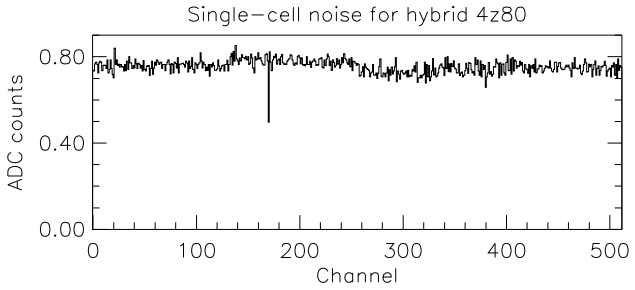
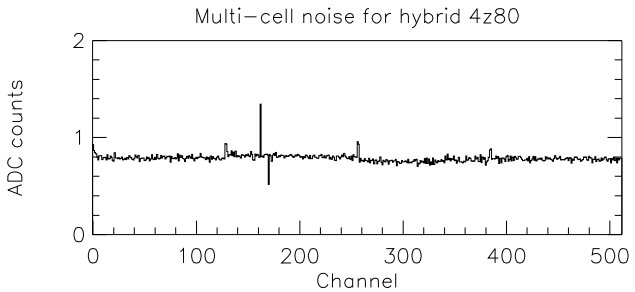
RMS Noise

The following plots show the single-cell and multi-cell RMS noise:

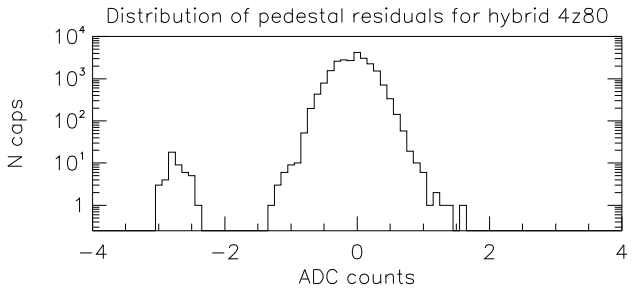
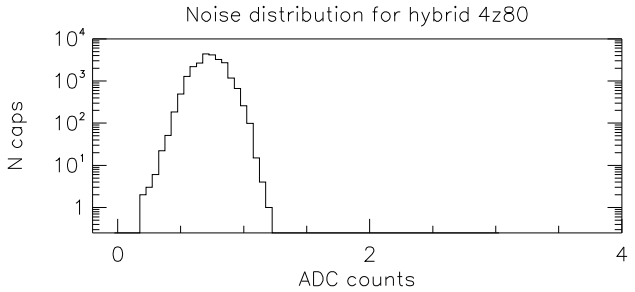
Distribution of Pedestals and Noise

The following are histograms of the pedestal of each pipeline capacitor relative to the chip average (top); and the RMS noise of each capacitor (bottom):

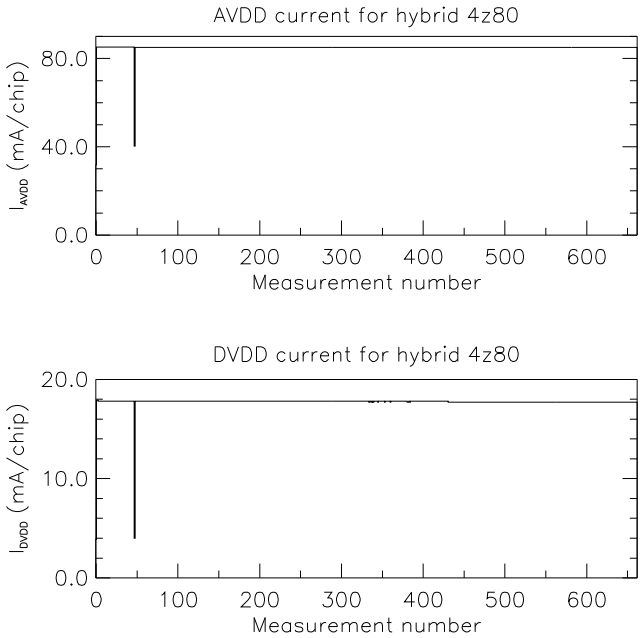
Supply Currents During Burn-in

The following plots show the supply currents per chip as a function of measurment number. Currents are measured approximately every 10 minutes:
