# Hybrid 4z87 Traveler

April 4, 2000

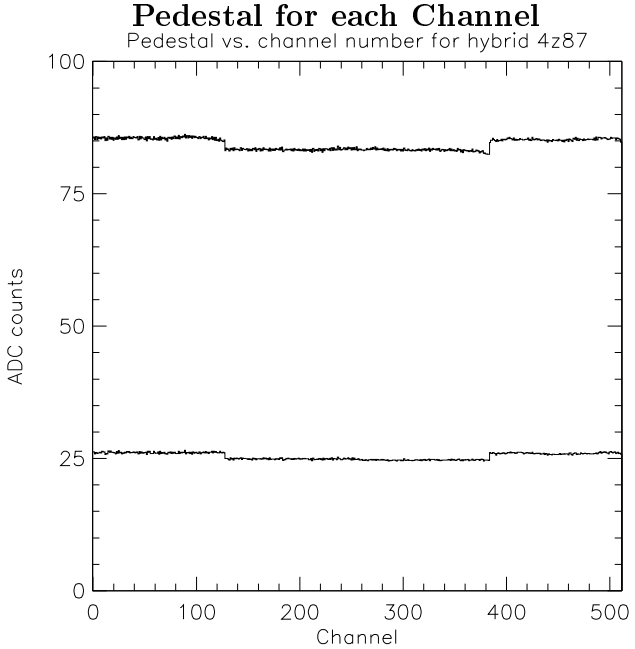
**Pedestal for each Channel**

The following plot shows the pedestals vs. channel number with and without charge injection:

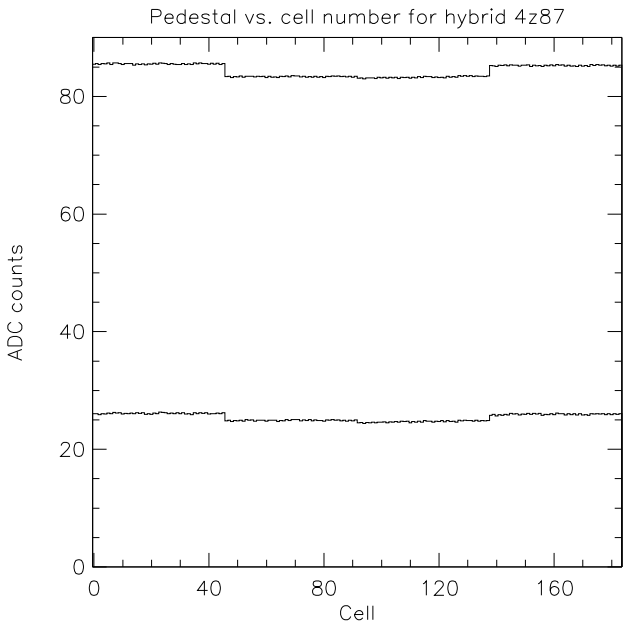
**Pedestal vs. Pipeline Cell ID**

The following plot shows the average pedestal vs. pipeline cell ID with and without charge injection. The x-axis is cell ID offset by 46 for each chip. Thus cell ID 5 for chip 1 is at x=5, chip 2 at x=51, chip 3 at x=97, etc.

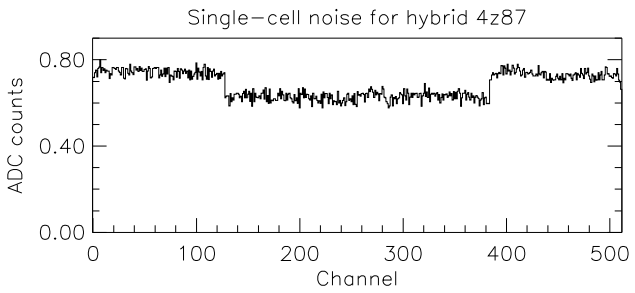
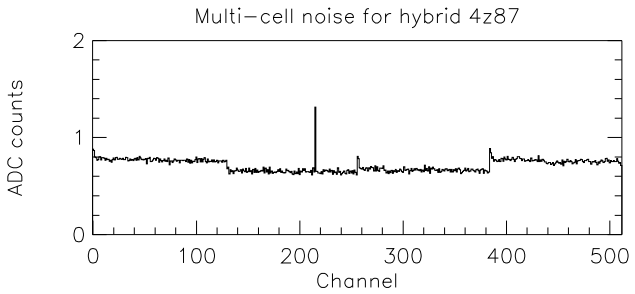
**RMS Noise**

The following plots show the single-cell and multi-cell RMS noise:

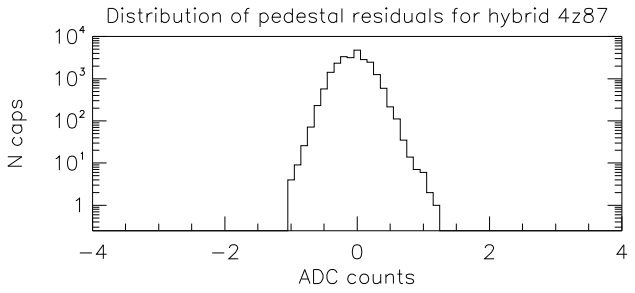
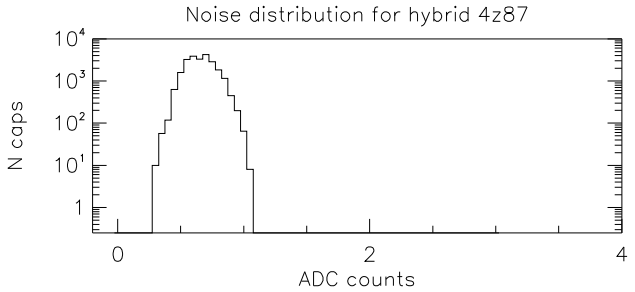
**Distribution of Pedestals and Noise**

The following are histograms of the pedestal of each pipeline capacitor relative to the chip average (top); and the RMS noise of each capacitor (bottom):

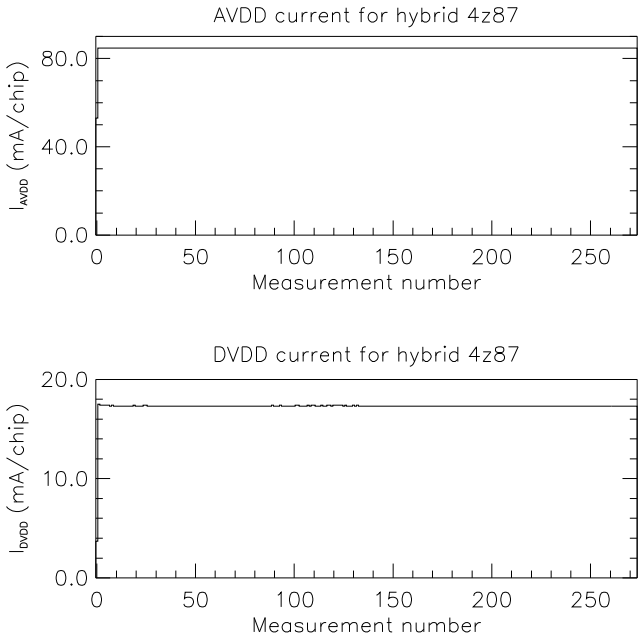
**Supply Currents During Burn-in**

The following plots show the supply currents per chip as a function of measurment number. Currents are measured approximately every 10 minutes:
