Hybrid 4z90 Traveler

February 24, 2000

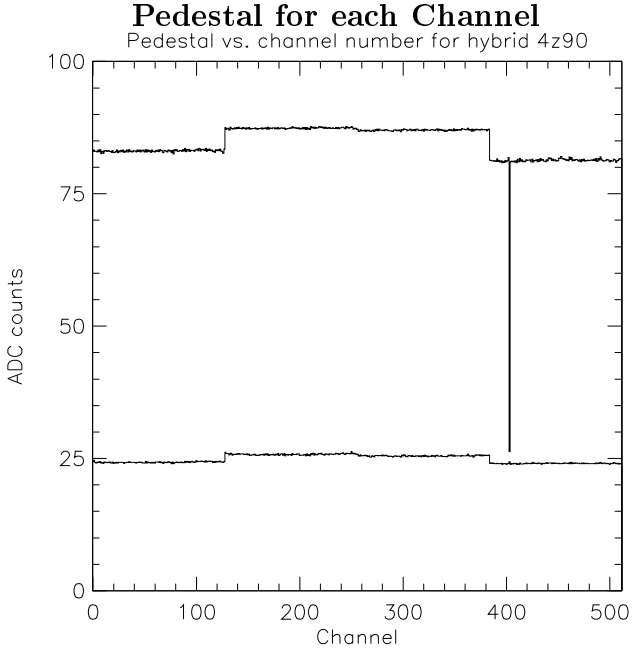
Pedestal for each Channel

The following plot shows the pedestals vs. channel number with and without charge injection:

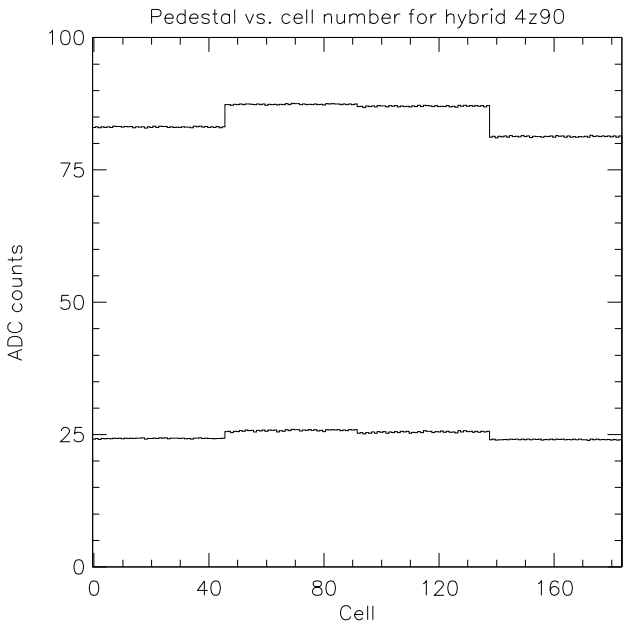
Pedestal vs. Pipeline Cell ID

The following plot shows the average pedestal vs. pipeline cell ID with and without charge injection. The x-axis is cell ID offset by 46 for each chip. Thus cell ID 5 for chip 1 is at x=5, chip 2 at x=51, chip 3 at x=97, etc.

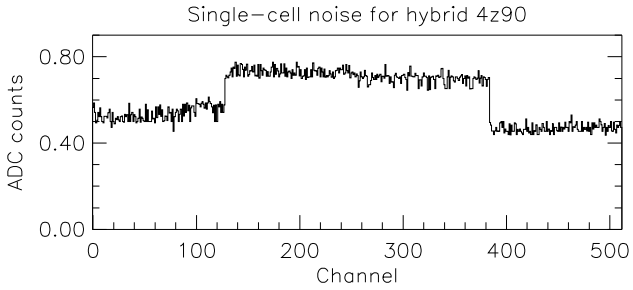
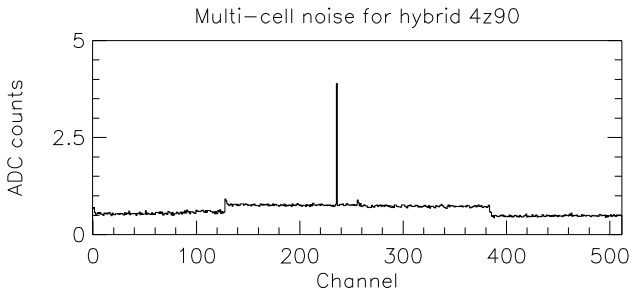
RMS Noise

The following plots show the single-cell and multi-cell RMS noise:

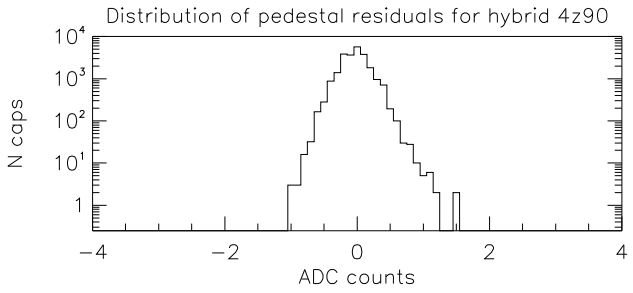
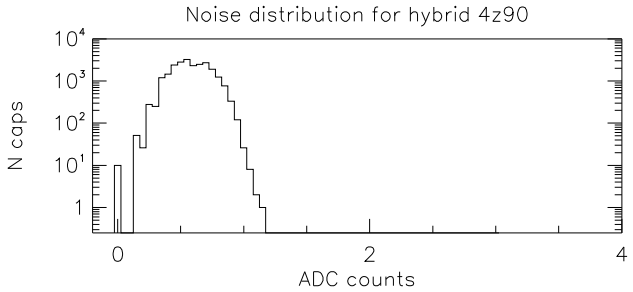
Distribution of Pedestals and Noise

The following are histograms of the pedestal of each pipeline capacitor relative to the chip average (top); and the RMS noise of each capacitor (bottom):

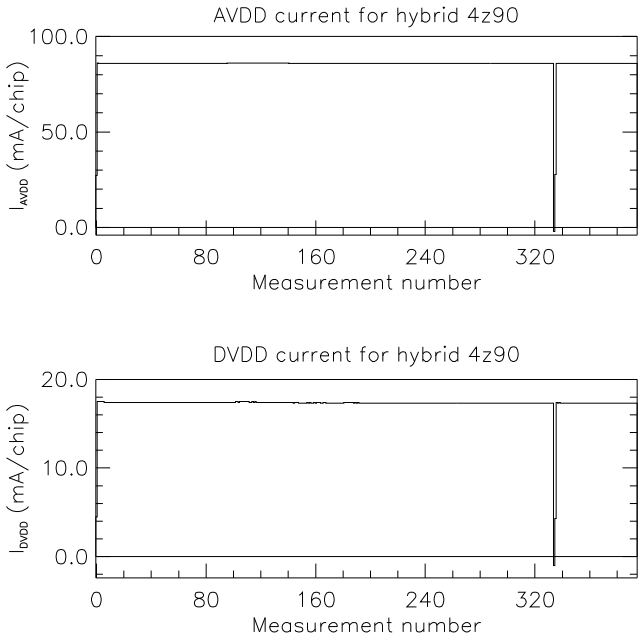
Supply Currents During Burn-in

The following plots show the supply currents per chip as a function of measurment number. Currents are measured approximately every 10 minutes:
