Hybrid 4z98 Traveler

January 19, 2000

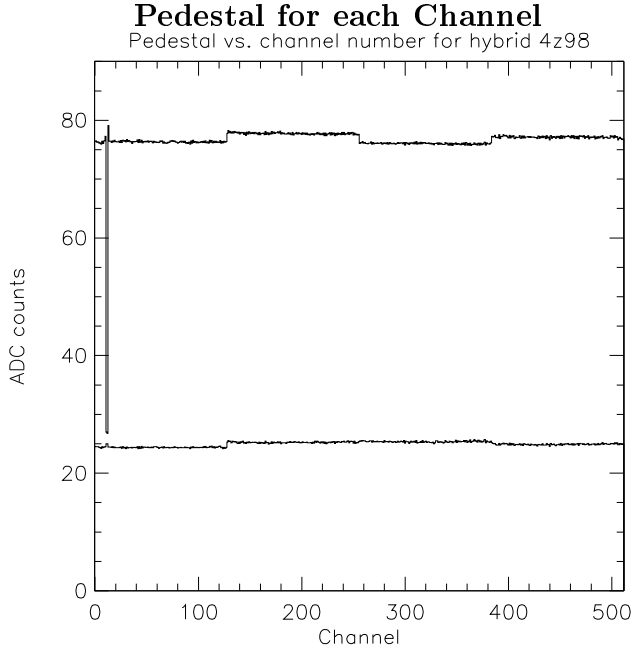
Pedestal for each Channel

The following plot shows the pedestals vs. channel number with and without charge injection:

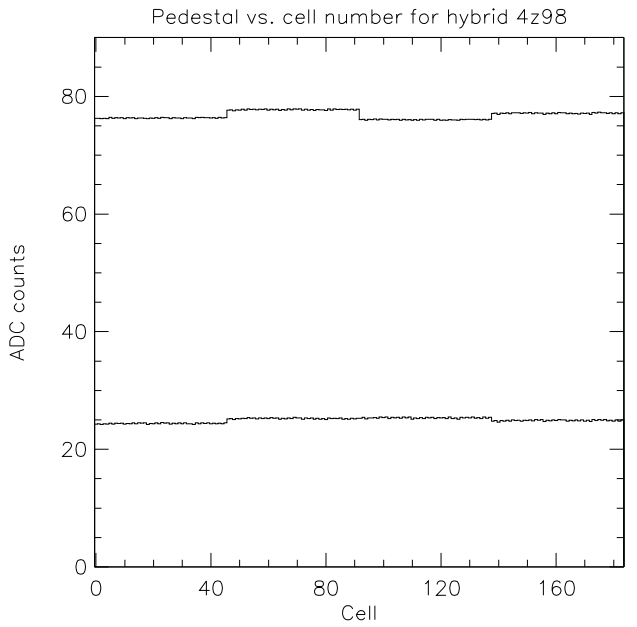
Pedestal vs. Pipeline Cell ID

The following plot shows the average pedestal vs. pipeline cell ID with and without charge injection. The x-axis is cell ID offset by 46 for each chip. Thus cell ID 5 for chip 1 is at x=5, chip 2 at x=51, chip 3 at x=97, etc.

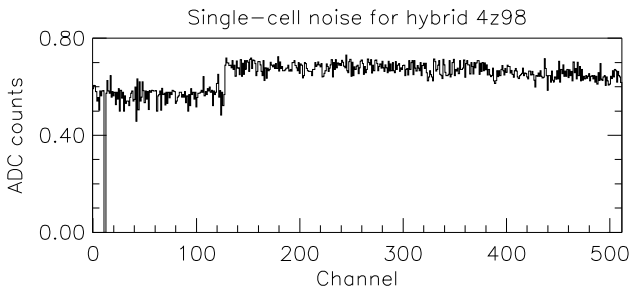
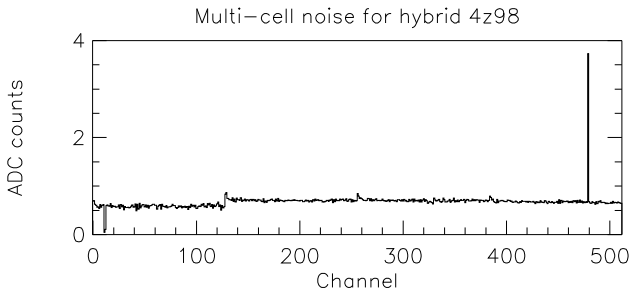
RMS Noise

The following plots show the single-cell and multi-cell RMS noise:

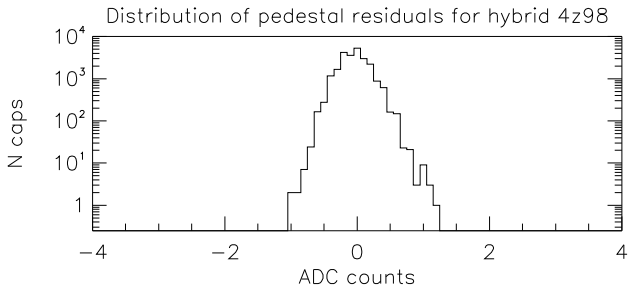
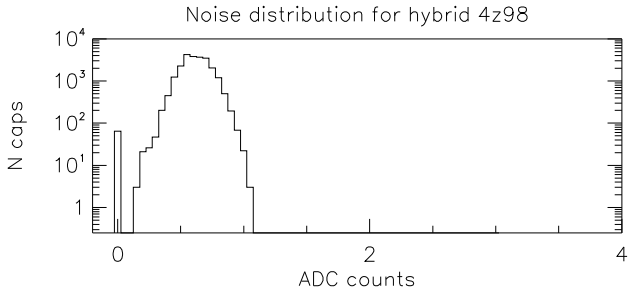
Distribution of Pedestals and Noise

The following are histograms of the pedestal of each pipeline capacitor relative to the chip average (top); and the RMS noise of each capacitor (bottom):

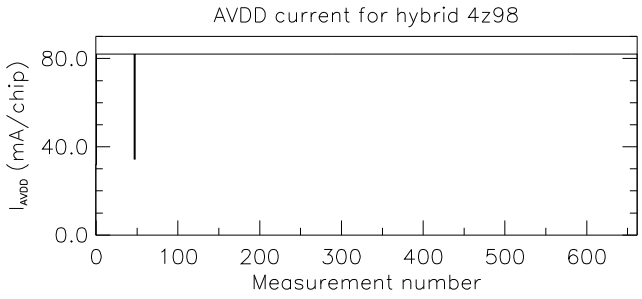
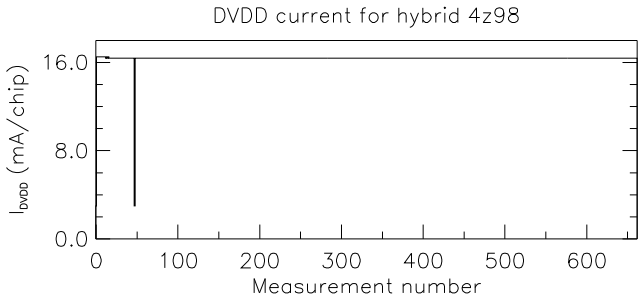
Supply Currents During Burn-in

The following plots show the supply currents per chip as a function of measurment number. Currents are measured approximately every 10 minutes:
