Hybrid 5p102 Traveler

January 14, 2000

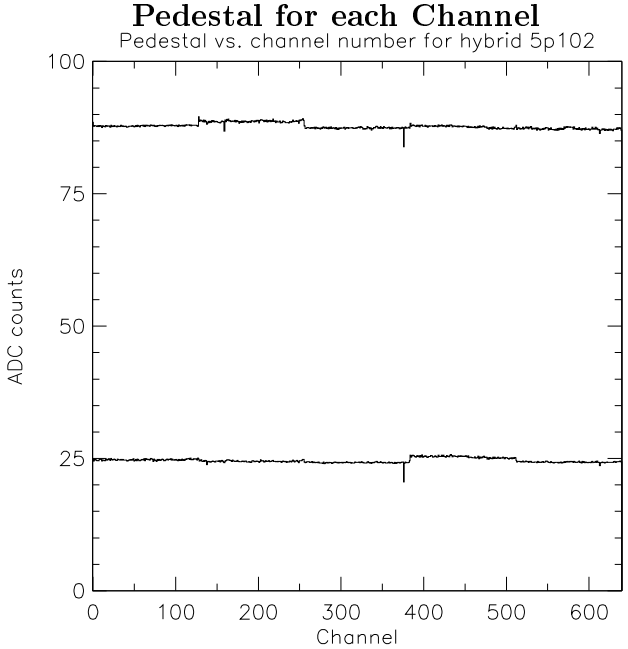
Pedestal for each Channel

The following plot shows the pedestals vs. channel number with and without charge injection:

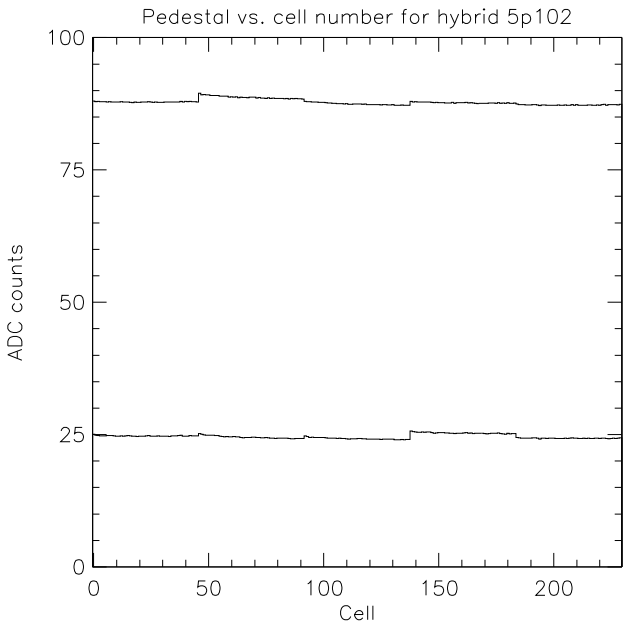
Pedestal vs. Pipeline Cell ID

The following plot shows the average pedestal vs. pipeline cell ID with and without charge injection. The x-axis is cell ID offset by 46 for each chip. Thus cell ID 5 for chip 1 is at x=5, chip 2 at x=51, chip 3 at x=97, etc.

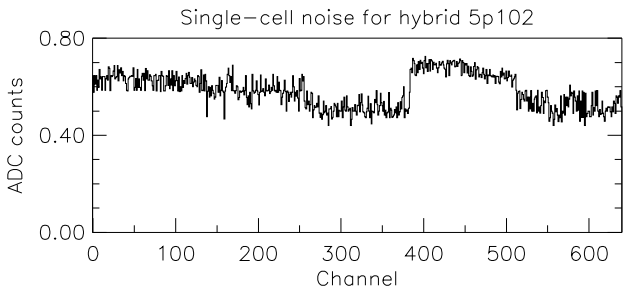
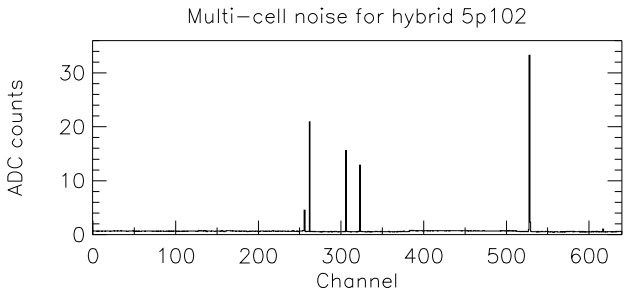
RMS Noise

The following plots show the single-cell and multi-cell RMS noise:

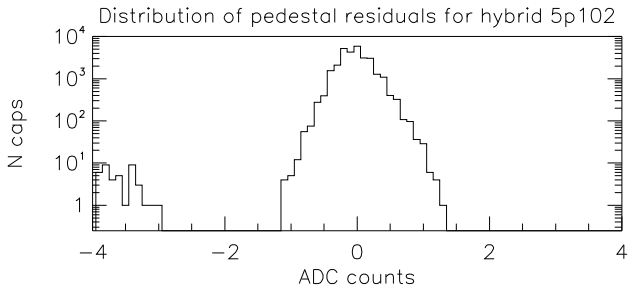
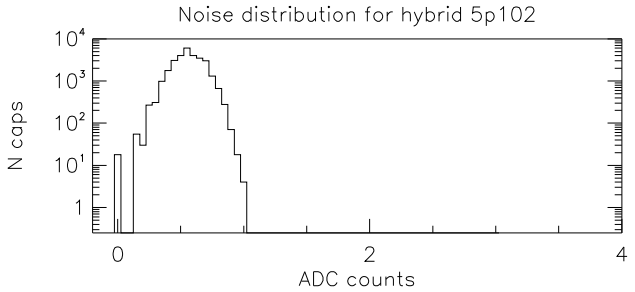
Distribution of Pedestals and Noise

The following are histograms of the pedestal of each pipeline capacitor relative to the chip average (top); and the RMS noise of each capacitor (bottom):

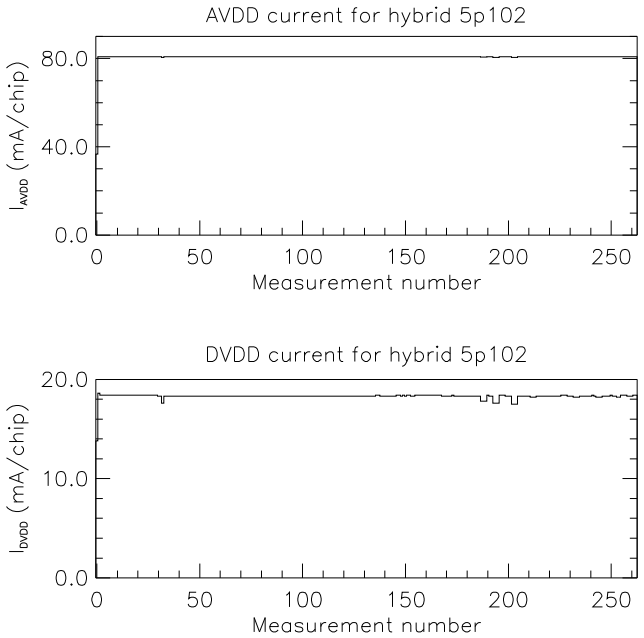
Supply Currents During Burn-in

The following plots show the supply currents per chip as a function of measurment number. Currents are measured approximately every 10 minutes:
