Hybrid 5p104 Traveler

December 8, 1999

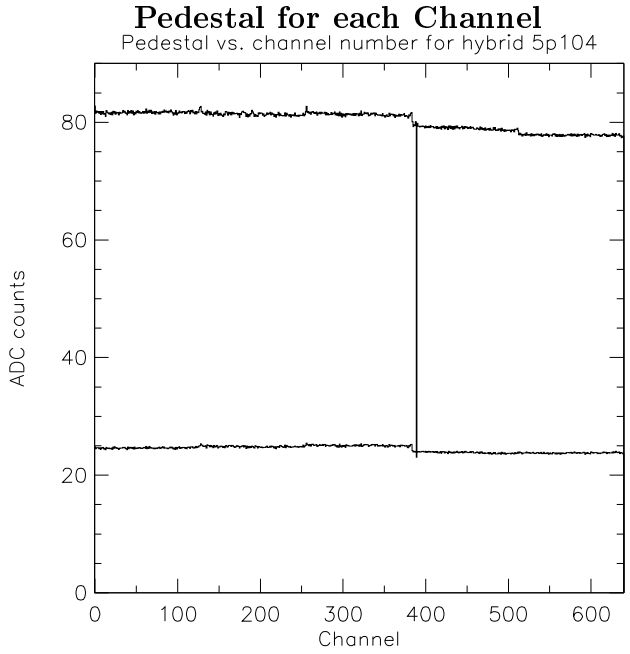
The following plot shows the pedestals vs. channel number with and without charge injection:

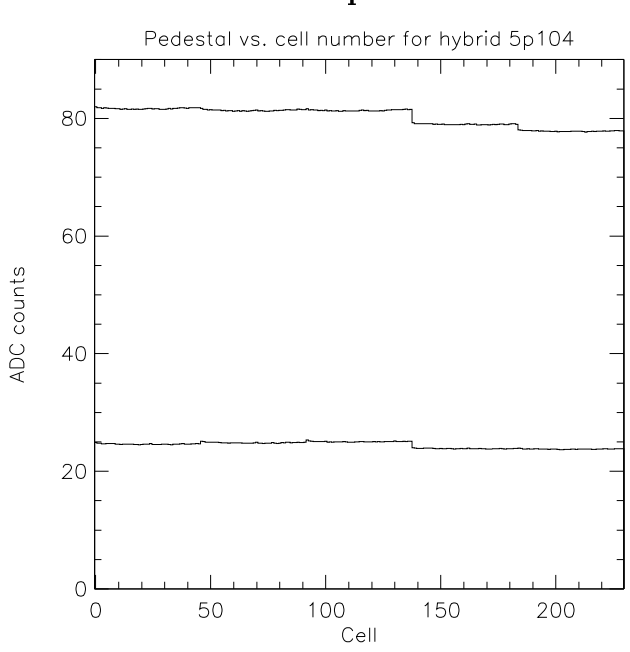
The following plot shows the average pedestal vs. pipeline cell ID with and without charge injection. The x-axis is cell ID offset by 46 for each chip. Thus cell ID 5 for chip 1 is at x=5, chip 2 at x=51, chip 3 at x=97, etc.

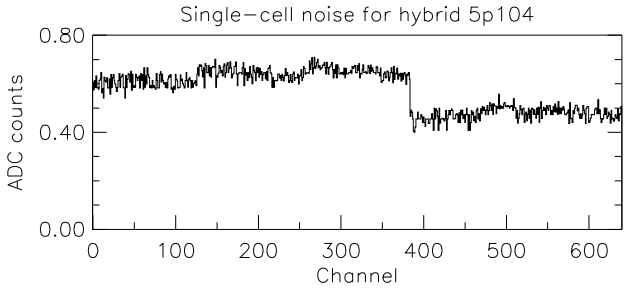
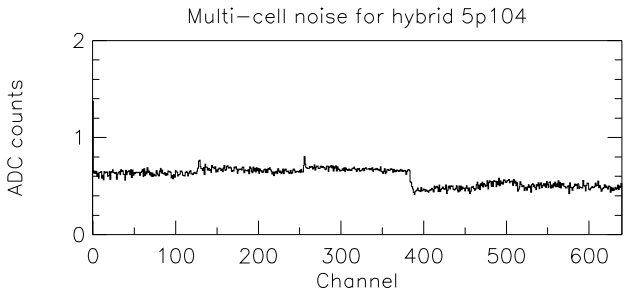
RMS Noise

The following plots show the single-cell and multi-cell RMS noise:

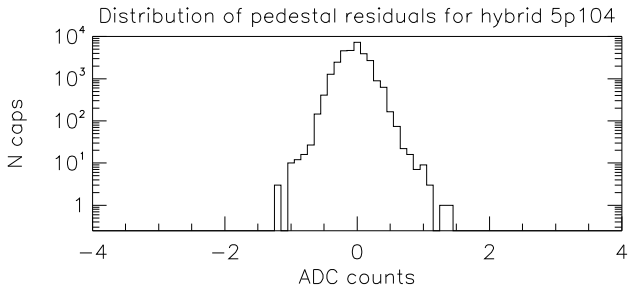
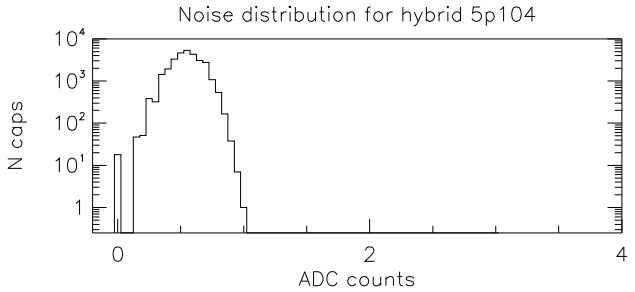
Distribution of Pedestals and Noise

The following are histograms of the pedestal of each pipeline capacitor relative to the chip average (top); and the RMS noise of each capacitor (bottom):

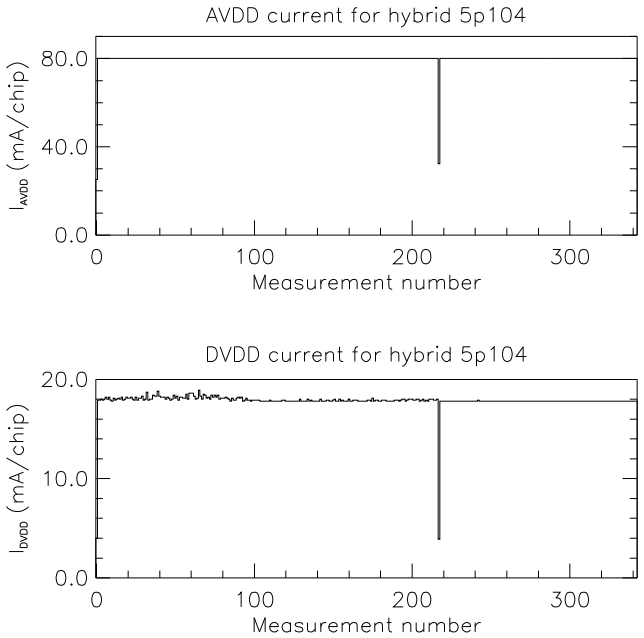
Supply Currents During Burn-in

The following plots show the supply currents per chip as a function of measurment number. Currents are measured approximately every 10 minutes:
