Hybrid 5p110 Traveler

January 28, 2000

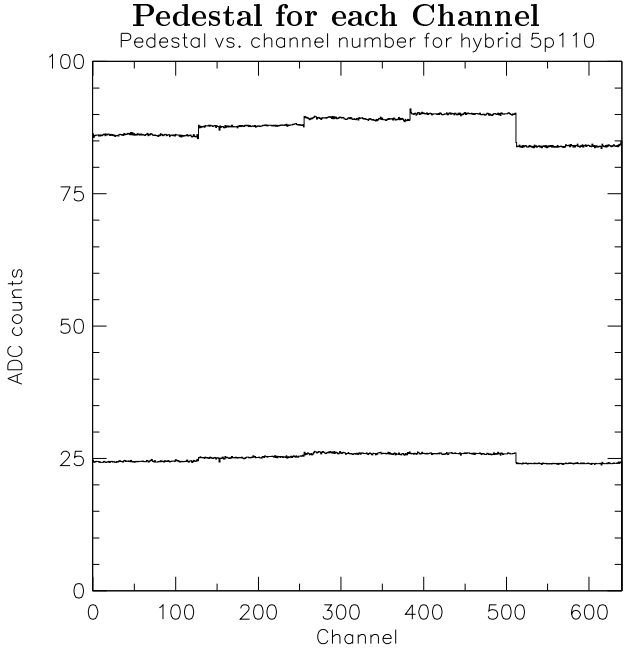
Pedestal for each Channel

The following plot shows the pedestals vs. channel number with and without charge injection:

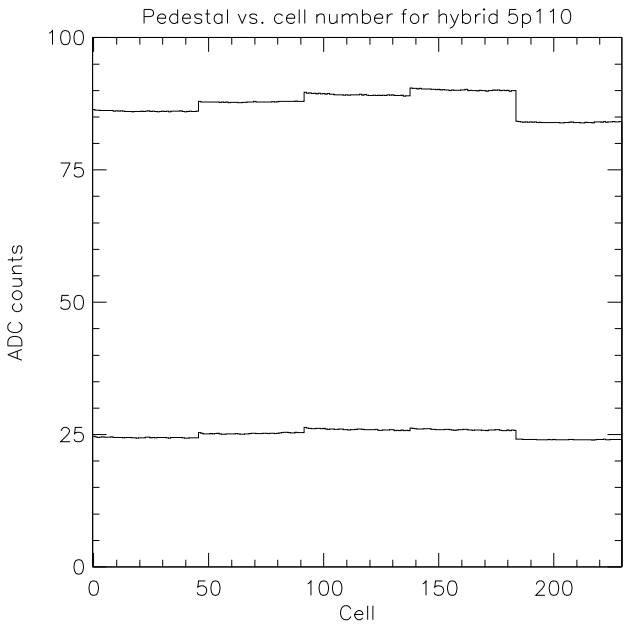
Pedestal vs. Pipeline Cell ID

The following plot shows the average pedestal vs. pipeline cell ID with and without charge injection. The x-axis is cell ID offset by 46 for each chip. Thus cell ID 5 for chip 1 is at x=5, chip 2 at x=51, chip 3 at x=97, etc.

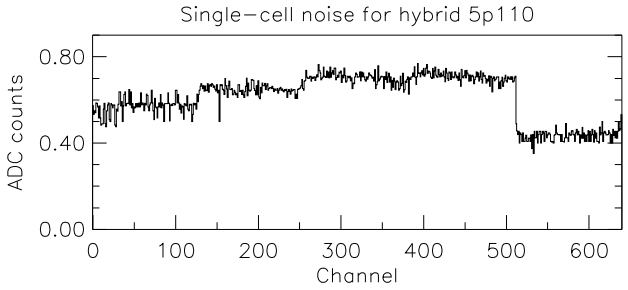
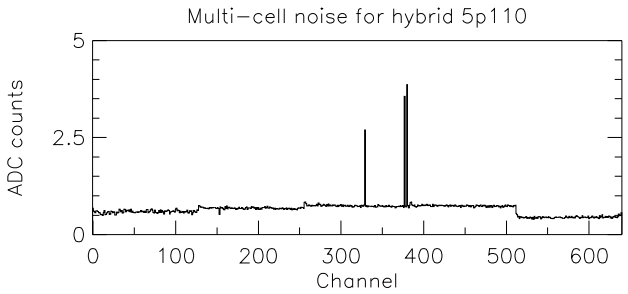
RMS Noise

The following plots show the single-cell and multi-cell RMS noise:

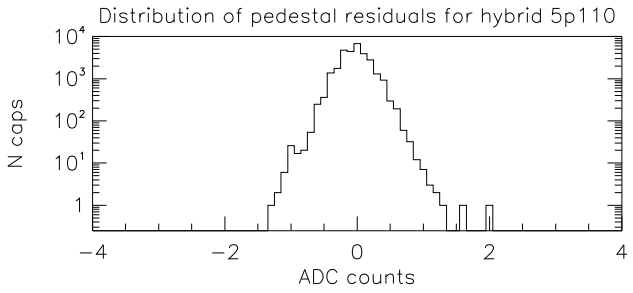
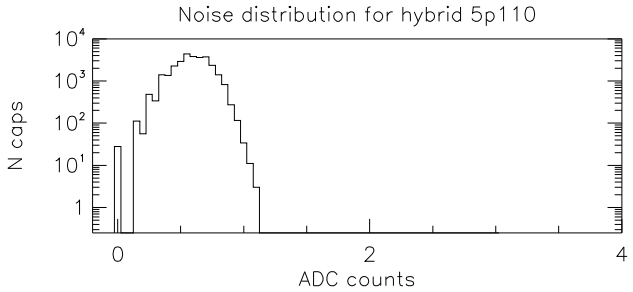
Distribution of Pedestals and Noise

The following are histograms of the pedestal of each pipeline capacitor relative to the chip average (top); and the RMS noise of each capacitor (bottom):

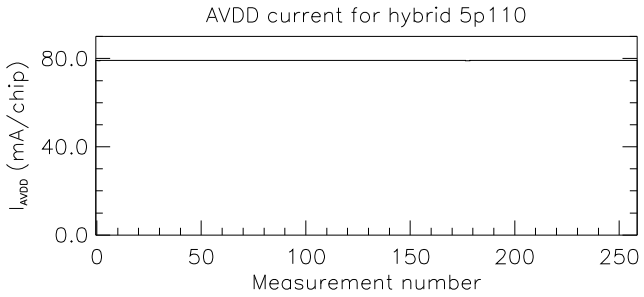
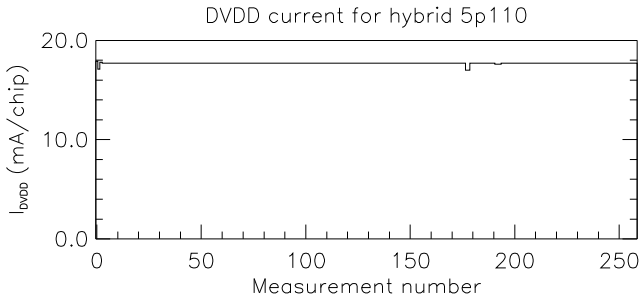
Supply Currents During Burn-in

The following plots show the supply currents per chip as a function of measurment number. Currents are measured approximately every 10 minutes:
