Hybrid 5p142 Traveler

January 14, 2000

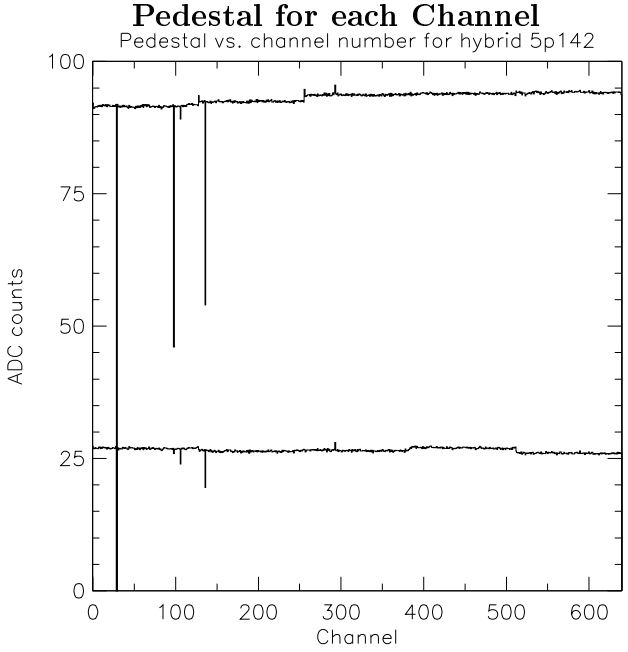
Pedestal for each Channel

The following plot shows the pedestals vs. channel number with and without charge injection:

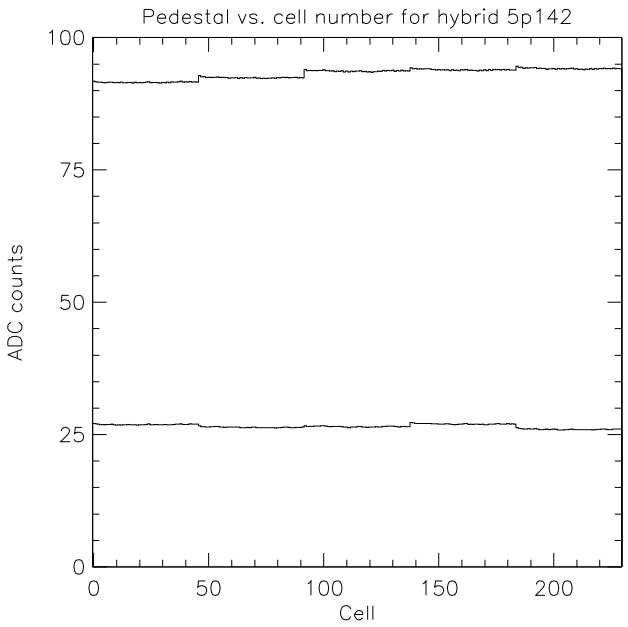
Pedestal vs. Pipeline Cell ID

The following plot shows the average pedestal vs. pipeline cell ID with and without charge injection. The x-axis is cell ID offset by 46 for each chip. Thus cell ID 5 for chip 1 is at x=5, chip 2 at x=51, chip 3 at x=97, etc.

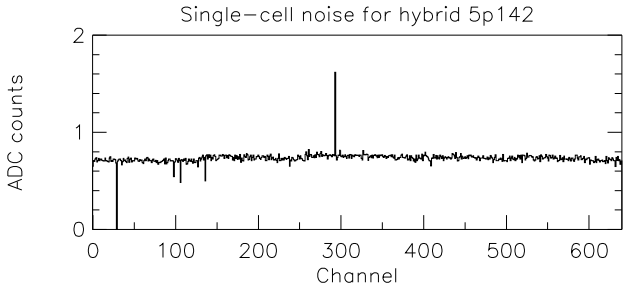
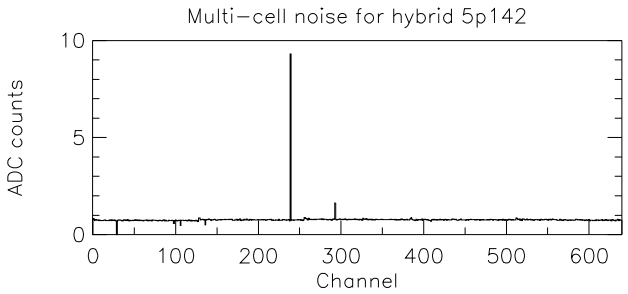
RMS Noise

The following plots show the single-cell and multi-cell RMS noise:

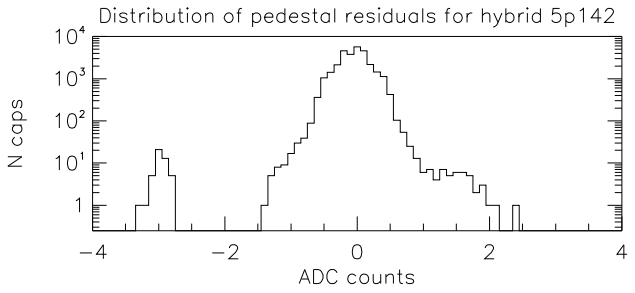
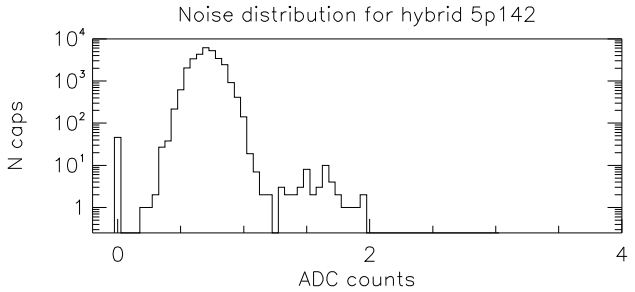
Distribution of Pedestals and Noise

The following are histograms of the pedestal of each pipeline capacitor relative to the chip average (top); and the RMS noise of each capacitor (bottom):

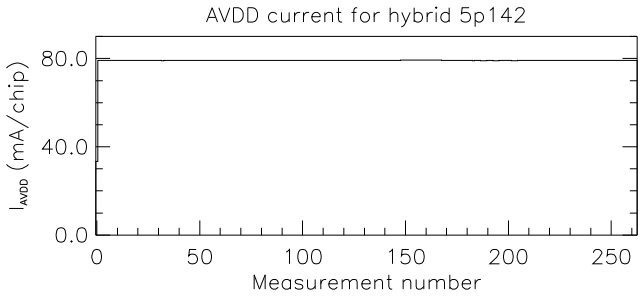
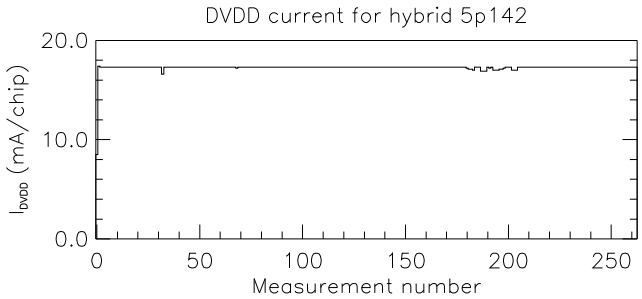
Supply Currents During Burn-in

The following plots show the supply currents per chip as a function of measurment number. Currents are measured approximately every 10 minutes:
