Hybrid 5p149 Traveler

April 17, 2000

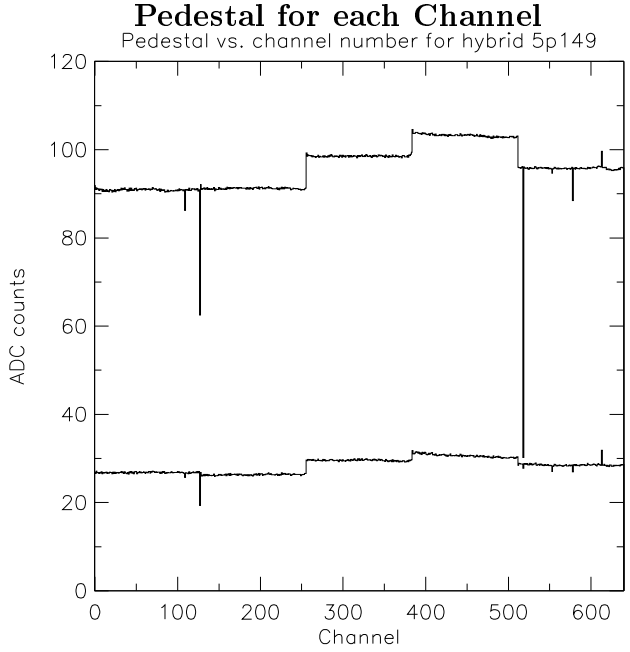
Pedestal for each Channel

Hybrid 5p149 quality: fair*
Chip classification: fair good good fair* fair
Bad channels (chip-channel): 0-109 0-127 4-6 4-66
Bad cells: none
Random bad capacitors (chip-cell-channel): 3-15-14 4-0-101
Channels at pedestal needed for DCMS: 36.1 34.6 35.6 37.8 37.4
```
