Hybrid 5p19 Traveler

January 25, 2000

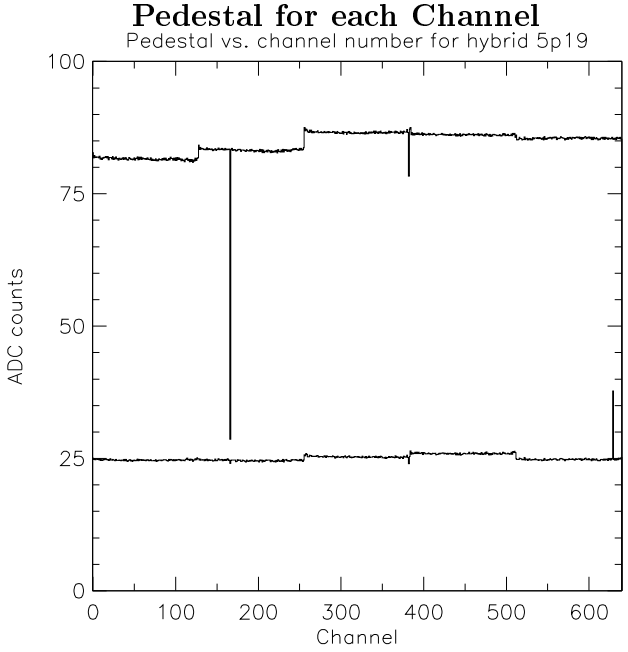
Pedestal for each Channel

The following plot shows the pedestals vs. channel number with and without charge injection:

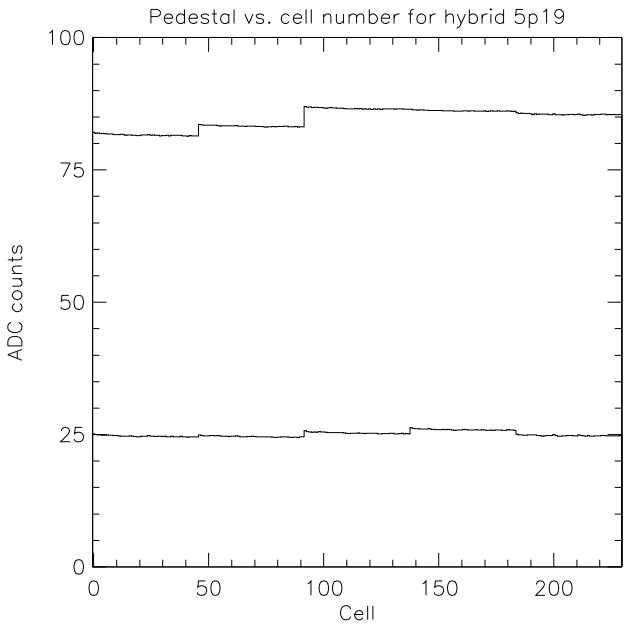
Pedestal vs. Pipeline Cell ID

The following plot shows the average pedestal vs. pipeline cell ID with and without charge injection. The x-axis is cell ID offset by 46 for each chip. Thus cell ID 5 for chip 1 is at x=5, chip 2 at x=51, chip 3 at x=97, etc.

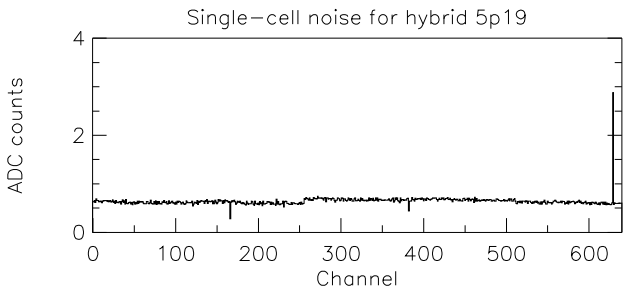
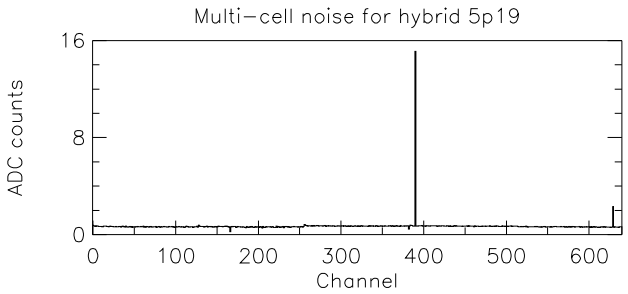
RMS Noise

The following plots show the single-cell and multi-cell RMS noise:

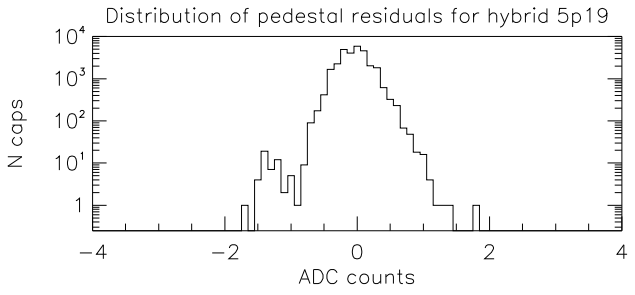
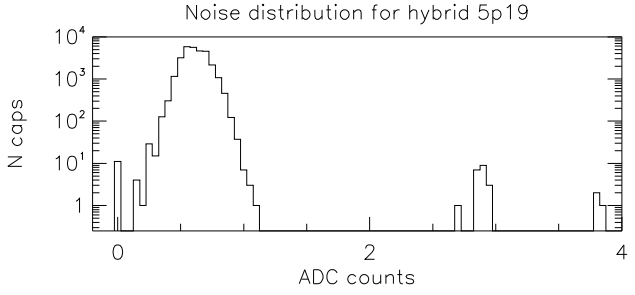
Distribution of Pedestals and Noise

The following are histograms of the pedestal of each pipeline capacitor relative to the chip average (top); and the RMS noise of each capacitor (bottom):

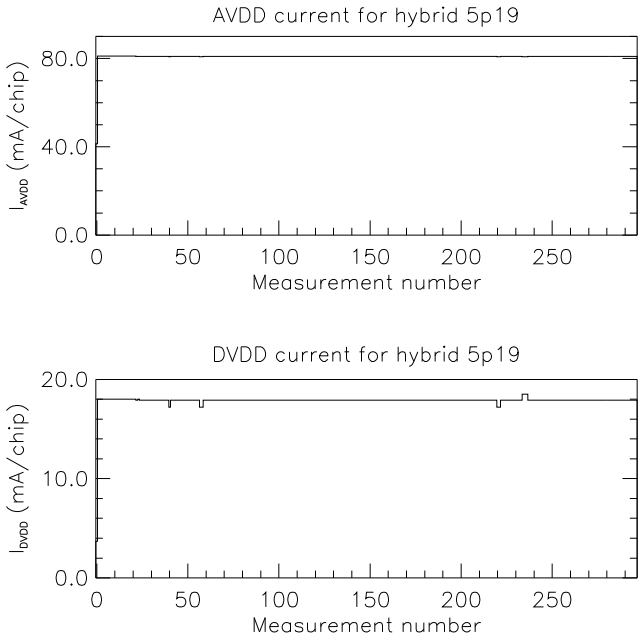
Supply Currents During Burn-in

The following plots show the supply currents per chip as a function of measurment number. Currents are measured approximately every 10 minutes:
