Hybrid 5p34 Traveler

March 7, 2000

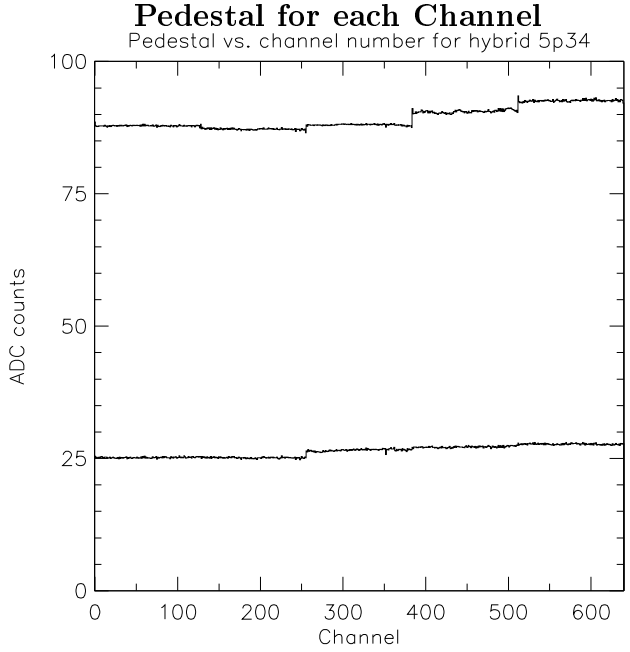
Pedestal for each Channel

The following plot shows the pedestals vs. channel number with and without charge injection:

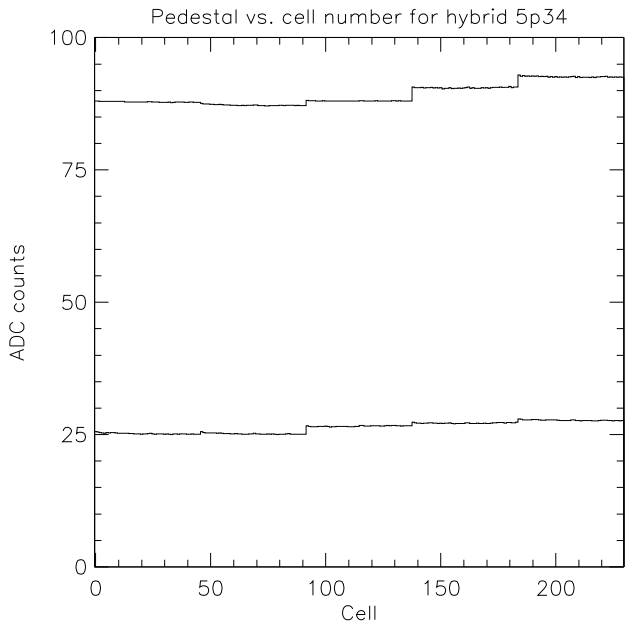
Pedestal vs. Pipeline Cell ID

The following plot shows the average pedestal vs. pipeline cell ID with and without charge injection. The x-axis is cell ID offset by 46 for each chip. Thus cell ID 5 for chip 1 is at x=5, chip 2 at x=51, chip 3 at x=97, etc.

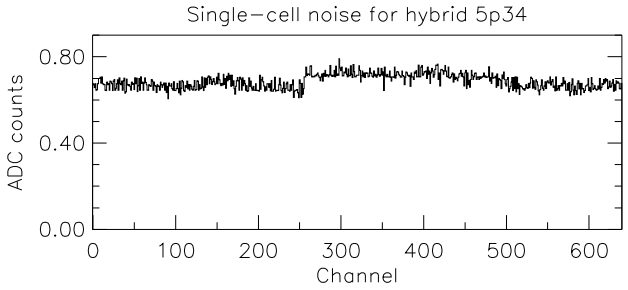
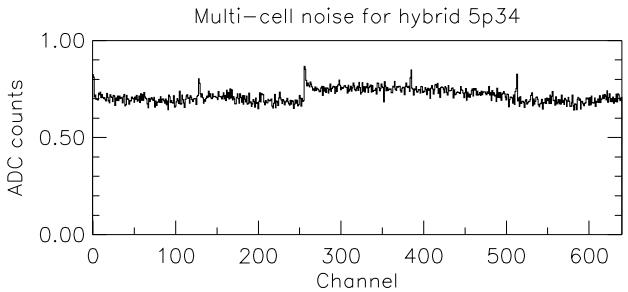
RMS Noise

The following plots show the single-cell and multi-cell RMS noise:

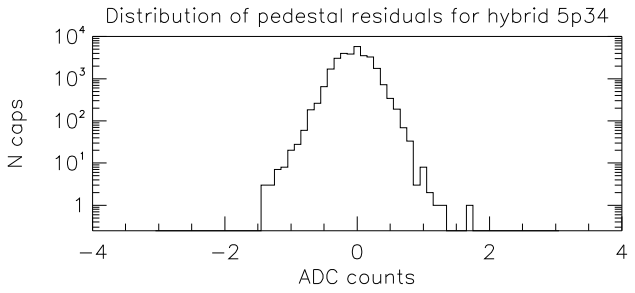
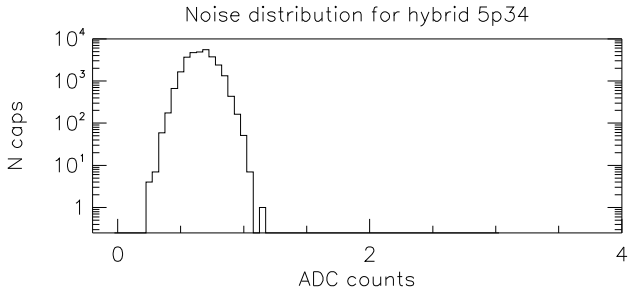
Distribution of Pedestals and Noise

The following are histograms of the pedestal of each pipeline capacitor relative to the chip average (top); and the RMS noise of each capacitor (bottom):

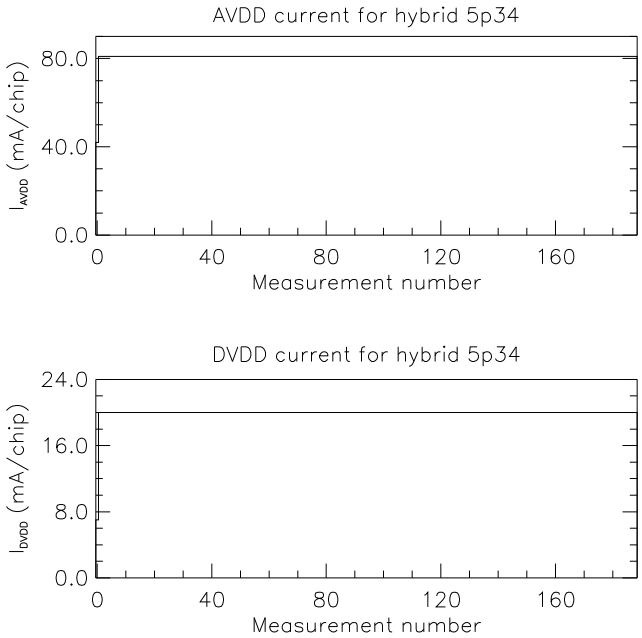
Supply Currents During Burn-in

The following plots show the supply currents per chip as a function of measurment number. Currents are measured approximately every 10 minutes:
