Hybrid 5p72 Traveler

January 18, 2000

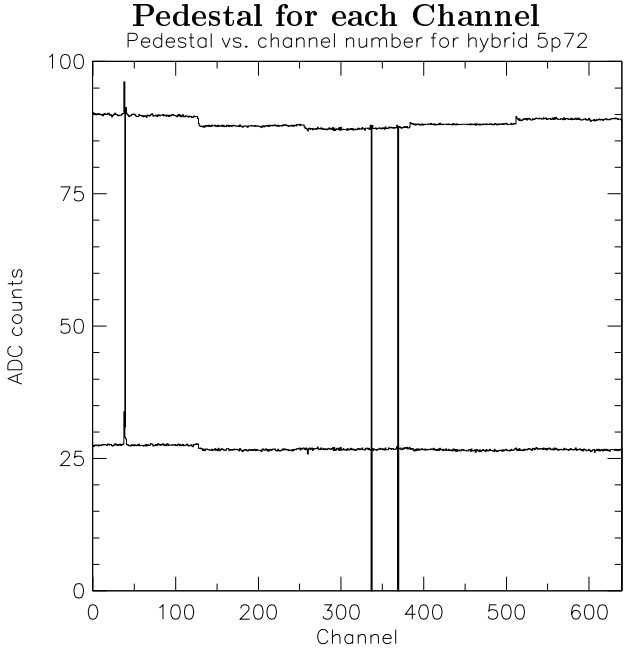
Pedestal for each Channel

Hybrid 5p72 quality: fair
Chip classification: fair good fair good fair
Bad channels (chip-channel): 0-38 0-39 2-81 2-113 4-11
Bad cells: none
Random bad capacitors: none
Channels at pedestal needed for DCMS: 28.7 33.7 33.7 36.7 32.7
```

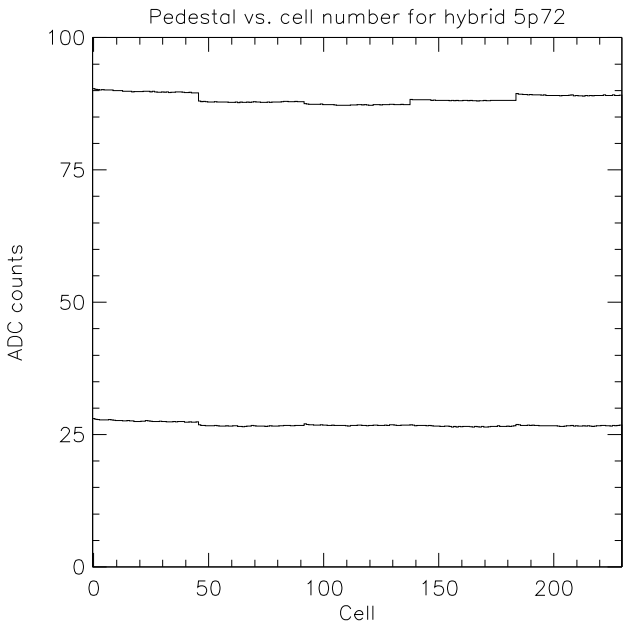
Pedestal vs. Pipeline Cell ID

The following plot shows the average pedestal vs. pipeline cell ID with and without charge injection. The x-axis is cell ID offset by 46 for each chip. Thus cell ID 5 for chip 1 is at x=5, chip 2 at x=51, chip 3 at x=97, etc.

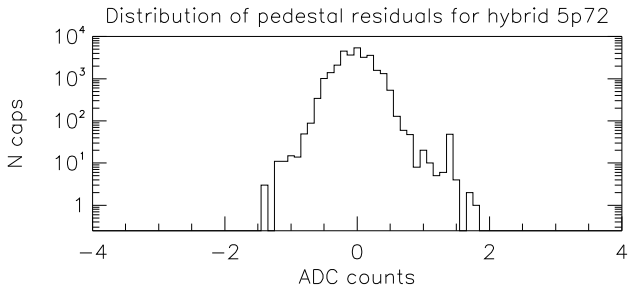
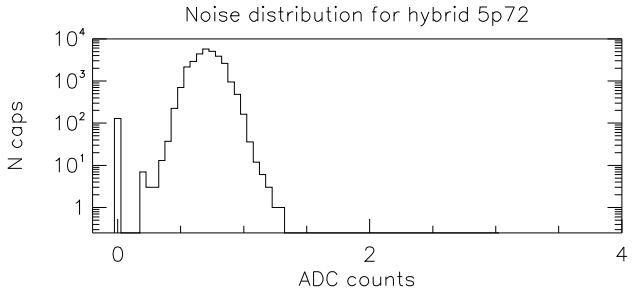
Distribution of Pedestals and Noise

The following are histograms of the pedestal of each pipeline capacitor relative to the chip average (top); and the RMS noise of each capacitor (bottom):

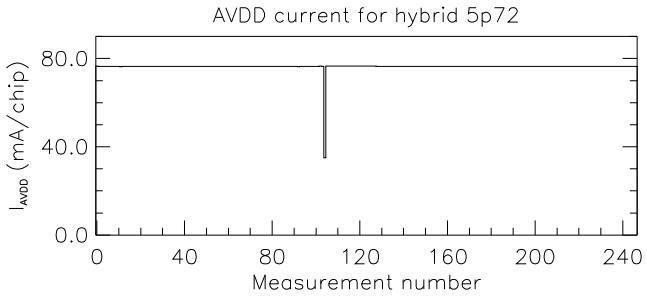
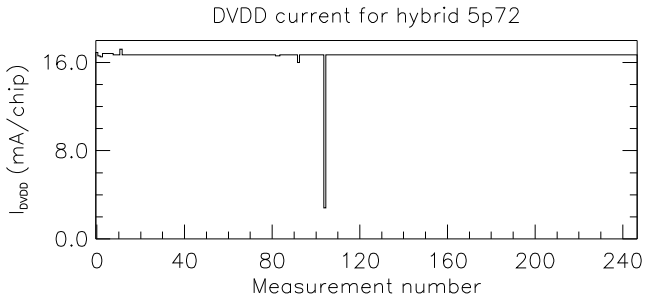
Supply Currents During Burn-in

The following plots show the supply currents per chip as a function of measurment number. Currents are measured approximately every 10 minutes:
