Hybrid 5p75 Traveler

June 5, 2000

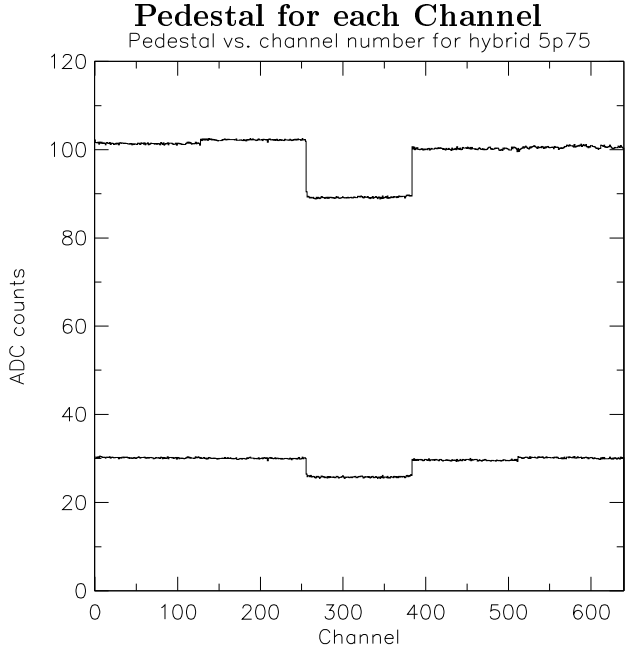
Pedestal for each Channel

Hybrid 5p75 quality: fair
Chip classification: good fair fair good good
Bad channels (chip-channel): 1-81 1-119 2-89
Bad cells: none
Random bad capacitors (chip-cell-channel): 1-30-81 2-2-17
Channels at pedestal needed for DCMS: 28.7 30.7 30.7 29.6 30.6
```

The following plot shows the pedestals vs. channel number with and without charge injection:

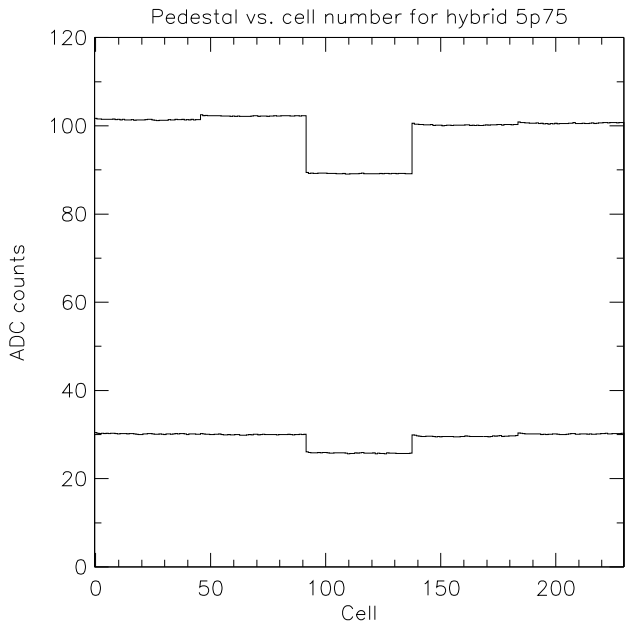
Pedestal vs. Pipeline Cell ID

The following plot shows the average pedestal vs. pipeline cell ID with and without charge injection. The x-axis is cell ID offset by 46 for each chip. Thus cell ID 5 for chip 1 is at x=5, chip 2 at x=51, chip 3 at x=97, etc.

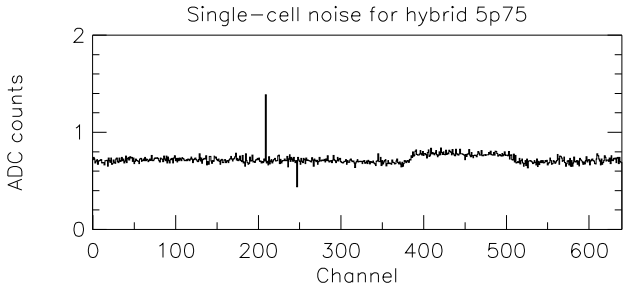
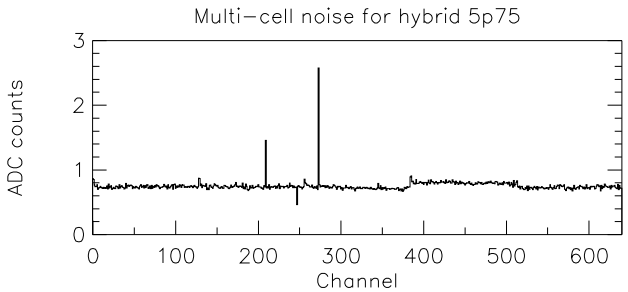
RMS Noise

The following plots show the single-cell and multi-cell RMS noise:

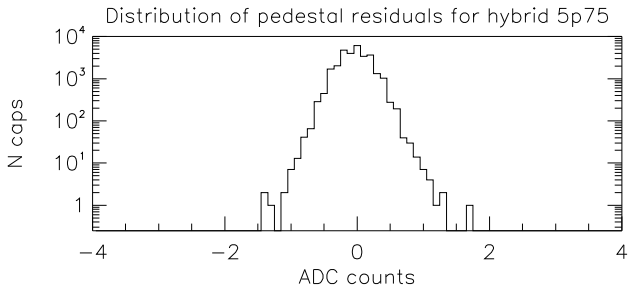
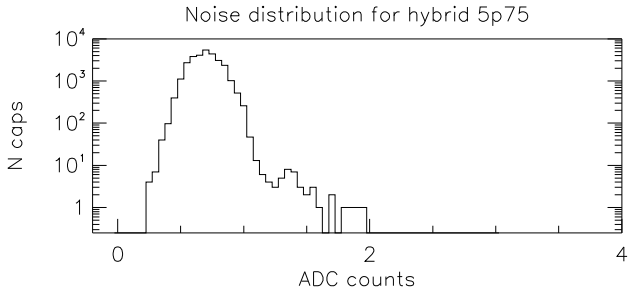
Distribution of Pedestals and Noise

The following are histograms of the pedestal of each pipeline capacitor relative to the chip average (top); and the RMS noise of each capacitor (bottom):

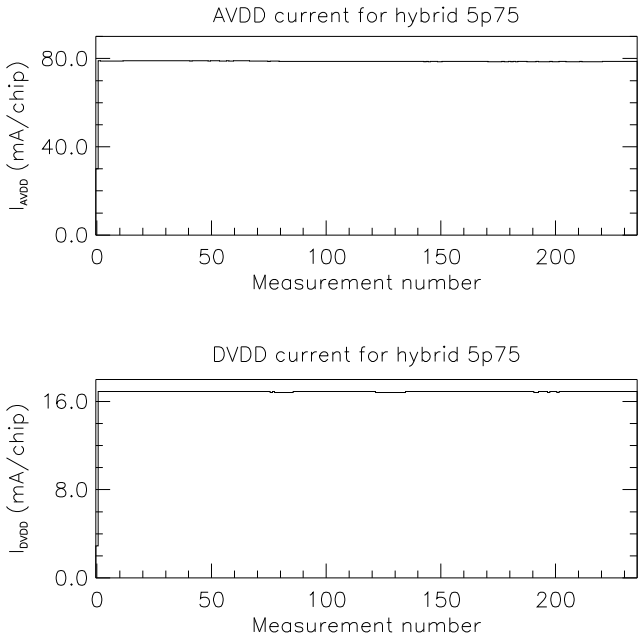
Supply Currents During Burn-in

The following plots show the supply currents per chip as a function of measurment number. Currents are measured approximately every 10 minutes:
