Hybrid 5p79 Traveler

April 14, 2000

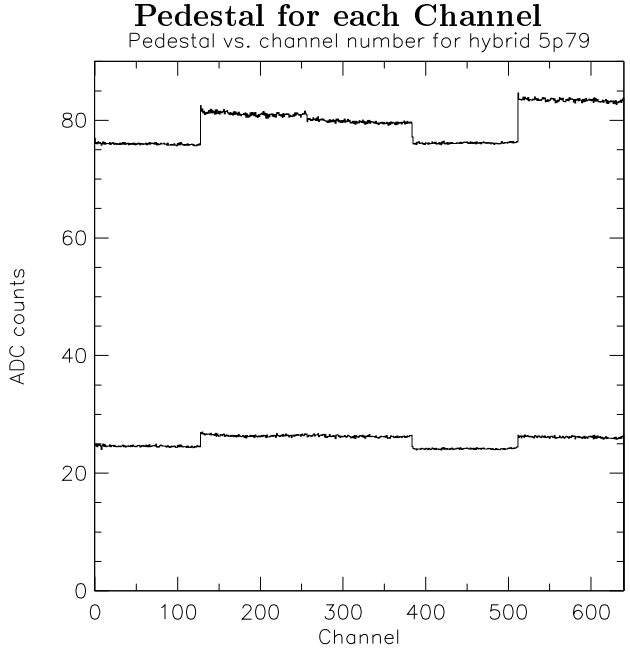
Pedestal for each Channel

The following plot shows the pedestals vs. channel number with and without charge injection:

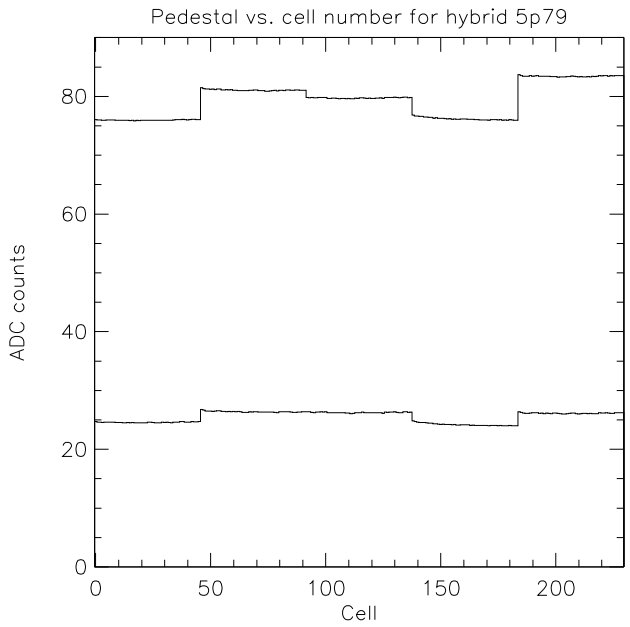
Pedestal vs. Pipeline Cell ID

The following plot shows the average pedestal vs. pipeline cell ID with and without charge injection. The x-axis is cell ID offset by 46 for each chip. Thus cell ID 5 for chip 1 is at x=5, chip 2 at x=51, chip 3 at x=97, etc.

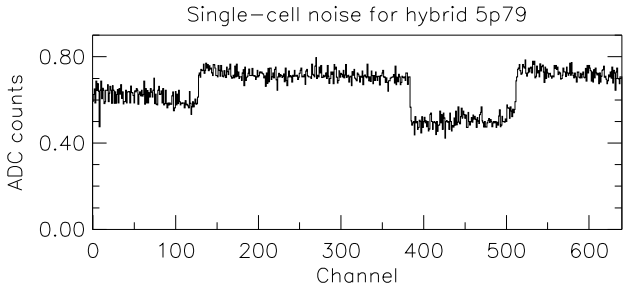
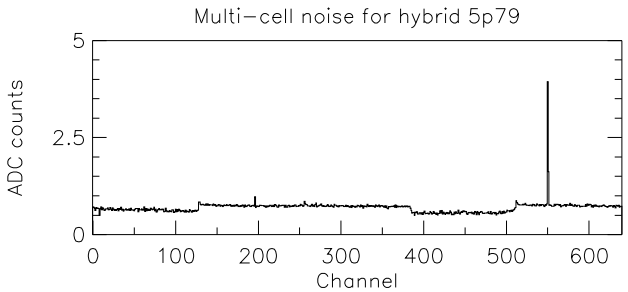
RMS Noise

The following plots show the single-cell and multi-cell RMS noise:

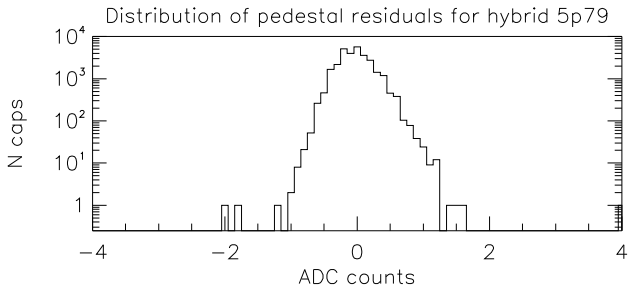
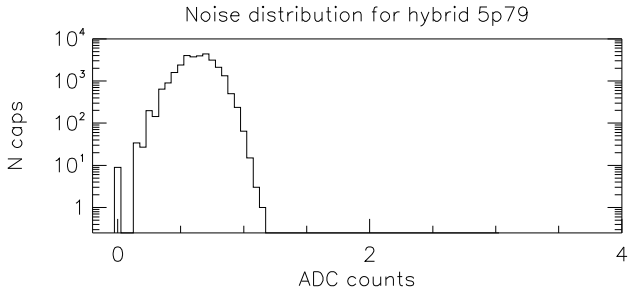
Distribution of Pedestals and Noise

The following are histograms of the pedestal of each pipeline capacitor relative to the chip average (top); and the RMS noise of each capacitor (bottom):

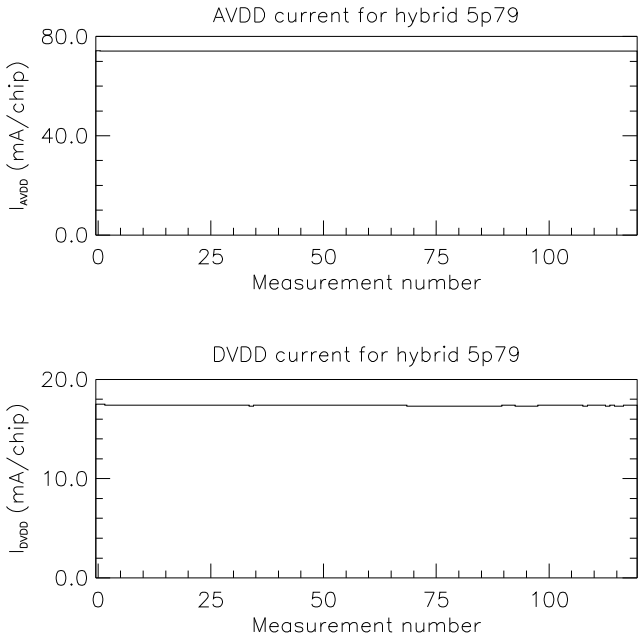
Supply Currents During Burn-in

The following plots show the supply currents per chip as a function of measurment number. Currents are measured approximately every 10 minutes:
