Hybrid 5p82 Traveler

March 7, 2000

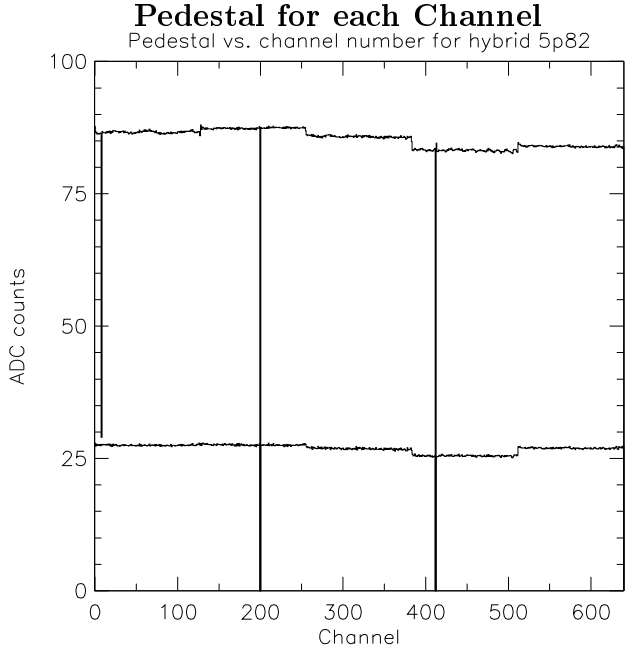
Pedestal for each Channel

The following plot shows the pedestals vs. channel number with and without charge injection:

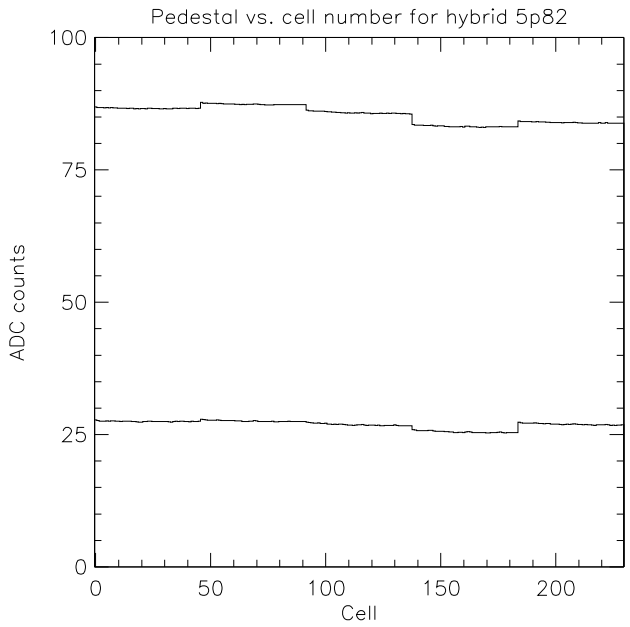
Pedestal vs. Pipeline Cell ID

The following plot shows the average pedestal vs. pipeline cell ID with and without charge injection. The x-axis is cell ID offset by 46 for each chip. Thus cell ID 5 for chip 1 is at x=5, chip 2 at x=51, chip 3 at x=97, etc.

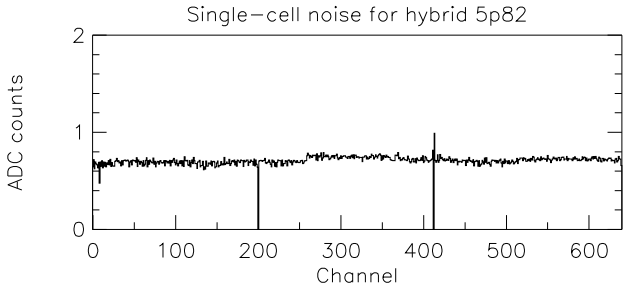
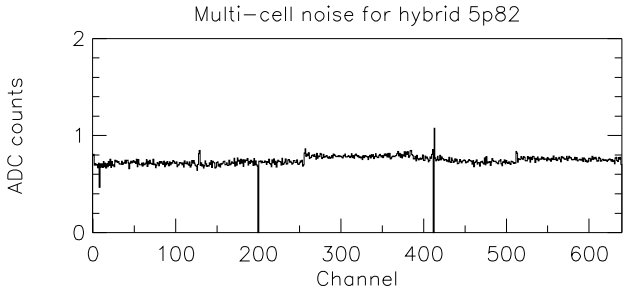
RMS Noise

The following plots show the single-cell and multi-cell RMS noise:

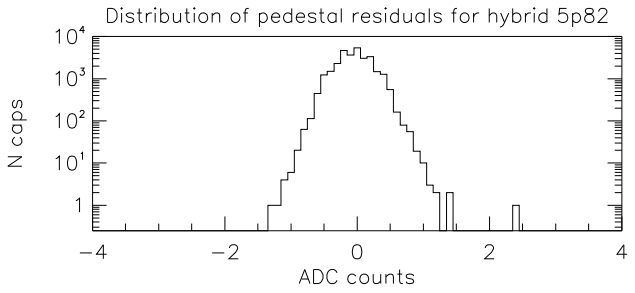
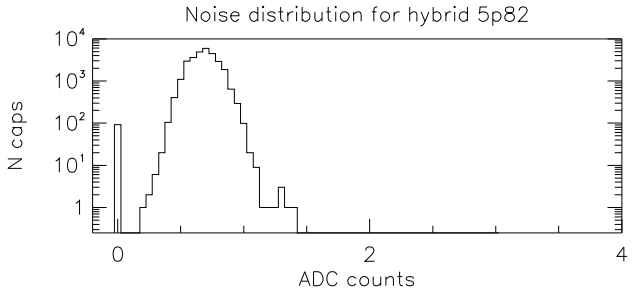
Distribution of Pedestals and Noise

The following are histograms of the pedestal of each pipeline capacitor relative to the chip average (top); and the RMS noise of each capacitor (bottom):

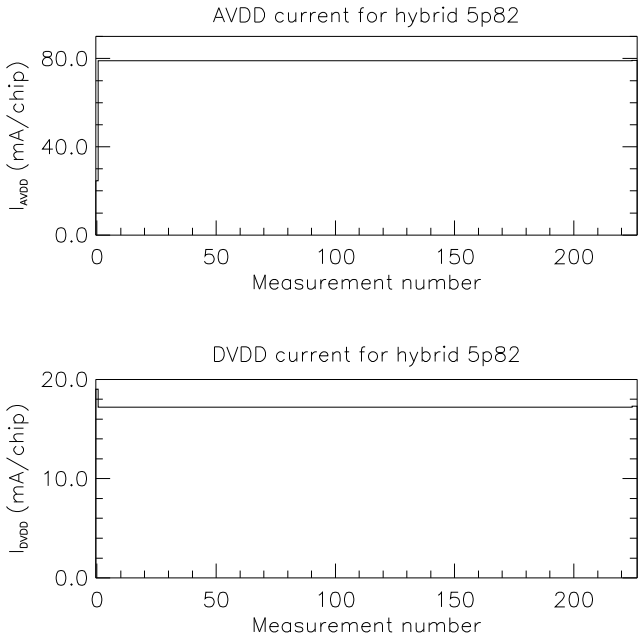
Supply Currents During Burn-in

The following plots show the supply currents per chip as a function of measurment number. Currents are measured approximately every 10 minutes:
