Hybrid 5p9 Traveler

January 4, 2000

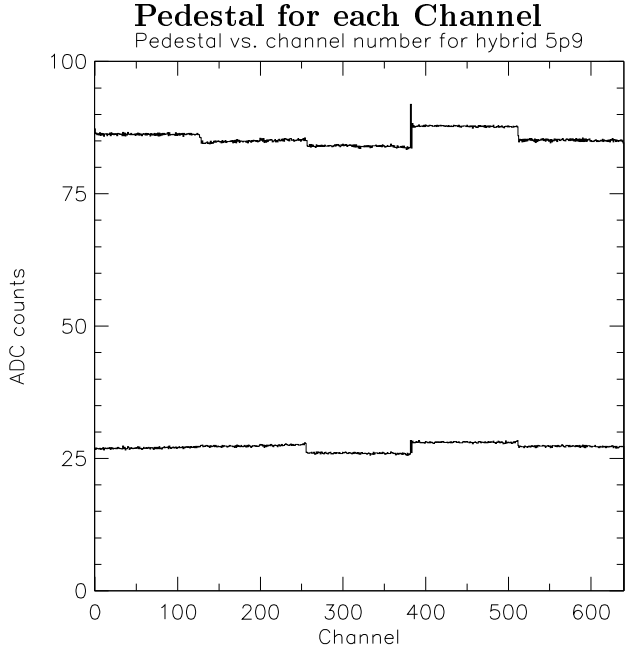
Pedestal for each Channel

The following plot shows the pedestals vs. channel number with and without charge injection:

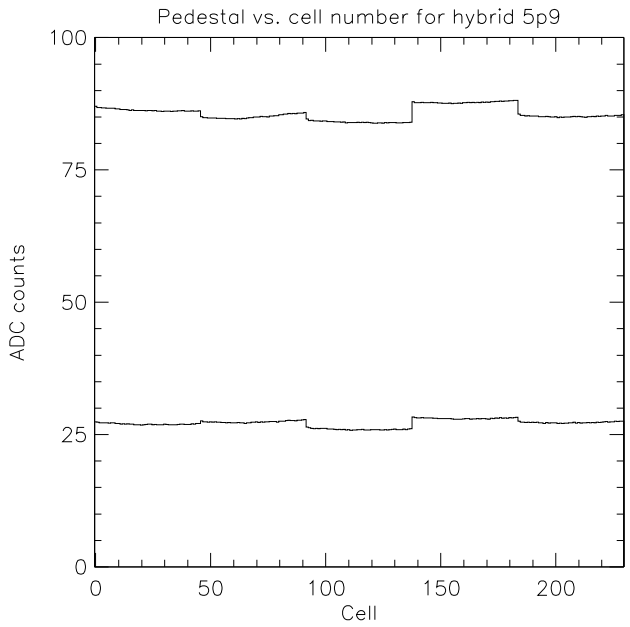
Pedestal vs. Pipeline Cell ID

The following plot shows the average pedestal vs. pipeline cell ID with and without charge injection. The x-axis is cell ID offset by 46 for each chip. Thus cell ID 5 for chip 1 is at x=5, chip 2 at x=51, chip 3 at x=97, etc.

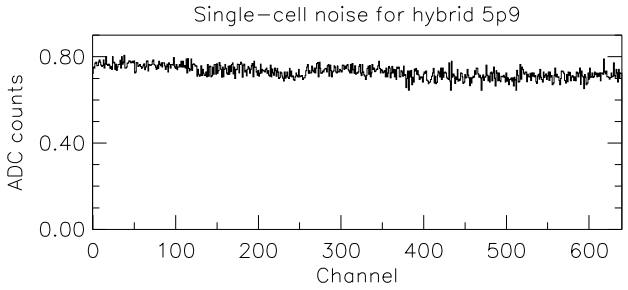
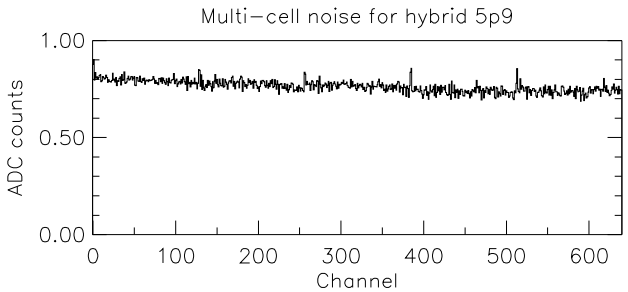
RMS Noise

The following plots show the single-cell and multi-cell RMS noise:

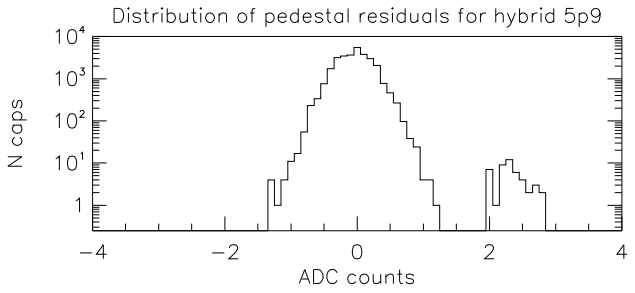
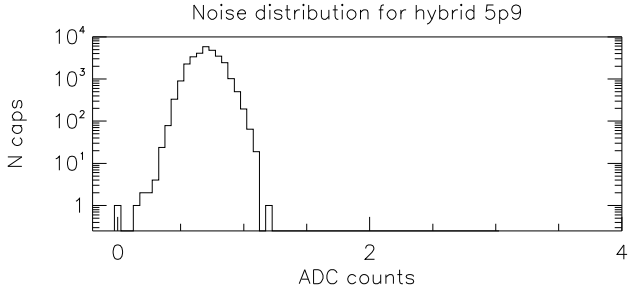
Distribution of Pedestals and Noise

The following are histograms of the pedestal of each pipeline capacitor relative to the chip average (top); and the RMS noise of each capacitor (bottom):

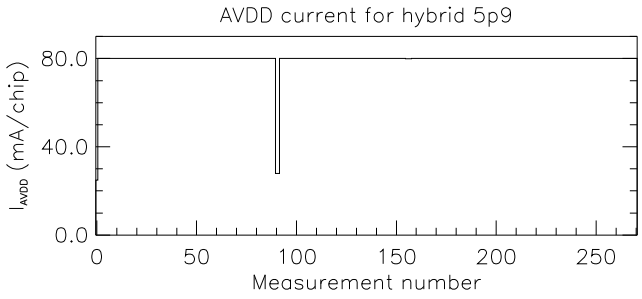
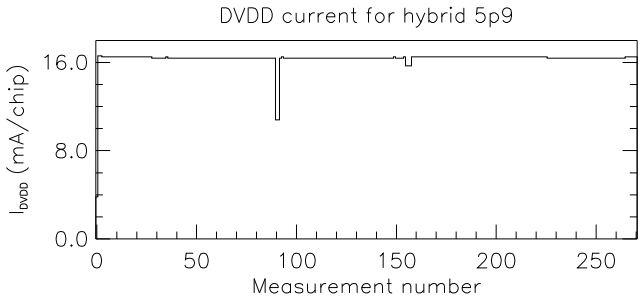
Supply Currents During Burn-in

The following plots show the supply currents per chip as a function of measurment number. Currents are measured approximately every 10 minutes:
