Hybrid 5p91 Traveler

December 21, 1999

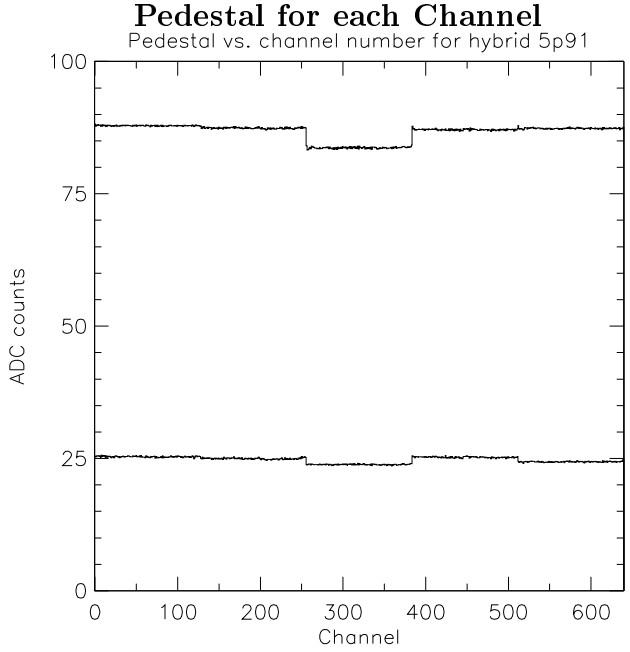
Pedestal for each Channel

The following plot shows the pedestals vs. channel number with and without charge injection:

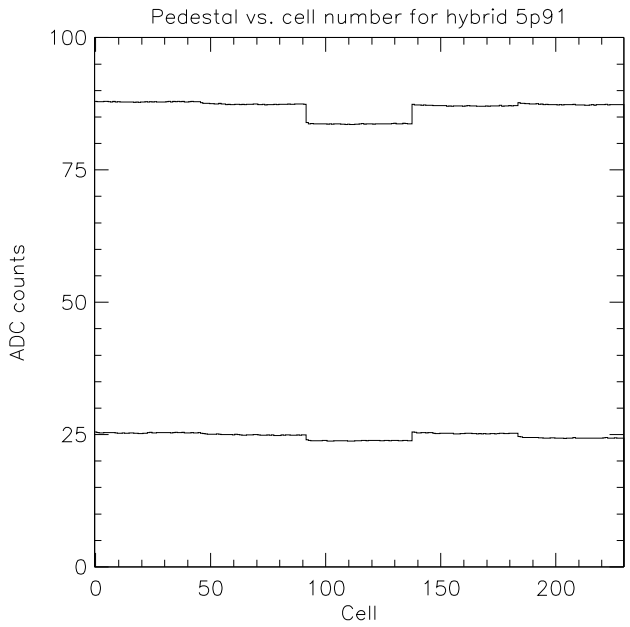
Pedestal vs. Pipeline Cell ID

The following plot shows the average pedestal vs. pipeline cell ID with and without charge injection. The x-axis is cell ID offset by 46 for each chip. Thus cell ID 5 for chip 1 is at x=5, chip 2 at x=51, chip 3 at x=97, etc.

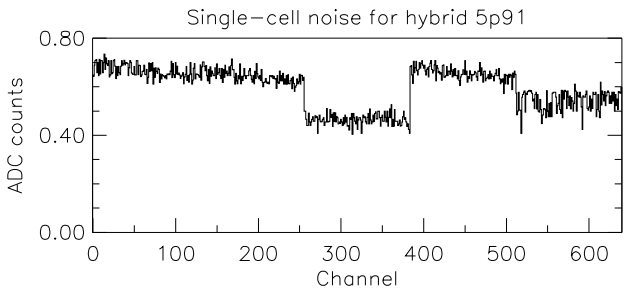
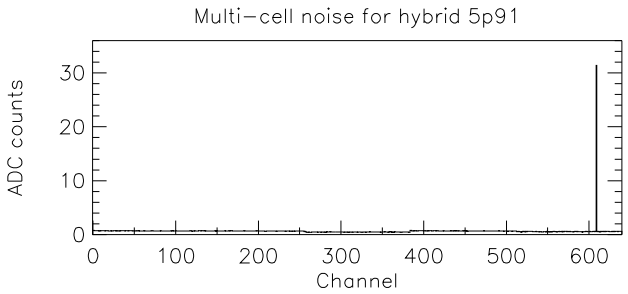
RMS Noise

The following plots show the single-cell and multi-cell RMS noise:

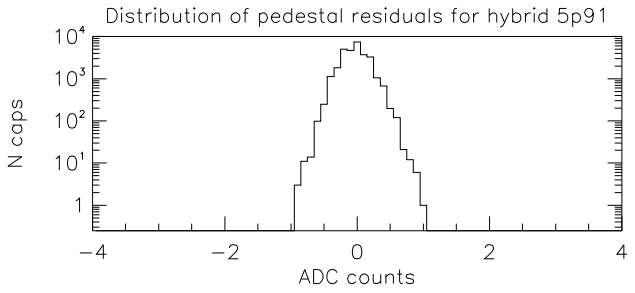
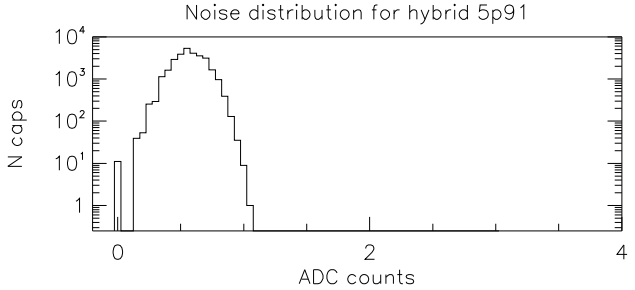
Distribution of Pedestals and Noise

The following are histograms of the pedestal of each pipeline capacitor relative to the chip average (top); and the RMS noise of each capacitor (bottom):

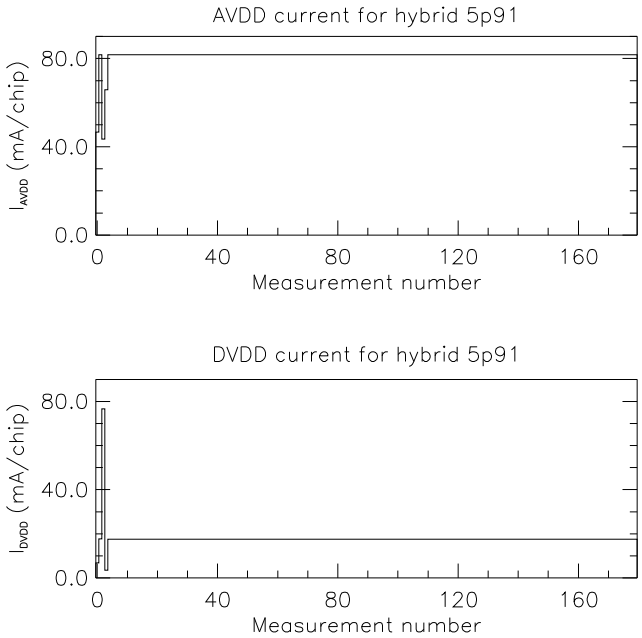
Supply Currents During Burn-in

The following plots show the supply currents per chip as a function of measurment number. Currents are measured approximately every 10 minutes:
