Hybrid 5p92 Traveler

February 8, 2000

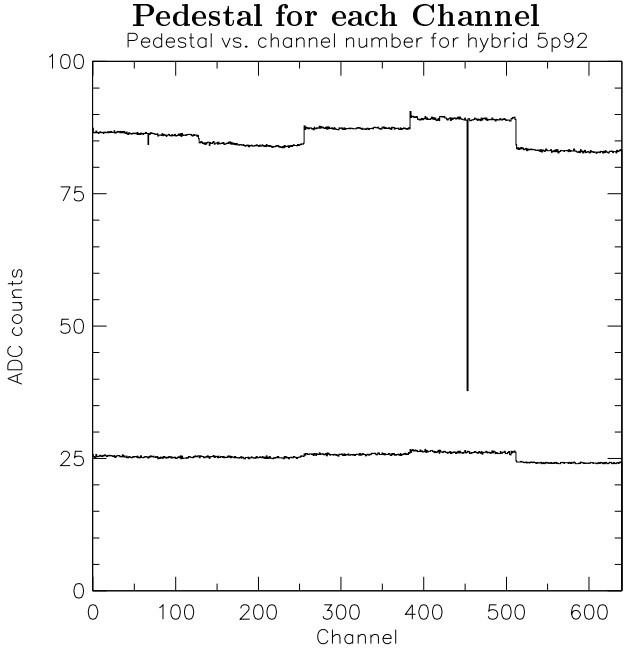
Pedestal for each Channel

The following plot shows the pedestals vs. channel number with and without charge injection:

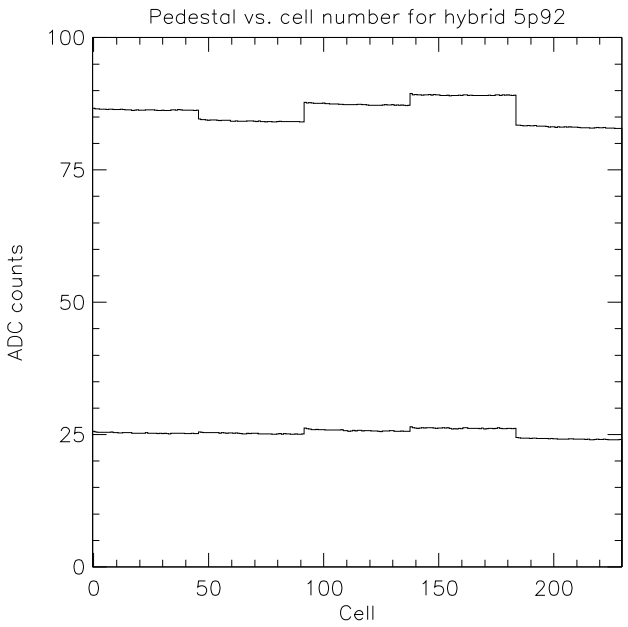
Pedestal vs. Pipeline Cell ID

The following plot shows the average pedestal vs. pipeline cell ID with and without charge injection. The x-axis is cell ID offset by 46 for each chip. Thus cell ID 5 for chip 1 is at x=5, chip 2 at x=51, chip 3 at x=97, etc.

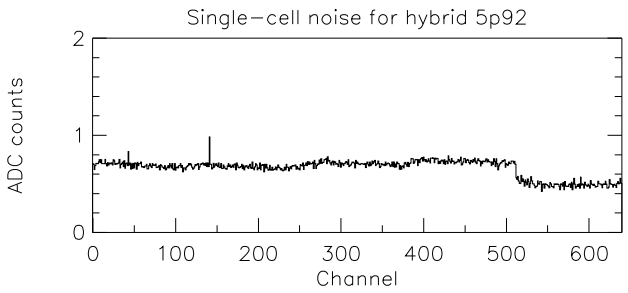
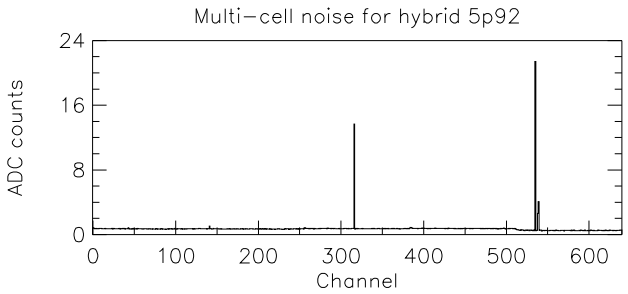
RMS Noise

The following plots show the single-cell and multi-cell RMS noise:

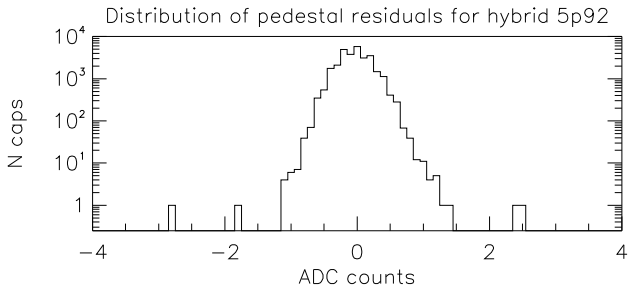
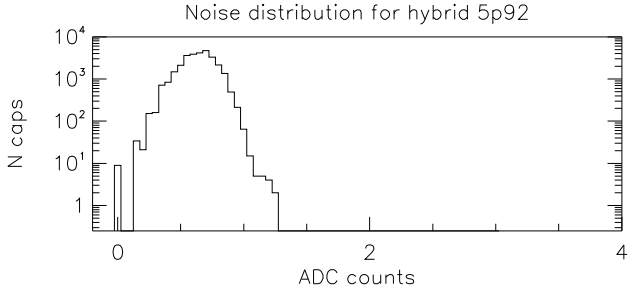
Distribution of Pedestals and Noise

The following are histograms of the pedestal of each pipeline capacitor relative to the chip average (top); and the RMS noise of each capacitor (bottom):

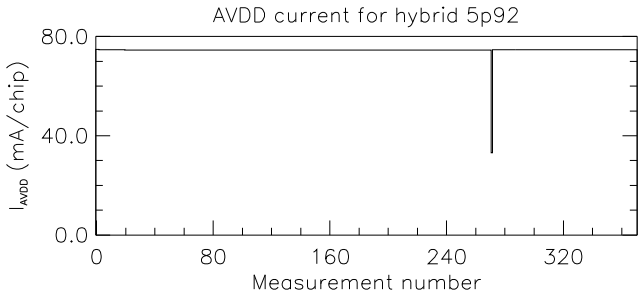
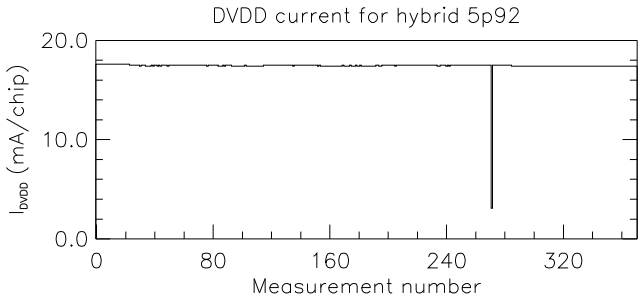
Supply Currents During Burn-in

The following plots show the supply currents per chip as a function of measurment number. Currents are measured approximately every 10 minutes:
